# Government of India Ministry of Railways

# Research, Designs & Standards Organisation Manak Nagar, Lucknow - 226 011

# MODIFICATION SHEET NO. RDSO/WAG 5/15 (New No. MS 228)

# <u>IMPROVEMENT MEASURES FOR SMOOTHING REACTORS TYPE: SL-42 AND SL-30</u>

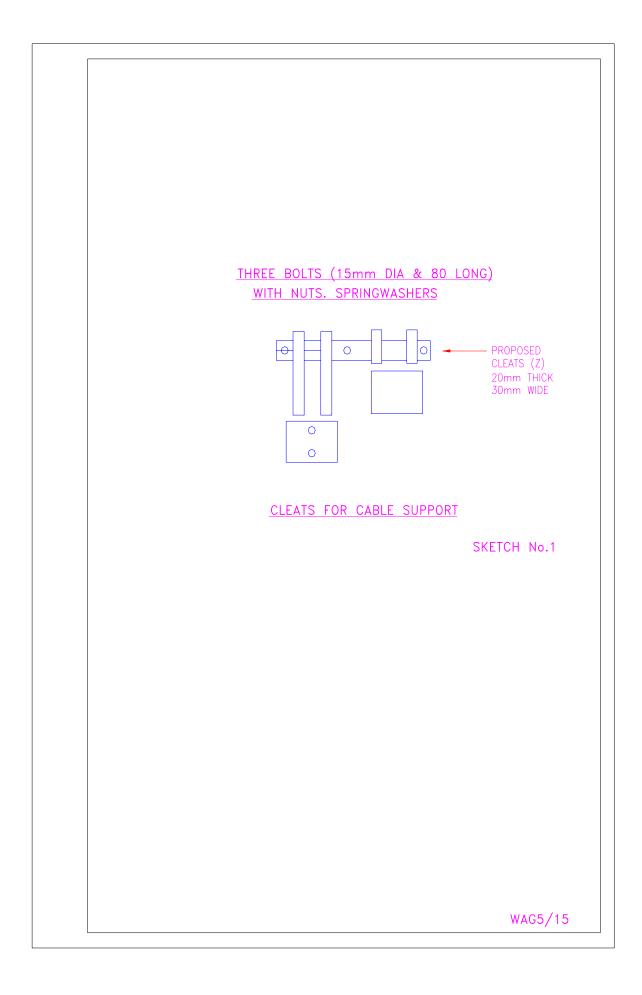
There exists a difference in levels of the two terminals on each side and the cables connected to the terminals at the lower levels passes close to the terminals on the higher level. due to vibration in service, these cables may rub with the terminals of the higher levels and cause failure.

In order to eliminate the possibility of such failure, a cleat made of synthetic resin bonded glss fibre conforming to IS: 10192 Gr. EPL should be provided as per details in sketch No.1

- (i) Cut two cleats to size as per details in sketch No.1
- (ii) The cut pieces maybe dried in oven at 110 deg. C for a period of 24 hours and then coated with anti tracking varnish.
- (iii) Fix these cleats on the smoothing reactor frame.

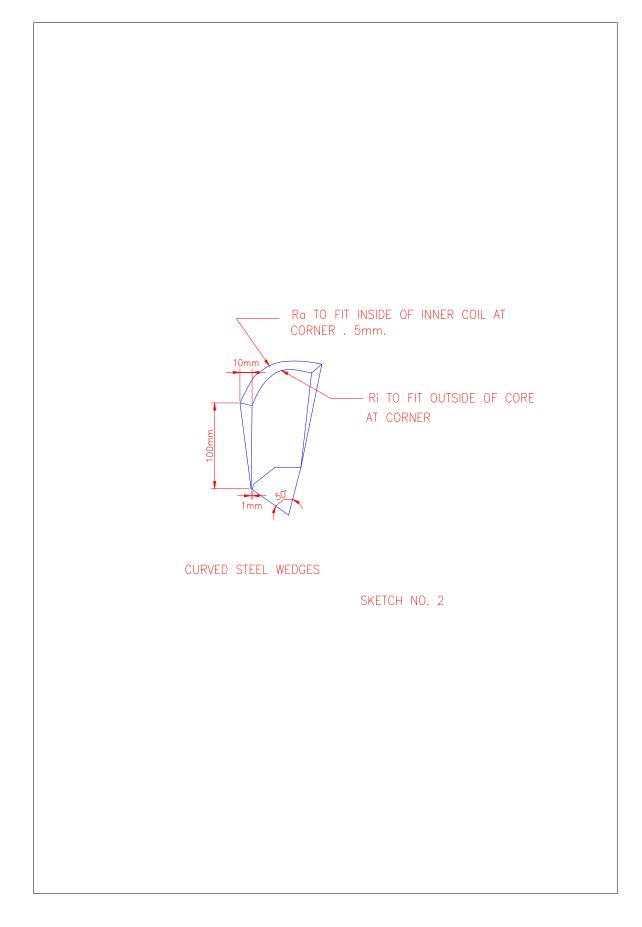
SL-42 and SL-30 if manufactured and assembled correctly will have a gap of 2.5 mm at the corners and 1 mm at the centres of flat portions of the core between the cores and the inner coils. some cases have been reported where ther was physical contach between the cores and the inner coils mostly at the corners. Due to expansion/contraction of the coil and also due to vibration the core coil insulation gets damaged and eventually there is an earth fault.

- **2.4** Re-insulate the core.
- 2.5 Correctly centre the coil on the core using curved steel wedges as shown in sketch No.2 at the corners. Remove these steel wedges after inserting flat insulating wedges in the flat portion of the core.

**Note:** The steel wedges can be manufactured by machining a hollow cylinder with tapered outer face and cutting it into 4 parts. All sharp edges and corners should be grounded off and surfaces polished to facilitate insertion and with drawl.
