GOVERNMENT OF INDIA MINISTRY OF RAILWAYS RESEARCH, DESIGNS & STANDARD ORGANISATION MANAK NAGAR, LUCKNOW-226011

MODIFICATION SHEET NO. ELRS/MS/0270/REV. 'O'

Standardization of location of BP/FP isolating cocks in electric locomotives.

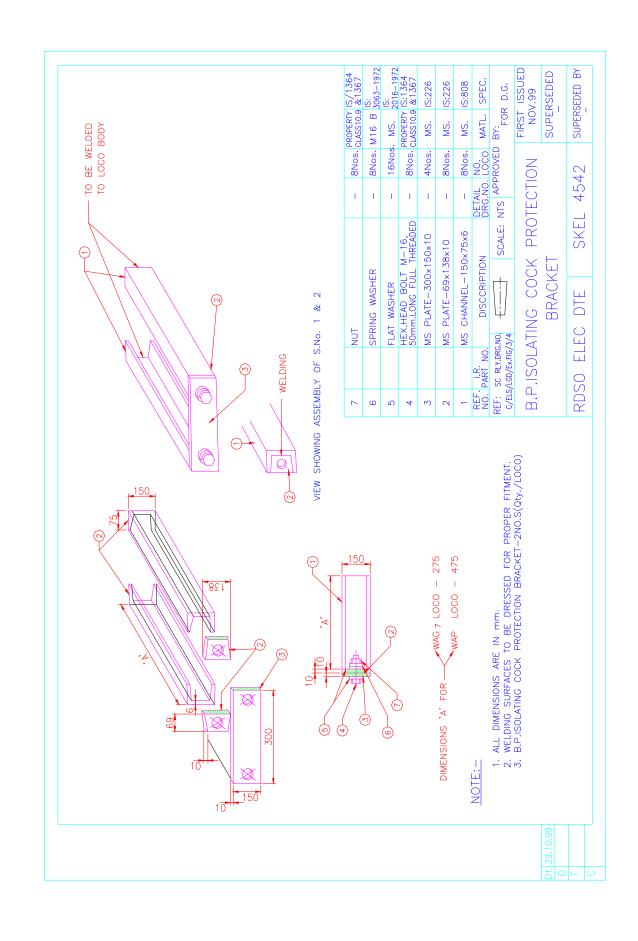
Drg. No SKEL-4542, Alt. '0'

The problem of breakage of BP/FP isolating cocks due to cattle run over is very common in electric locomotives. From time to time, different arrangements of BP/FP isolating cocks were tried and finally the arrangement suggested vide RDSO's letter No. SD. Dev. IRAVB-2 dated 18.5.93 was found most effective in reducing the cases of BP/FP isolating cocks breakages due to cattle run over. This is also presently being followed by CLW. During CELE's Conference held recently at Railway Board, it was decided that RDSO will issue a modification sheet to standadise the final location of BP/FP isolating cocks in order to clear all existing doubts on this subject. Accordingly this modification sheet is being issued.

2.2 To avoid breakage of `BP' isolating cock due to cattle hits a safety bracket is to be provided.

- 3.1 The location for BP/FP isolating cocks to be modified as per CLW's Drg No. 05/1/37/38. Alt `10' for WAG5/WAM4\WAG7 class of locomotives.
- 3.2 The location of BP/FP isolating cocks to be modified as per CLW's Drg. No. 03/1/37/33 `Alt `O' for WAP1/WAP3/WAP4 class of locomotives.
- 3.3 The safety bracket for protection of BP. Isolating cock, against damage in case of external hitting due to cattle runover is to be provided as per RDSO Drg. No. SKEL-4542.
- 3.4 BP isolating cock is to be painted `Green' and stenciled as `BP' and `FP' isolating cock is to be painted `White' and stenciled as `FP' during every schedule.
