Government of India Ministry of Railways Research, Designs & Standards Organisation Manak Nagar, Lucknow - 226 011

Modification Sheet No.RDSO/WAG5/25

Provision of grease outlet i.e. drain hole in CE outer bearing cap of Traction Motor type HS 15250A and procedure for re-greasing of armature roller bearing(PE & CE).

2. Application: Traction Motor type HS 15250A.

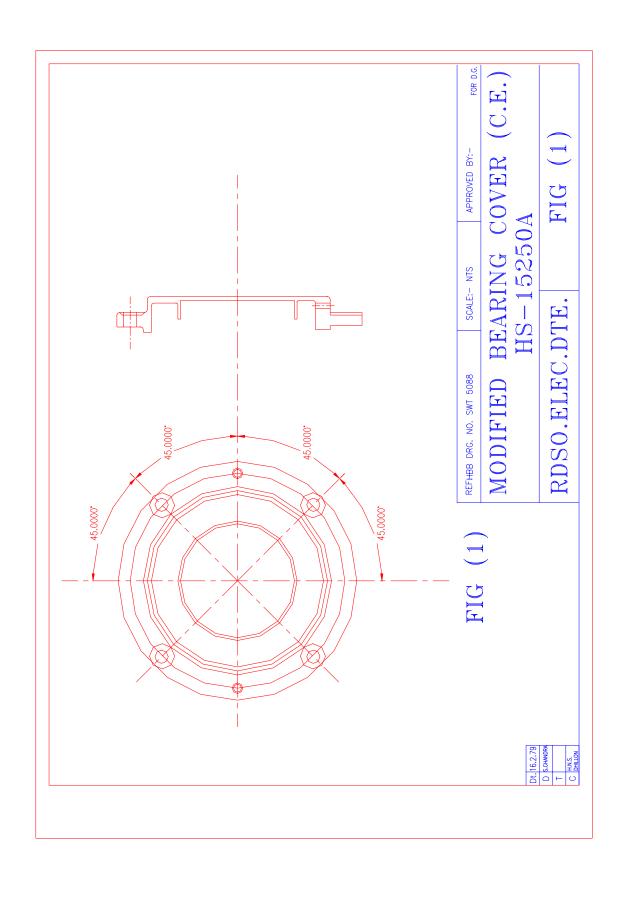
Railways have reported large cases of failure of Traction Motor type HS 15250A due to heavy flash over. One of the reasons of the flash over is the accumulation of excess quantity of grease of CE bearing inside the comutator chamber which results the deposition of carbon in dust etc. In the commutator chamber during service and causes flash over. Further, Railways are reporting failure of CE bearing which may be due to overgreasing causing heating of the bearing and its consequent failure.

Whenever greasing is done in the electric loco sheds by the staff, the excessive grease comes out from the grease outlet from the PE side bearing assembly but due to absence of grease, instead of coming out, gets deposited inside the comuttaor chamber. This results in collection of carbon dust etc. on the grease resulting in flashover.

- **4.1** Remove the existing CE bearing cap from the Traction Motor.
- 4.2 Modify the CE bearing cap as per Fig. No. 1 (copy enclosed) by miling, drilling and taping 1/4th" (6mm) BSP hole and provide a plug to avoid entry of dirt and dust in the above hole.
- **4.3** Refit the modified CE bearing cap on the Traction Motor
- **4.4** Greasing in CE bearing assembly is to be carried out by the suitable grease gun till the grease comes out from the grease outlet.
