Government of India - Ministry of Railways
Research Designs & Standards Organization
LUCKNOW - 226 011

MODIFICATION SHEET No. RDSO/2007/EL/MS/0349 Rev.'0' Dated 18.05.2007

Modification of providing additional isolating cock in series with existing BP angle cock in pure air brake and dual brake Electric Locomotives.

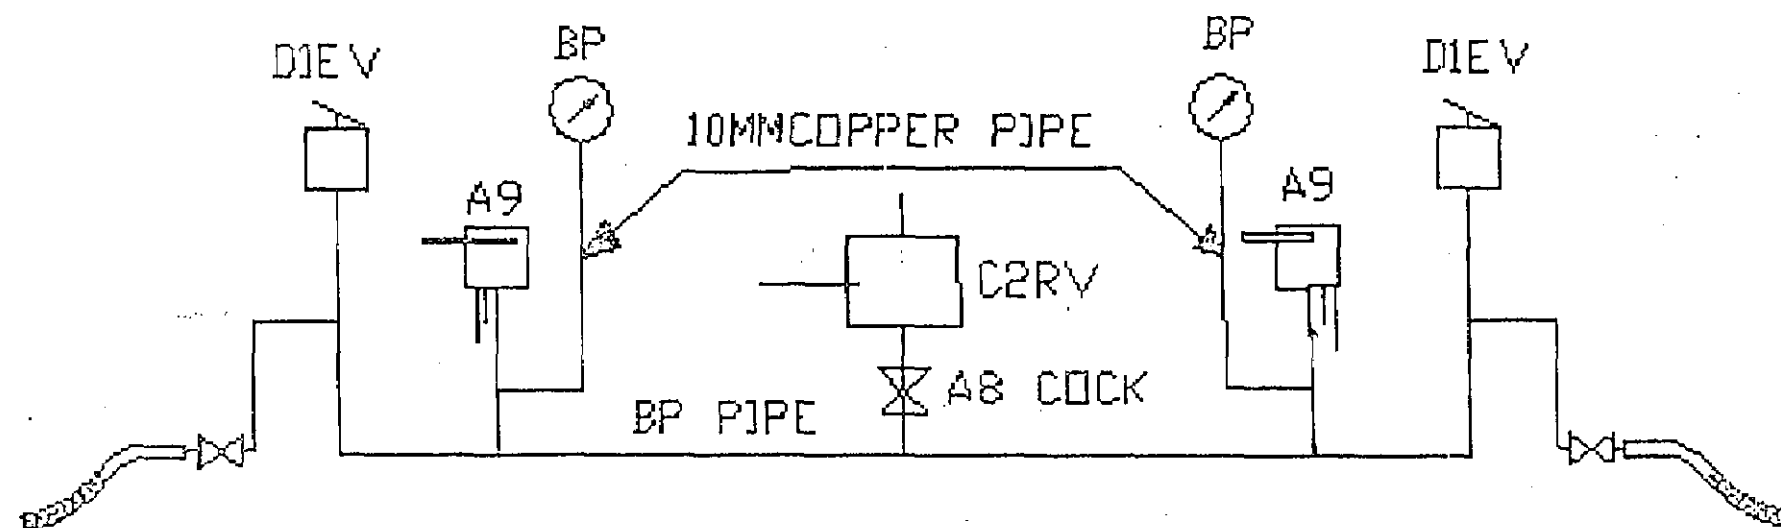
ANNEXURE- I of MODIFICATION SHEET No. RDSO/2007/EL/MS/0349 Rev.'0' Dated 18.05.2007

In the existing pneumatic brake system for Electric Locomotive on Brake Pipe (BP) & Feed Pipe (FP) line angle cock are provided

in front of buffer beam. There are cases of breakage of BP & FP angle cocks due to cattle run over.

Railways are reporting that failures of Electric Locomotives are taking place due to breakage of Brake Pipe and Feed Pipe angle cocks. Therefore, provision of additional Isolating cocks, behind the loco buffer beam at an approachable location, has been considered so that loco failures can be avoided by closing these isolating cocks, to prevent air leakage due to damage of existing angle cock by cattle run over.

EXISTING ARRANGEMENT OF BP ISOLATING COCK.

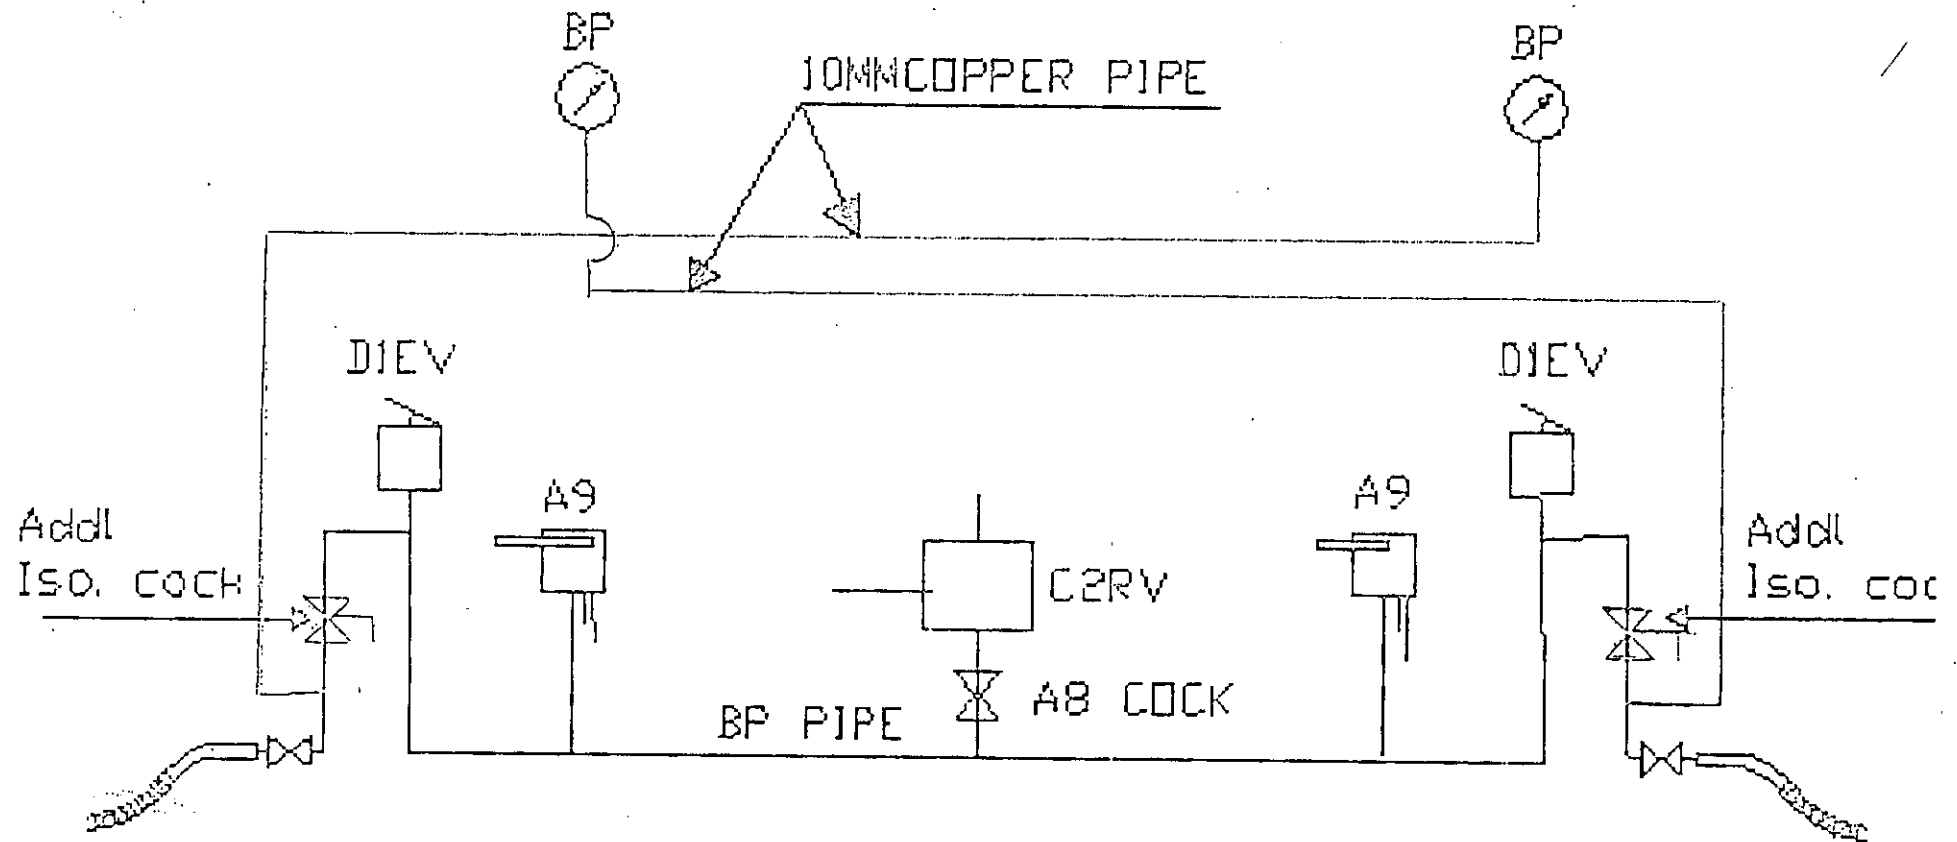
ANNEXURE - II of MODIFICATION SHEET No. RDSO/2007/EL/MS/0349 Rev.'0' Dated 18.05.2007

MODIFIED ARRANGEMENT WITH ADDITIONAL BP ISOLATING COCK AND
TRANSPOSITION OF BP GAUGES

In view of above, one additional Isolating cock of size 1¼" without vent may be provided on brake pipe only in both the driving cabs. To ensure the 'Open' position of additional BP isolating cock fitted in the non-driving cab of the locomotive, a modification in the BP gauge pipe line may be done to adopt fail-proof system. BP pressure gauge of cab-1 may be connected to the brake pipe beyond the additional BP isolating cock of cab-2 and vice-versa. With this arrangement, the BP pressure gauge of the driving cab indicates the BP pressure beyond the additional BP isolating cock of the non-driving cab. A sketch showing the above arrangement is enclosed as Annexure - II.

As per Annexure – I & II, the Brake Pipe line is to be modified.
