## No. EL/3.2.19 (G)

Dated 01.11.2012

# Modification Sheet No. RDSO/2012/EL/MS/ 0418 Rev. '0'

Modification on relocation of BP & FP Angle cock in WAP-1/4 class of Electric Locomotives.

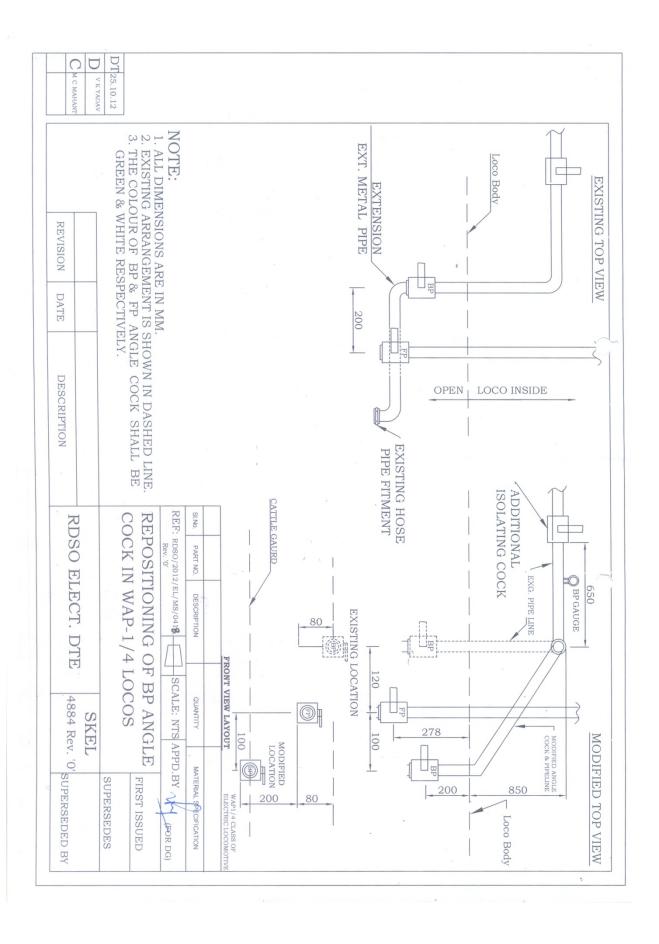
Drawing no. SKEL 4884 Alt. '0' enclosed.

iv) Though cases of breakage of angle cock have reduced due to provision of protection brackets but few failures have taken place due to breakage of BP extension pipe & BP angle cock. For diagonal connection of BP hose pipe of locomotive with load BP hose pipe, additional extension pipe is required with BP angle cock of WAP-1/4 class of Electric Locomotives. BP extension pipe which is inherently a weak member gets damaged during CRO resulting in loco failure.

Therefore the breakage of the BP angle cock & extension pipe can be minimized by relocating the BP angle cock. To eliminate the extension pipe, BP angle cock is to be shifted below the FP angle cock at ALP side keeping FP angle cock at the same location.

- \* Remove BP hose, BP extension pipe & BP angle cock.
- Unclamped the BP pipe & safety brackets.
- \* Disconnect the BP pipe line after additional isolating cock.
- Re-route the existing BP pipe line below the FP angle cock just above cattle guard at a location where vacuum pipe was connected as shown in drawing enclosed.
- Properly Clamp the BP pipe line if additional holding clamp is required.
- Reconnect the BP angle cock. The existing opening in buffer beam & cattle guard for vacuum pipe is to be utilized for re-connecting BP angle cock as shown in drawing enclosed.
- \* Reconnect the BP hose pipe. Ensure fitment of re-located BP hose pipe on dummy hose pipe bracket on cattle guard.
- Properly stenciled the BP angle cock location. Ensure proper colour coding of BP angle it should be 'Green' and stenciled as BP.

- \* Ensure there should not be any infringement with CBC coupler operation and also ensure diagonal connection of BP hose pipe with stock and with existing as well as with modified locomotives.
- The safety bracket for protection of BP angle cock, against damage in case of external hitting due to cattle run over is to be provided as recommended vide modification Sheet No. ELRS/MS/0270/Rev.'0' dated 08.11.1999.
- Though FP angle cock will remain at same location but ensure FP angle cock is to be painted 'White' and stenciled 'FP'.
