<u>Sub.:-</u> Modification in Vigilance Control Device in Tap changer Electric locomotives. Ref.:- MOM of XXXVII MSG circulated vide letter no EL/2.1.8 dated 27.08.2015.

# Modification Sheet No. RDSO/2015/EL/MS/0444 (Rev. '0')

Modification in Vigilance Control Device in tap changer electric locomotives for:

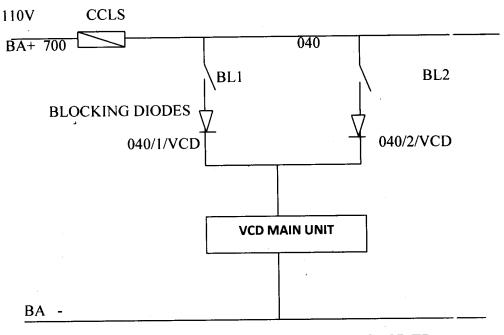
- At present the 110 Volt DC power supply is fed directly through battery for activation 2.1 of VCD in tap changer electric locomotives.
  - a. In multiple loco operation, battery remains on in both the locos. Due to this, 110 V battery supply remains available in VCD main unit in both locos, even though VCD in rear locomotive remains in suppress mode. As the supply of VCD through battery is always available in both locos, any failure in VCD in rear loco, which is in suppressed mode, results in brake application in both the locomotives.

- b. A case study of failure in ELS/ET/WCR, base multi-loco 23109 + 23734 revealed that VCD main unit of trailing loco 23734 was malfunctioning and caused failure of the locomotive. After analysis it was observed that due to malfunctioning of VCD of rear loco, QVCD relay got energized and subsequently IP valve got deenergized which led to drop in BP pressure & resulted in application of brakes in both the locos.

To activate VCD main unit, supply will be fed through BL key in Vigilance Control Device as shown below. This modification will prevent energizing o VCD of rear loco.

Note: Cable no 003 to be removed from terminal no. L of VCD TB
