Government of India - Ministry of Railways Research, Designs & Standards Organization, LUCKNOW - 226011

MODIFICATION SHEET NO. RDSO/2013/EL/MS/0426, (Rev.'0'), Dated 18.07.13.

Modification Sheet of Bogie isolation rotary switch (Sch. Pos. 154 cut out switch) in three phase electric locomotives.

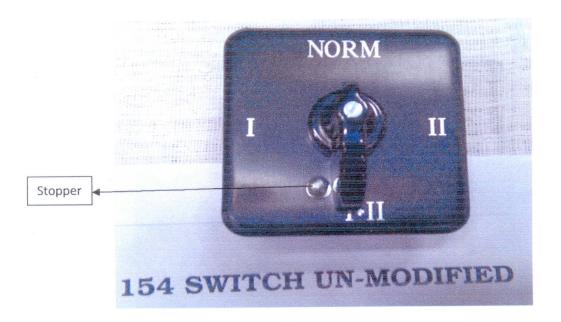
Fig.1

For isolating bogie-II, cut out switch 154 is to be put first in bogie-I cut out position, then bogie-I&II position and then the bogie-II cut out position. This is because a stopper is provided on the surface of the switch to prevent the rotation in clockwise direction (shown in Annexure-I, Fig.1) and the locking provided inside the switch (shown in Annexure-I, Fig.2). In the process of sequential operation, if the Loco Pilots keeps the cut out switch either in bogie-I or bogie-I&II position for more than 10 seconds bogie-I or both bogies get isolated. To bring back the isolated bogie, the driver has to switch OFF/ON MCE, failing which, subsequent operation for isolation of bogie-II by keeping the switch in bogie-II position will result in main power off. Once main power off is noticed, LP fails the loco. Even if they do trouble shoots considerable time is lost in proper isolation of bogie.

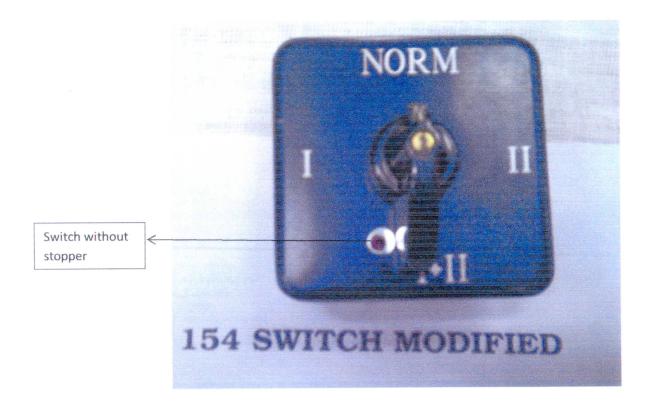
A number of failures of 3-phase locos have taken place due to improper operation of 154 cut out switch by crew, resulting into severe detentions to trains. In all these cases, in the process of isolation of bogie-II, Loco Pilots have in advertently put the switch in bogie-I cut out position for more than 10 seconds leading to bogie-I isolation and further put the cut out switch in bogie-II cut out position without bringing back the bogie-I into service (by switching OFF/ON MCE) leading to isolation of both bogies and further resulting into complete main power off.

To overcome the problem, the stopper provided on the surface of the switch, which prevent the rotation in clockwise direction and the locking provided inside the switch need to be removed (shown in Annexure-II, Fig.1 & Fig.2) respectively.
