भारतसरकार-रेलमंत्रालय
अनुसन्धानअभिकल्पऔरमानकसंगठन
लखनऊ- 226011
Government of India - Ministry of Railways
Research, Designs & Standards Organization,
LUCKNOW - 226011

MODIFICATION SHEET NO. RDSO/2009/EL/MS/0375 (Rev.1) , Dated
28.09.12.

Provision of MCB (128.1) in Air Dryer circuit of 3-Phase electric locomotives.

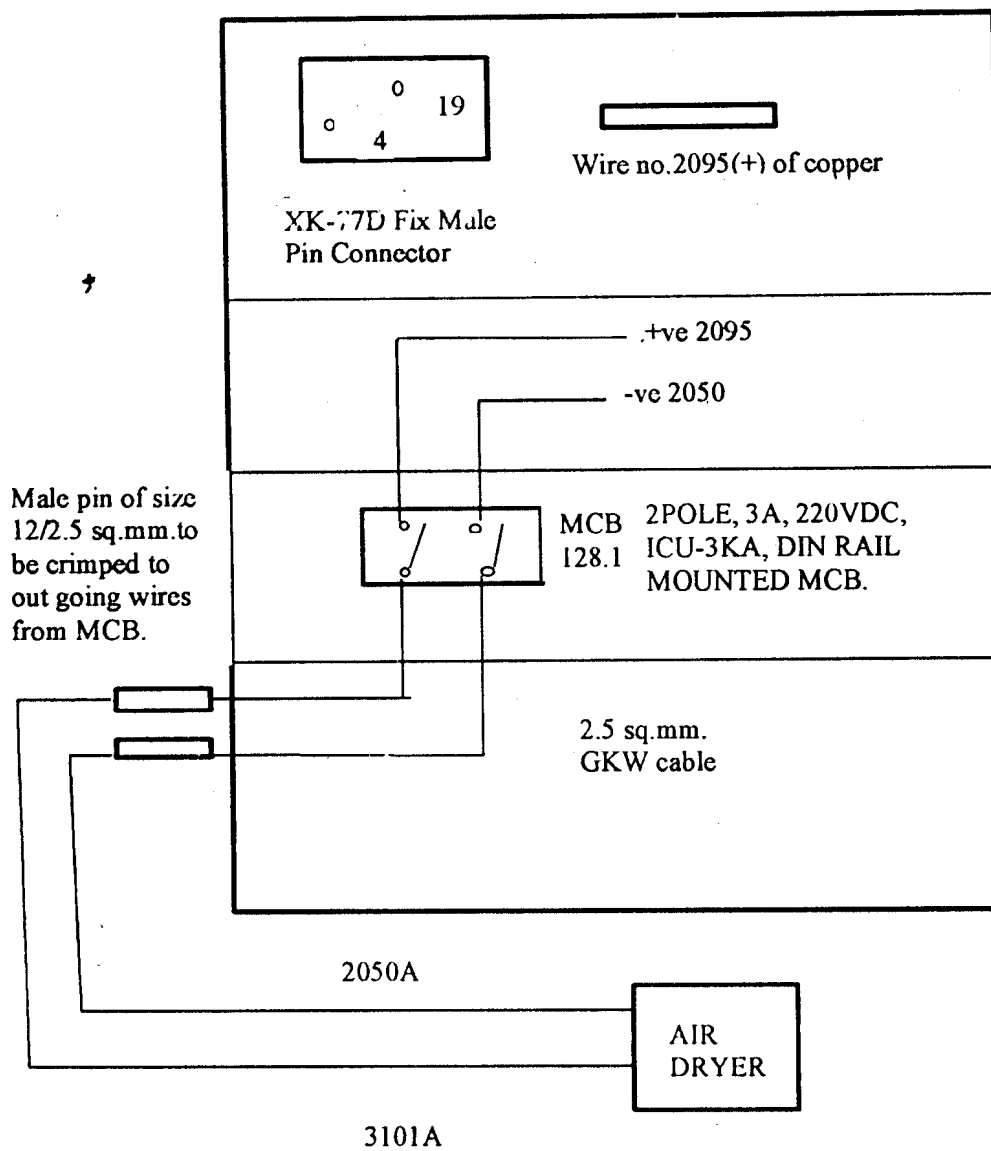
Annexure

2.2 In this modification sheet, supply to air dryer is extended through an additional MCB 128.1 provided in series with MCB 127.7. If fault current in air dryer is low MCB (128.1) only trips, however, if there is a severe fault, both MCBs 127.7 and 128.1 trip. This leads to confusion in troubleshooting in locomotive by drivers.

- 2.4 In this connection, SCR has proposed that MCB 128.1 provided in series vide above modification sheet may be provided in parallel so that any fault in Air dryer circuit shall results in tripping of MCB 128.1 only.

Amendment-1 of circuit diagram for 3A MCB for Air Dryer

- The following steps are to be taken for provision of MCB (128.1) switch in parallel with MCB 127.7 for air dryer:

- 4.1. MCB (128.1) for air dryer is to be provided in SB-2 panel.
- 4.2. In SB-2 panel, there is a copper strip for wire no.2095(positive)and negative SB-2 for wire no. 2050 which is to be connected to input of MCB 128.1. In movable conk XK77D pin no. 4 wire no. 2050 is(negative) and pin no. 19 wire no.3101 is positive . Pin no. 4 and pin no.19 have to be removed from movable conk along with pin. Male counterpart of this pin have to be crimped to out going cable from MCB (128.1). Connections to the respective terminals shall be made by inserting male female pins and shall be secured with the help of heat shrink sleeve.
