Government of India - Ministry of Railways Research, Designs & Standards Organization, LUCKNOW - 226011

MODIFICATION SHEET NO. RDSO/2009/EL/MS/0385 (Rev.0), Dated 15.12.2009

Partial blocking of opening duct of back side of auxiliary converter of three phase electric locomotives.

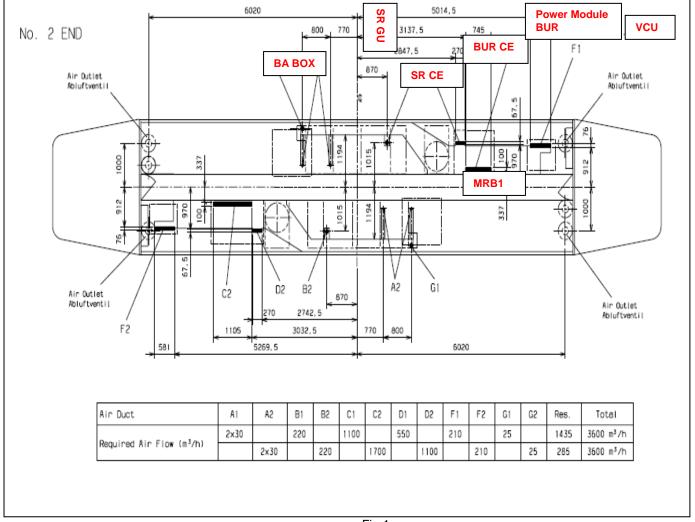
Fig-1

RDSO conducted the measurement of air flow at the various locations of duct outlet in MRB-1 circuit (fig-1) by removing traction converter, auxiliary converter and vehicle control unit in one imported locomotive (loco no. 31015) at Electric Loco Shed, GMO and in one new loco at CLW. The measurements are summarized in table-1

It can be seen from the above table that there is a variation in air velocity in CLW built locomotive as compared to imported locomotive.

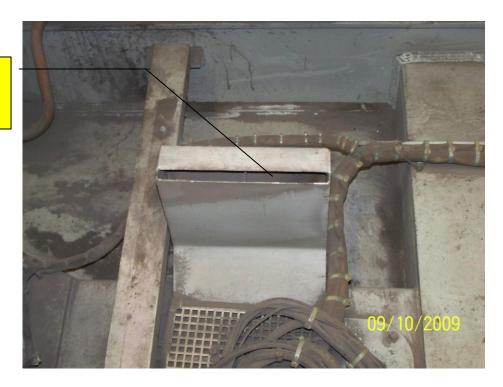
Fig-2: Imported loco

One of the reason attributed for this in CLW built locomotive is "the duct opening of back side of auxiliary converter which was found to be blocked around 75% in imported loco where as in CLW built loco this was 100% open (fig-2 & 3)."

Blocked around 75% in imported locos

The modification shown in fig-2 was done by ABB vide modification release no. 431 rev A dated 26.11.2000 (copy enclosed) on all imported WAG9 and WAP5 loco to improve front side cooling of power modules of auxiliary converter. This modification has not been implemented by CLW in indigenously built three phase locomotives.

Thus in order to improve the front side cooling of power modules of auxiliary converter, the modification as per ABB vide modification release no. 431 rev A dated 26.11.2000 (copy enclosed) is required to be done at the earliest.

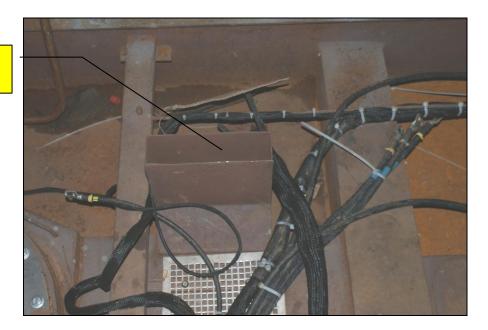
Fig-3: CLW loco

100% open in CLW built locos

The duct opening of back side of auxiliary converter is found 100% open in CLW built WAP-7 & WAG-9 locomotives.

Duct opening of back side of Auxiliary Converter has to be blocked 75% in place of 100% open with MS plate of 2 mm thickness of proper and required size.
