Government of India - Ministry of Railways Research, Designs & Standards Organization, LUCKNOW - 226011

MODIFICATION SHEET NO. RDSO/2014/EL/MS/ 435, Rev. '0' Dated 06.06.2014

Modification sheet to avoid necessity of cab changing in case of failure of processor cards of VCU of three phase locomotive (WAP7).

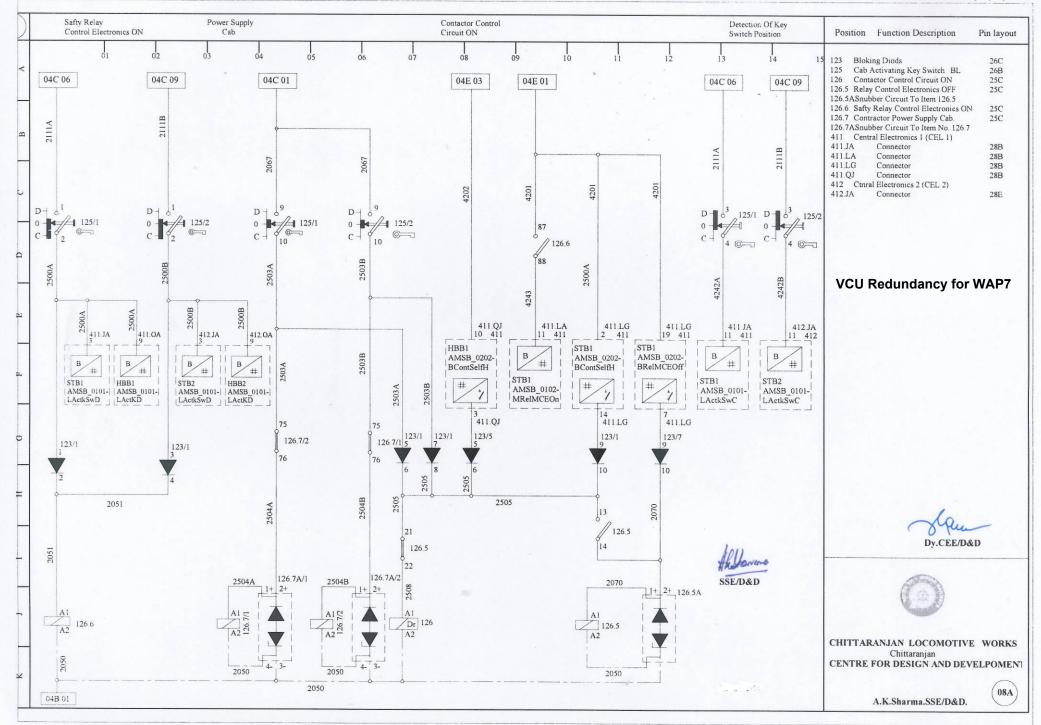
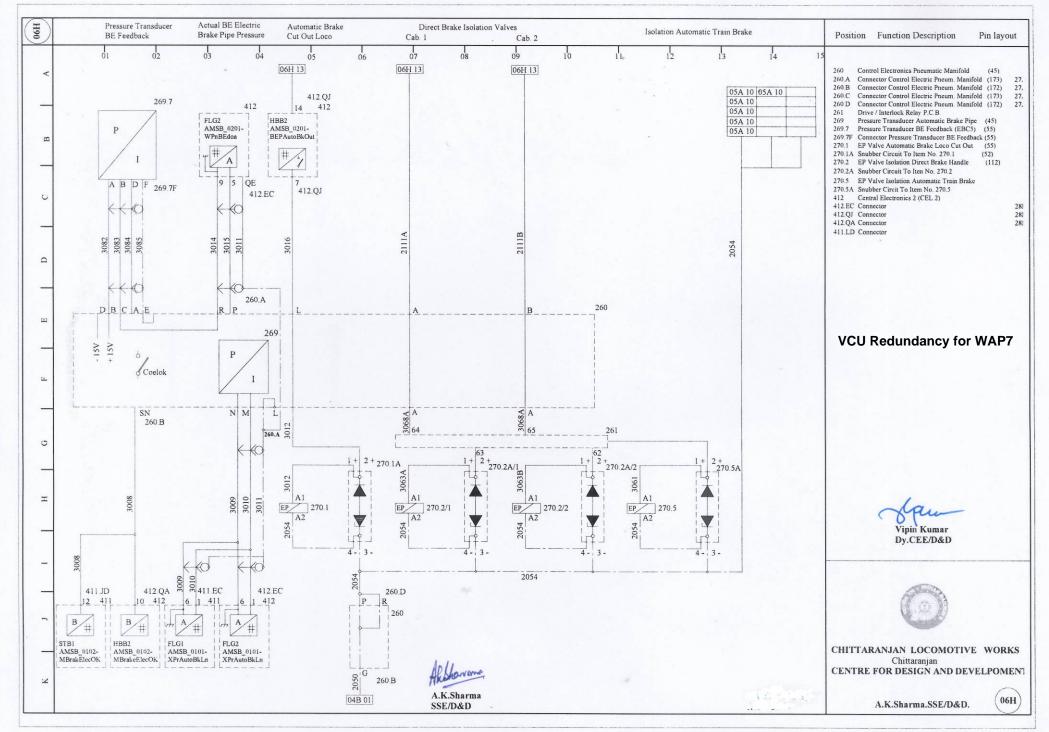
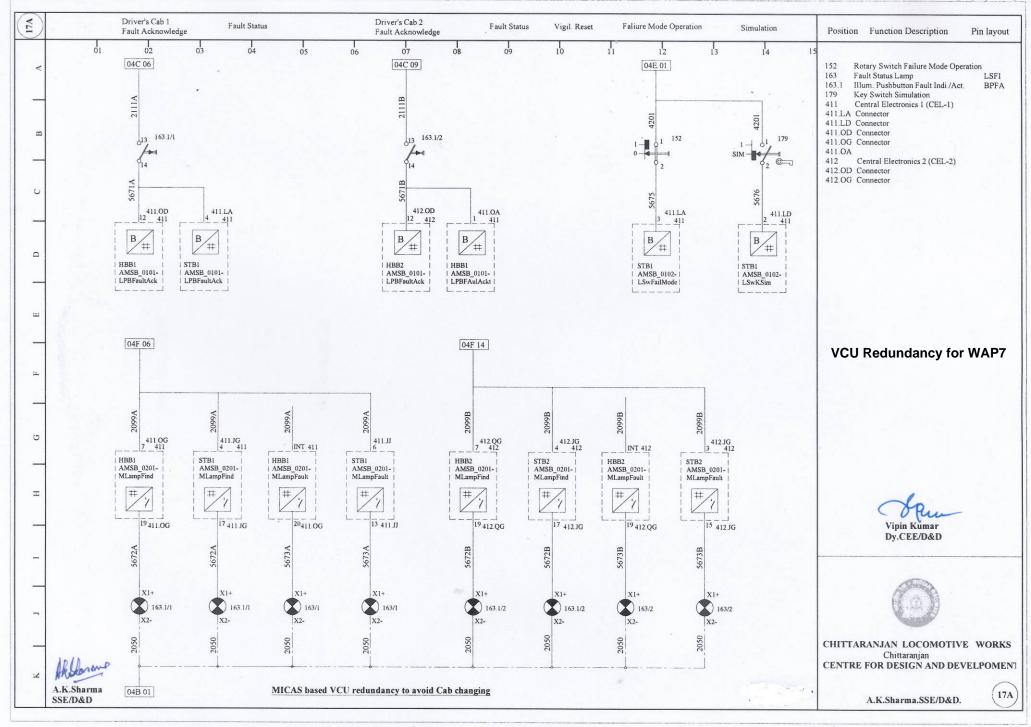
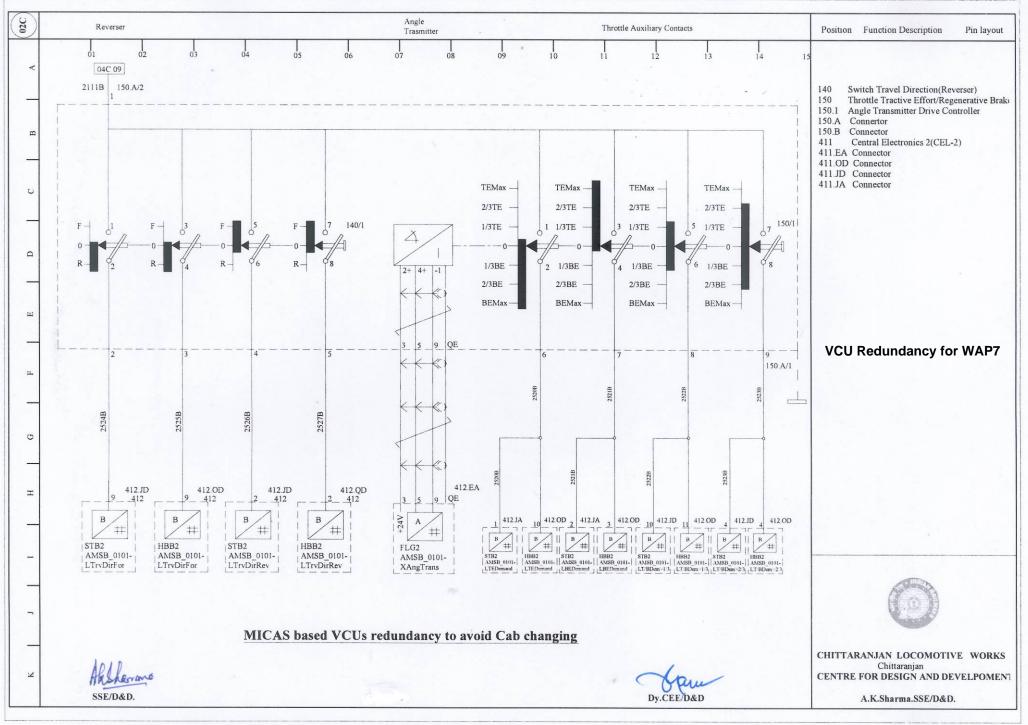
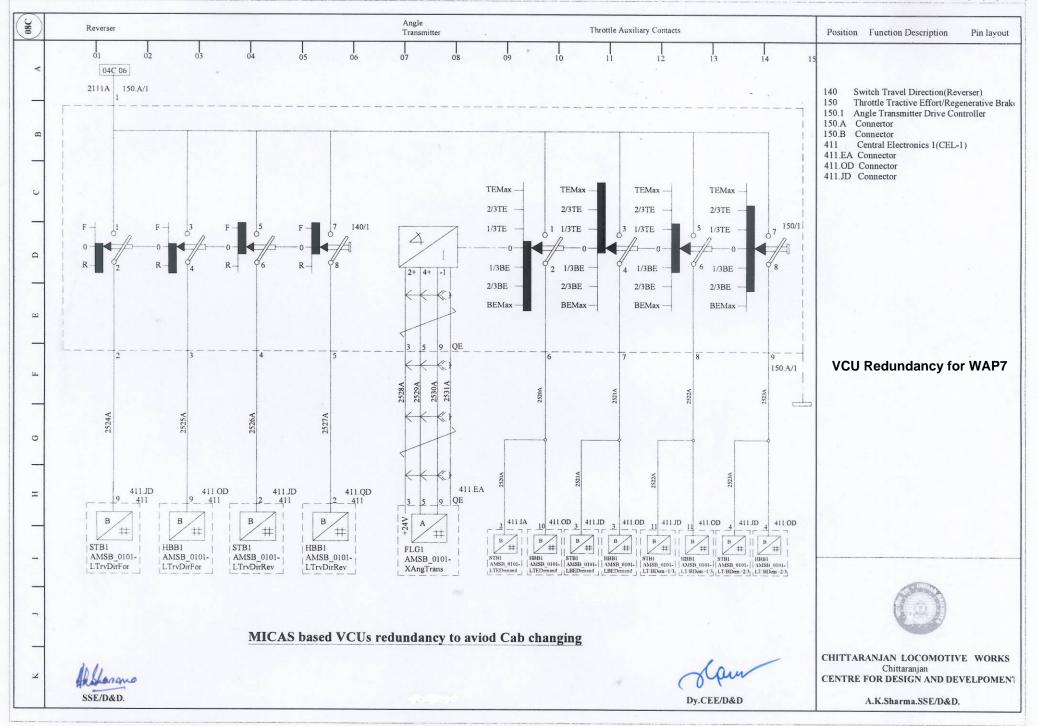
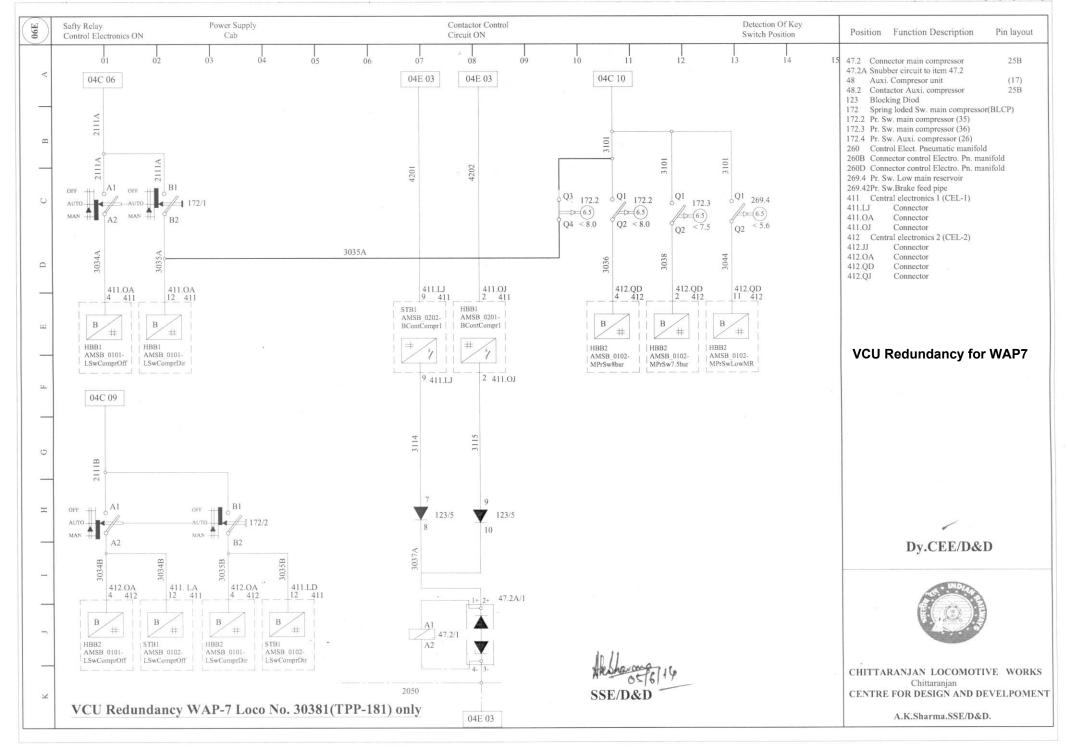
12.0 **Modification Drawing**:

The modified schematics are enclosed at Annexure-IV.
