No. EL/11.5.5/5

**Modification sheet No. RDSO/2014/EL/MS/0436 (Rev.0), Dated 11.07.2014**

Modification to address failures of DC link capacitors of 3x100 kVA, GTO based auxiliary converter.

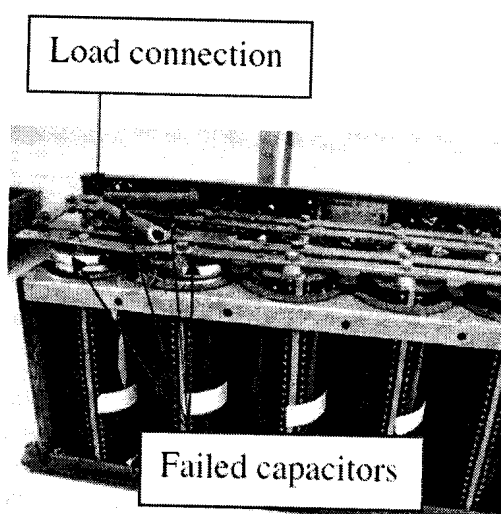
Fig.1

- 2.4 As per investigation, the reasons of failure of DC link capacitors are following:
- (i) High loading of capacitor nears the load connections;
  - (ii) Restricted cooling of capacitor due to support frame;

**Existing Design:** In most cases, it has been observed that failure is initiated from the load side as shown in Fig1. This is attributed to higher loading of capacitors near the load connections. The reason for this load imbalance is that the two parallel banks of capacitors are linked to each other via just a single link as shown in Fig2.

**Modified Design:** As shown in Fig. 1 & 2, two parallel banks of capacitors shall be linked with a number of links individually instead of a single link in order to achieve better load sharing. Further, the load connections shall be connected to the center of the capacitor banks shown in fig.3 & 4 as A1 and A2.

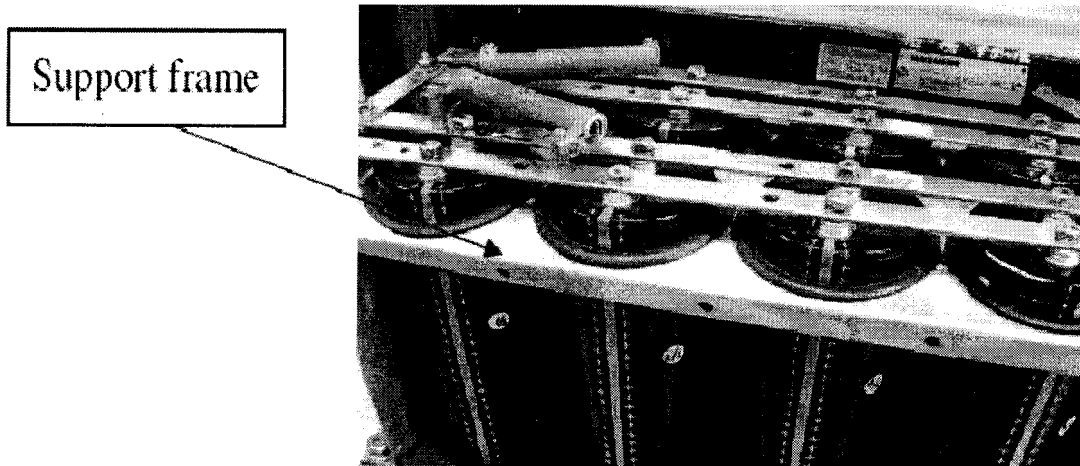
Fig.5

- (iii) Not changing of rubber gaskets during the schedule, as prescribed, resulting in rubbing of top support frame with capacitors and damaging of outer insulating sheath of capacitor; and

**Existing Design:** As seen in Fig.5, the presence of the support frame around capacitor bank restricts the air flow between the capacitors and therefore capacitors are more prone to get heated up.

**Modified Design:** Frame arrangement shall be removed as shown in Fig.6 which allows better air circulation between the capacitors.
