भारत सरकार - रेल मंत्रालय  
अनुसंधान अभिकल्प और मानक संगठन  
लखनऊ - 226011  
Government of India - Ministry of Railways  
Research, Designs & Standards Organization,  
LUCKNOW - 226011

**SPECIAL MAINTENANCE INSTRUCTIONS**  
**NO. RDSO/2012/EL/SMI/ 0276 Rev '0' Dated: 27.07.2012**

Maintenance instruction of Dynamic braking excitation contactor C145 auxiliary contact for 25 kv ac electric locomotives.

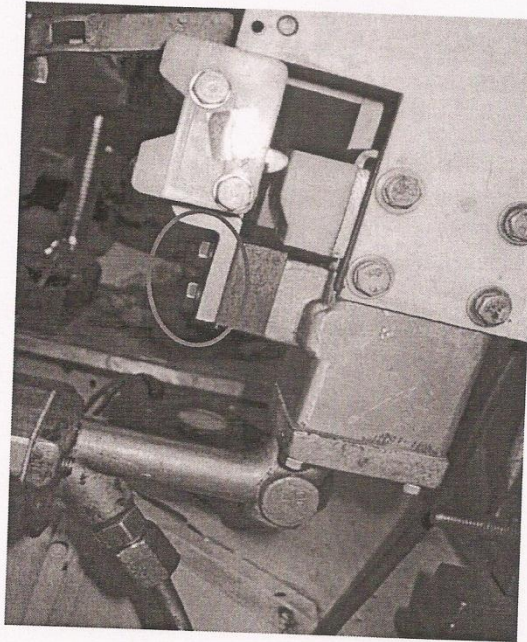
- iii. CAM of auxiliary contact and fixed contact shall not be replaced in-situ in loco rather complete C145 assembly should be replaced with overhauled unit. The old C145 assembly should be taken to maintenance section for Cam replacement where proper operation can be checked.
- iv. Proper tightening of fixed auxiliary contact assembly should be ensured using spring washer during overhauling.
- v. The 'cam support' on which cams are fixed has a fixing hole of dia 6.2 mm which is shifted by 2.5 mm on one side as per CLW Drawing No. 4TWD.112.097. The fixing of cam support should be done in such a way that smaller portion remains on bottom side. Wrong fitment of cam support will cause inadequate crushing and pass spurious signal during vibration. Fitment of cam support plate in a correct manner is shown below:

- ii. Proper fixing of fixed auxiliary contact assembly should be checked in each schedule of inspection.
