SPECIAL MAINTENANCE INSTRUCTIONS NO. RDSO/ELRS/SMI/101**Method for confirming that the pin is nitrided and procedure for replacement of journal pin (Pt. no 4518) tap changer No. 32 type of HBB make.****1. Object :**

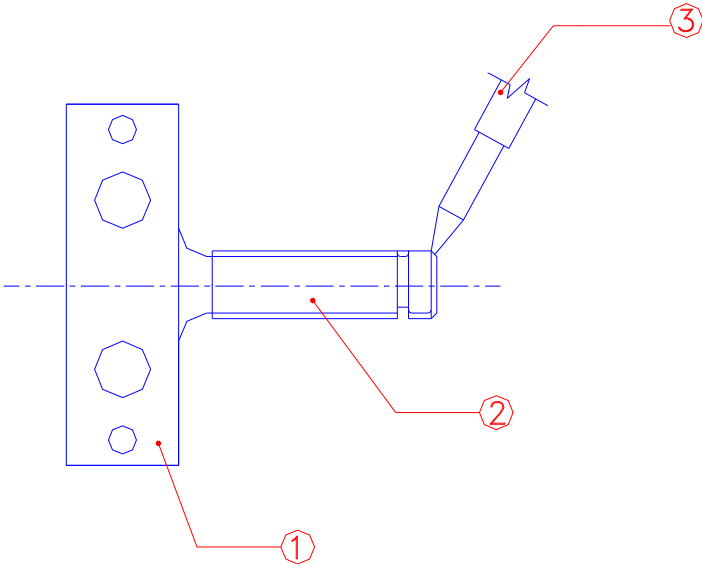
SKEL 3523

Railways have reported a few cases of breakage of journal pin (pt. No. 4518) on stage III tap changers. Investigation has shown that this was due to the un-nitrided pins used on some of the stage III tap changers by mistake at HBB works during assembly.

The scratch pen (already distributed by HBB to Rlys) to be rubbed against the ground surface of all existing pins (part No. 4518) as shown in SK EL 3523. In the case of assembled journal pins the rubbing can be done beyond the circlip groove portion.

Result:- The pen should not make any scratch mark on the ground surface.

2.2 If it makes a scratch mark, the Bearing complete (Pt. No. 4518) with journal pin to be replaced as follows --

- Remove the Fly Wheel.
- Take out the lever complete 4501
- Remove the broken journal pin alongwith its block (4518)
- Assemble the new bearing block with its journal pin (4518) in position with the help of roll pins and bolts.
