# Government of India Ministry of Railways

## Research, Designs & Standards Organisation Manak Nagar, Lucknow - 226 011

### SPECIAL MAINTENANCE INSTRUCTION NO. RDSO/ELRS/SMI/130

Damping adjustment of isolating drive complete (2400) of circuit breaker (DJ) type DBTF 30i250 of HBB make.

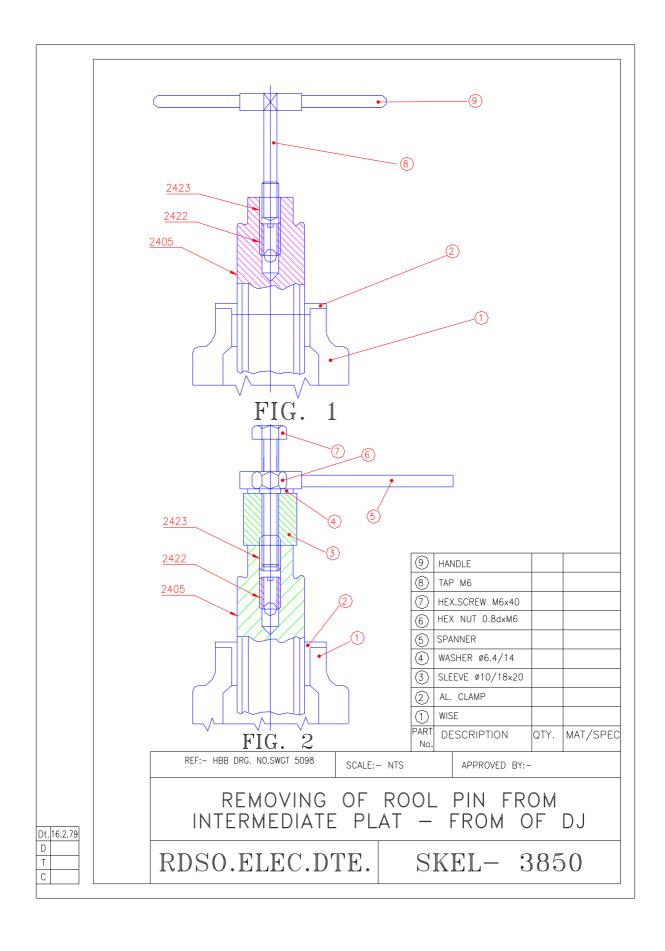
Railways have reported a few cases of breakage of isolator blade (6031), sleeve (2408and 2404) etc. of circuit braker. It is observed that during investigation that these breakages are mainly due to any of the following reasons:

- i) Step formation on the isolator blade (6031)
- ii) Unmodified sleeve (2408/2404)
- iii) Over shooting of the isolator blade (6031)
- iv) Improper damping of isolator drive (2400)

- (i) Hold intermediate platform 2405 in a Vice.
- (ii) Using M6 HSS taps (1st and IInd and IIIrd) and wrench handle cut M/s threads on the rol pin 2423 as shown in SK. EL. 3850 Fig.(1).

- (iii) Mount the spacer/sleeves (3), washer(4) Hex screw M6(7) with nut (8) as shown in RDSO Drg.No. SK. EL.. 3850.Fig.(2)Screw the M6 screw on to the roll pin. continue to tighten the nut using a spanner (5) Further tightening of the nut after it touches the washer, results in the pulling out of the roll pin which ultimately comes out as per Fig.2.

- (iv) Now adjusting screw 2422 can be adjusted to allow less air to escape through. The damping is said to be OK When the isolator closes and trips without appreciable vibration. Insert new roll pin 2423 to lock the adjusting screw 2422.
