**Government of India
Ministry of Railways
Research, Designs & Standards Organisation
Manak Nagar, Lucknow - 226 011**

No. EL/3.2.30

**SPECIAL MAINTENANCE INSTRUCTIONS NO.
RDSO/ELRS/SMI/144
FLASHING INSIDE THE SELECTOR OF TAP CHANGER No. 32**

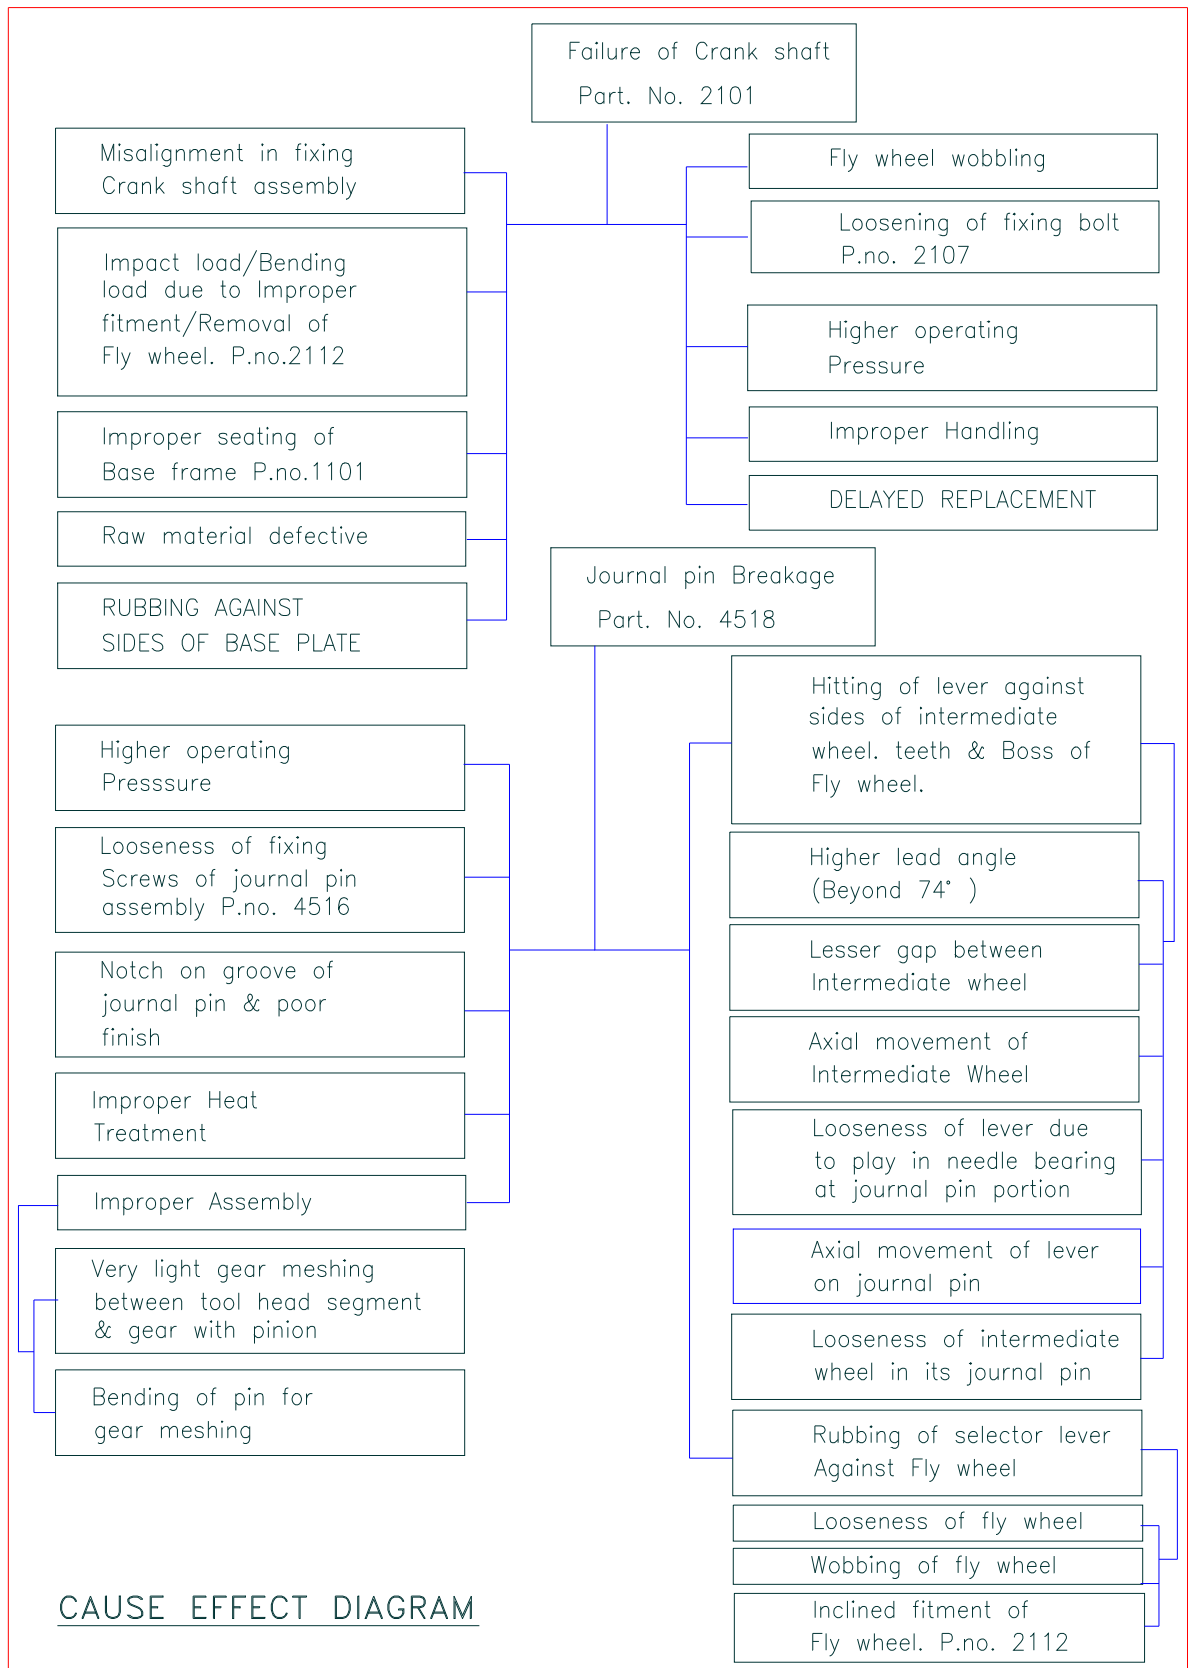
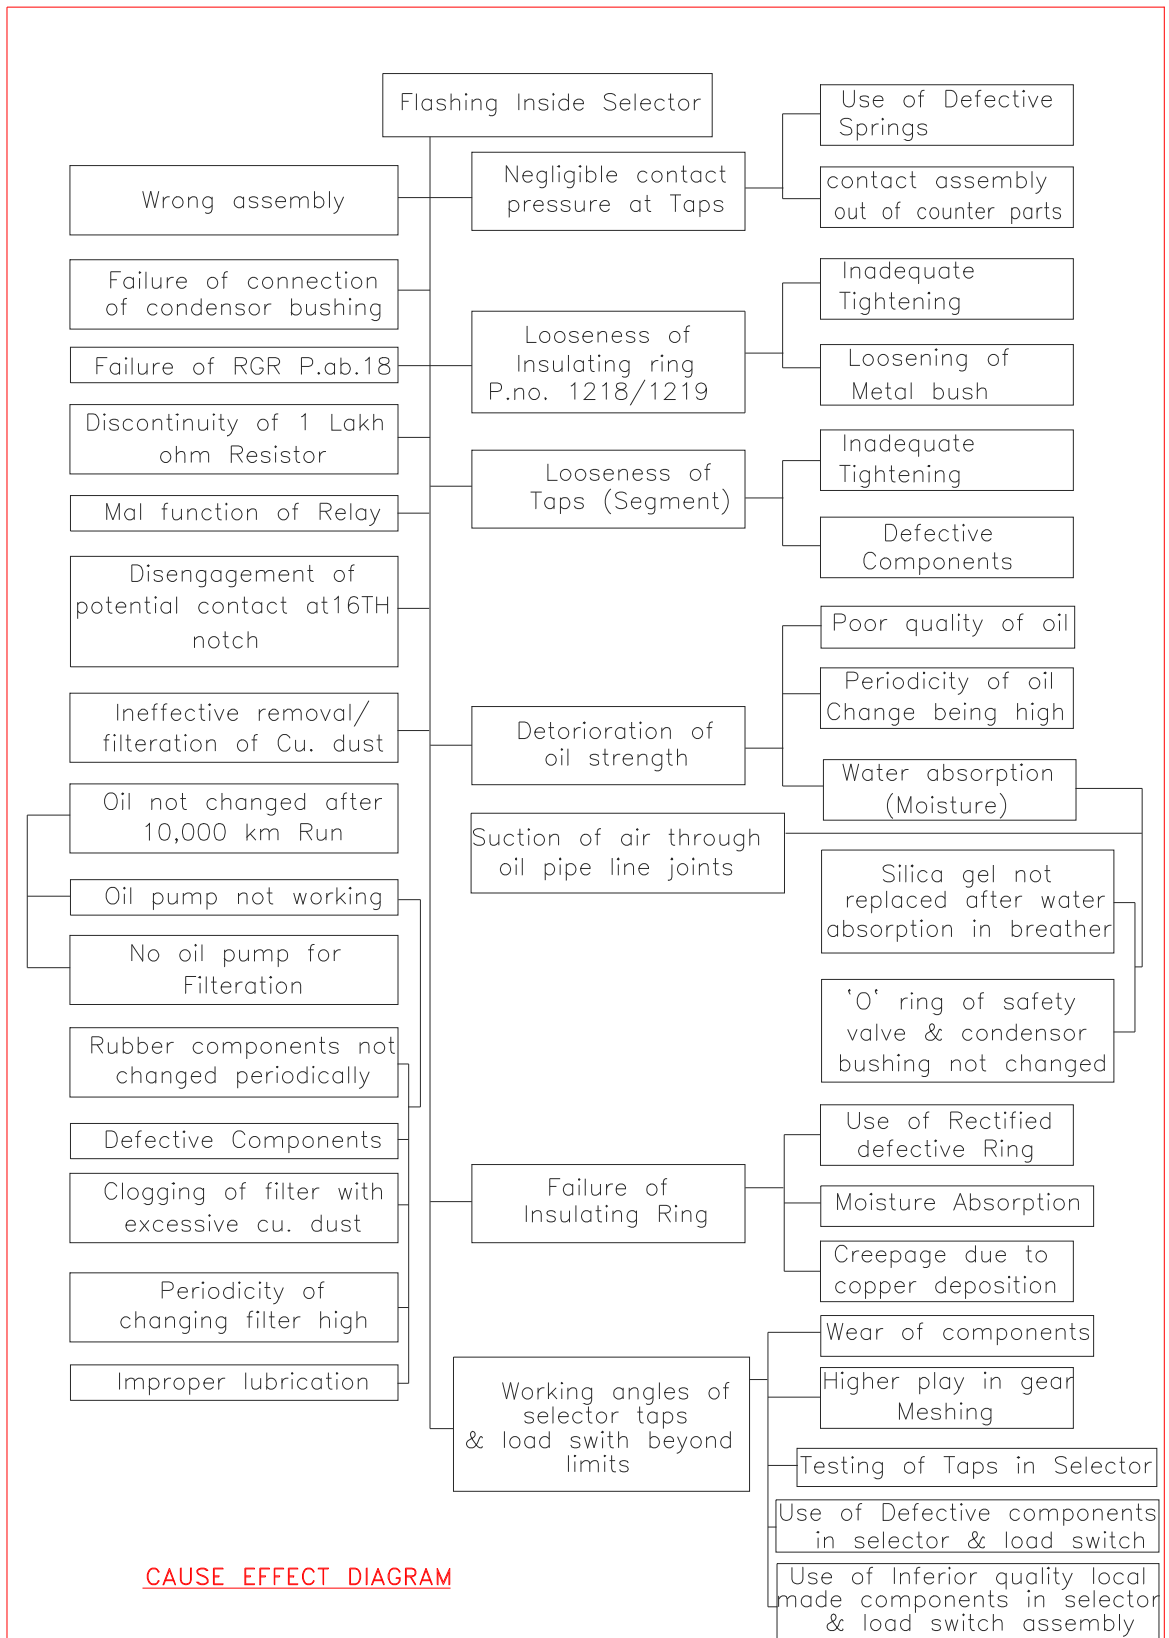
**FLASHING INSIDE SELECTION, PROBABLE REASONS AND
REMEDIAL MEASURES.**

- 1 Deterioration of transformer oil due to moisture absorption & copper deposition.
- 2 Tracking of insulating ring/contact plate due to copper deposition
- 3 Incorrect making and breaking angle of contacts and load switch.
- 4 Looseness of contact segments
- 5 Looseness of insulating ring
- 6 Discontinuity of contact of central gearing with 16th notch
- 7 Discontinuity of 1 lakh ohm resistor across load switch
- 8 Lesser contact pressure between roller and taps
- 9 Wrong assembly
- 10 Failure of connection of condenser bushing
- 11 Failure of RGR
- 12 Sticking of SMGR
