A. PROCEDURE FOR REPAIR OF CENTRE PIVOT BOTTOM CROSS PALTE AS PER ARRANGEMENT SHOWN IN CLW DRAWING NO. 03/1/31/2.

B. SYMPTOMS OF POOR WELDING OF VERTICAL PLATES (ITEM NO.6) IN WAP1/WAP4 LOCOMOTIVES :

C. PROCEDURE FOR CHECKING THE HEALTH OF BOX SECTION FORMED BETWEEN TOP CROSS PLATE (ITEM NO.31) TWO VERTICAL CROSS PLATES (ITEM NO.5) AND MIDDLE PLATE (ITEM NO. 14) AS PER ARRANGEMENT SHOWN ON CLW DRAWING NO.03/1/31/2

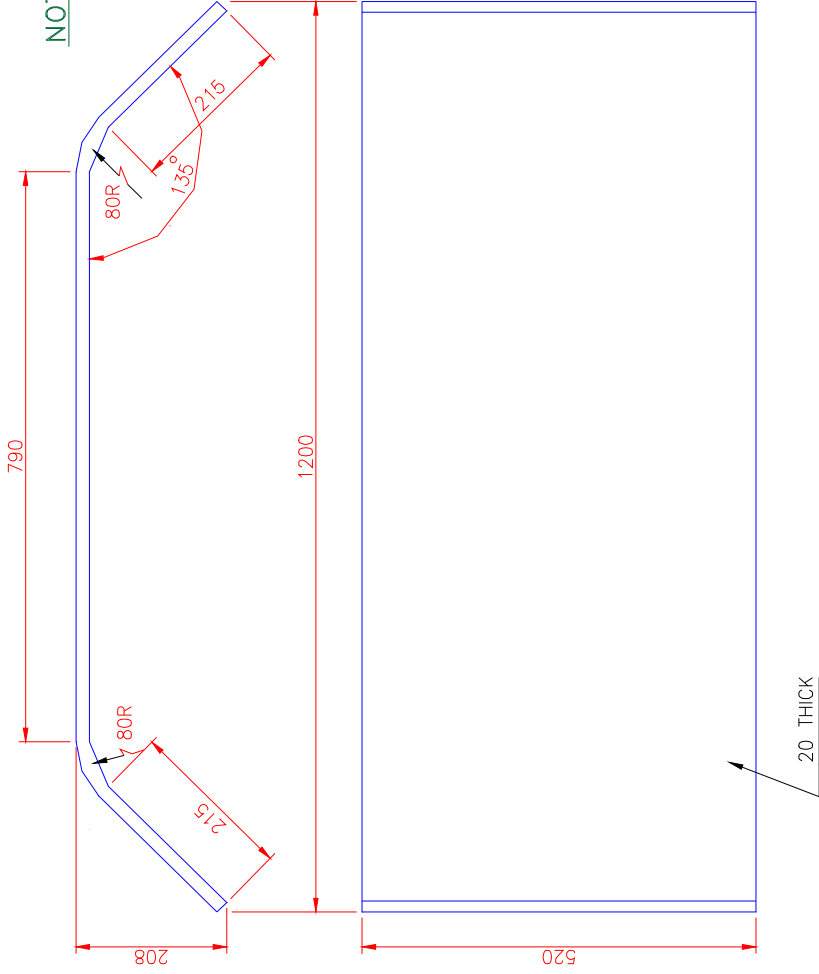
RDSO. ELEC. DTE. SKEL-4433

BOTTOM CROSS PLATE

- iv) The plate should be heated at the bending locations by oxy-aceteleve flame and the necessary force required for bending is developed by mechanical turfer. The plate after bending from both ends should conform to enclosed drawing SKEL-4433.
