**Government of India**  
**Ministry of Railways**  
**Research, Designs & Standards Organisation**  
**Manak Nagar, Lucknow - 226 011**

No.EL/3.2.10/Gen/J-6

**MODIFICATION SHEET NO. RDSO/WAM4/156**

**MODIFICATION FOR BBC MAKE DI TYPE QLM RELAYS**

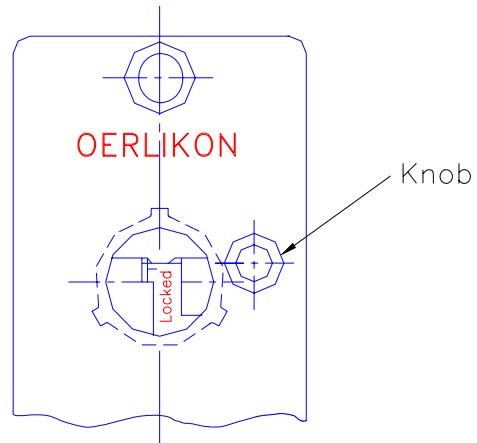
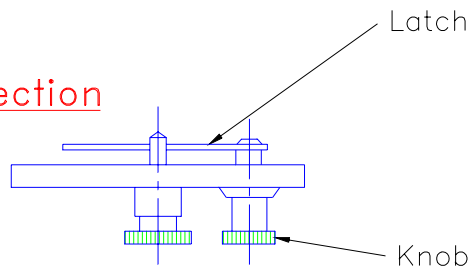
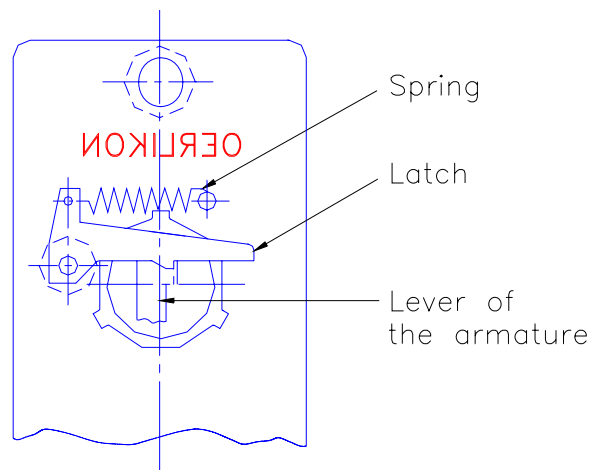
A 4	0	1	1
BBC	From	Relay type DI – Locking of the armature			HBTA 8659

**1.5** The large number of auto reset type QLM relays already in service shall be modified by providing a different type of latching arrangement as per the details given below:

- 2.1** See BBC Drg. No. HBTA 8659 Relay type DI-Locking of the Armature.
- 2.2** Procure latching arrangement KA 220094 according to BBC Drg. No. HBTA 8659 as per the requirement. Remove the old one and replace with the new arrangement. One sample relay No. HB 547548 with modified latching arrangement is available in GZB Elect. loco shed in which actual fitment of component may be studied if required.

- Locking arrangement for relays type DI QLM-application KA 220094 according to BBC Drg. No. HBTA 8659.
- Quantity will be as per the sheds require.
