No. EL/3.2.30 Dated: 3.11.1989

MODIFICATION SHEET NO. RDSO/WAM4/157

Modification in insulating ring (1218, 1219) fixing arrangement.

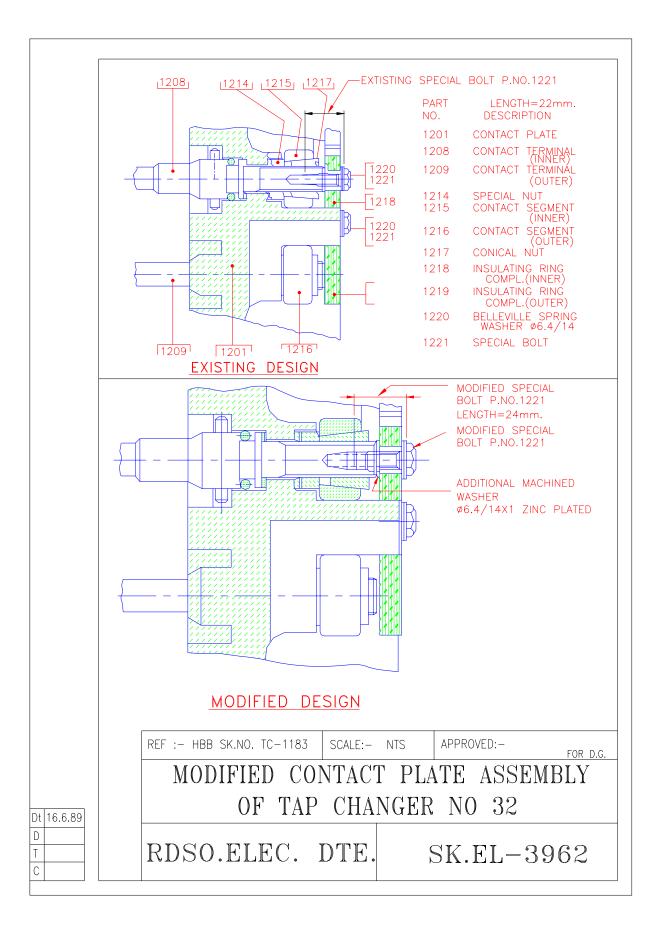
RDSO Drg. SK EL 3962

Railways have reported a few case of flashing over inside the selector housing assembly of tap changers. Investigations have shown that one of the reason for the flashing was intermediate contact terminals were touching the insulating ring. In case of copper deposition the chances of creepage between taps are more. In order to increase the path it is decided to provide an additional machined washers in between insulating ring (1218, 1219) and fixing contact terminal (1208, 1209).

- Dismantle the contact plate assembly.
- Replace the existing special bolt (1221) of 22 mm length with 24 mm length.
- Provide No.1 mm additional machined washer zinc plated ϕ 6.4 $x\phi$ 14x1 in between insulating ring and the stud at the screwing points.
- Reassemble the contact plate.
