## Government of India Ministry of Railways

## Research, Designs & Standards Organisation Manak Nagar, Lucknow - 226 011

#### **MODIFICATION SHEET NO. RDSO/WAM4/160**

# Modification to improve the oil circulation in the neck portion of the locomotive transformer.

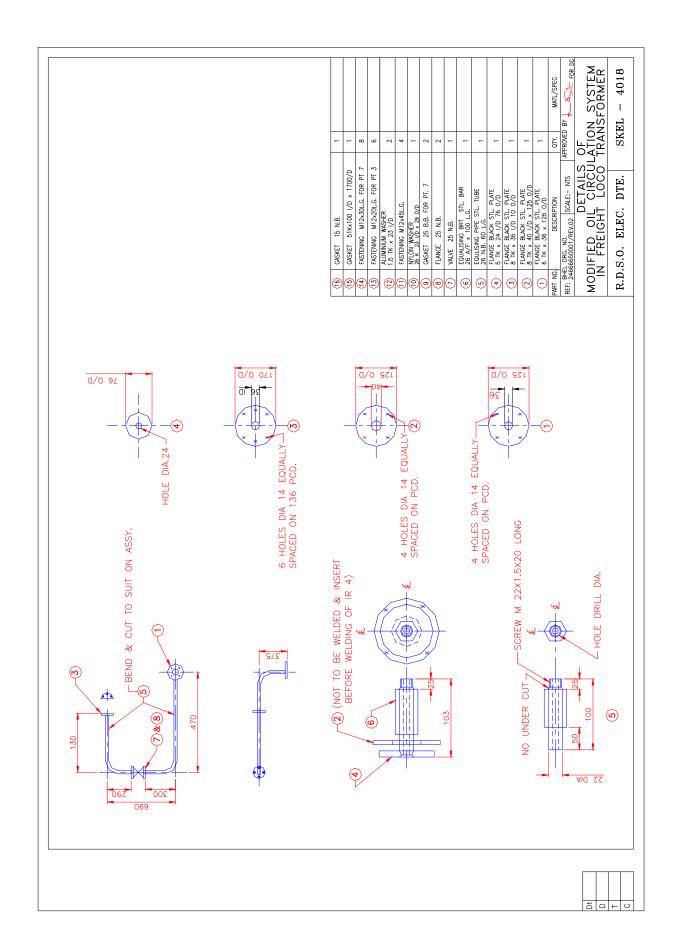
Railways have reported cases of insulation deterioration/failure of transformer auto winding leads. Investigations have revealed that the main reason for such failures is the presence of large amount of sludge in the neck portion with practically no movement of oil in the region. In order to overcome the problem it has been decided that the oil circulation in the transformer neck area should be increased by bleeding a small amount of oil from the bottom of the rediator and injecting the same in the neck of the transformer as shown in SK. EL.-4012.

Assemble an equalising pipe from the bottem of the rediator to the neck of the transformer as shown in schentic sketch SK. EL.-4010.
