Government of India
Ministry of Railways
Research Designs & Standards Organisation
Manak Nagar , Lucknow - 226011

MODIFICATION SHEET NO. RDSO/WAM4/184

Tolerances between motor bars and slots to be adopted on M/s Jyoti make of Arno Convertor.

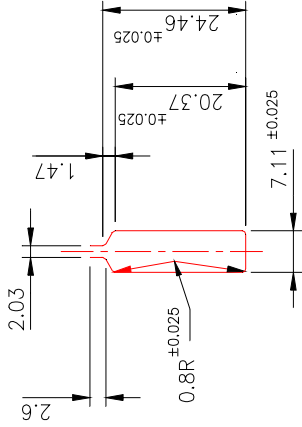
ROTOR SLOT DETAIL

Dimension	Nominal	Minimum	Maximum
Slot width	7.11	7.085	7.135
Copper bar width	6.5	6.39	6.61
Tolerance between			
slots & bar	-	0.475	0.745
Slot height	20.37	25.345	20.395
Copper bar height	20	(Not specified in IS:1897)

The above tolerances will ensure that the minimum clearance is 0.345 mm. However, radial clearance has not been clearly defined in the drawings and in IS:1897 But M/s Jyoti has advised that this radial clearance will be about 0.4 mm.

- 5.4 In order to achieve the radial clearance of 0.4 mm the rotor bars must all be firmly bedded down in the core slots.
- 5.5 While repairing any rotor with cracked bars, it is desirable to replace all the bars and both the end rings i.e. old bars and rings should not be reused.
- 5.6 Rotor bars should be "Araldited" only in the middle third of the rotor slots leaving the end third portion free for expansion and contraction.

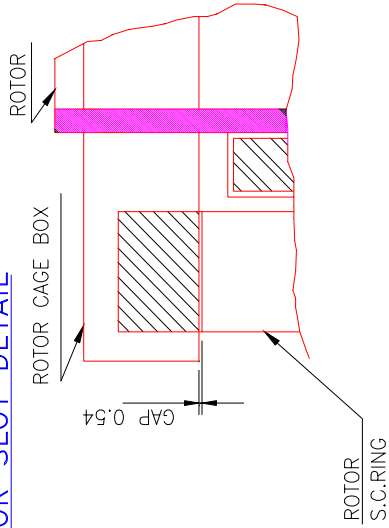
S.C.RING & CAGE BAR ASSY.

3.1 Railways have reported regarding the cracking of rotor bars of arno convertor. Detailed investigation into the failure and discussions with M/s Jyoti revealed that these defects are caused mainly by thermal stresses produced as a result of the expansion and contraction of the bars and end ring during starting, running and rest.
