Government of India
Ministry of Railways
Research Designs & standards Organisation
Manak Nagar, Lucknow 226011.

MODIFICATION SHEET NO. RDSO/WAM4/83

MOUNTING OF R'5 & RCL RESISTORS
OF BCF-7 BATTERY CHARGERS

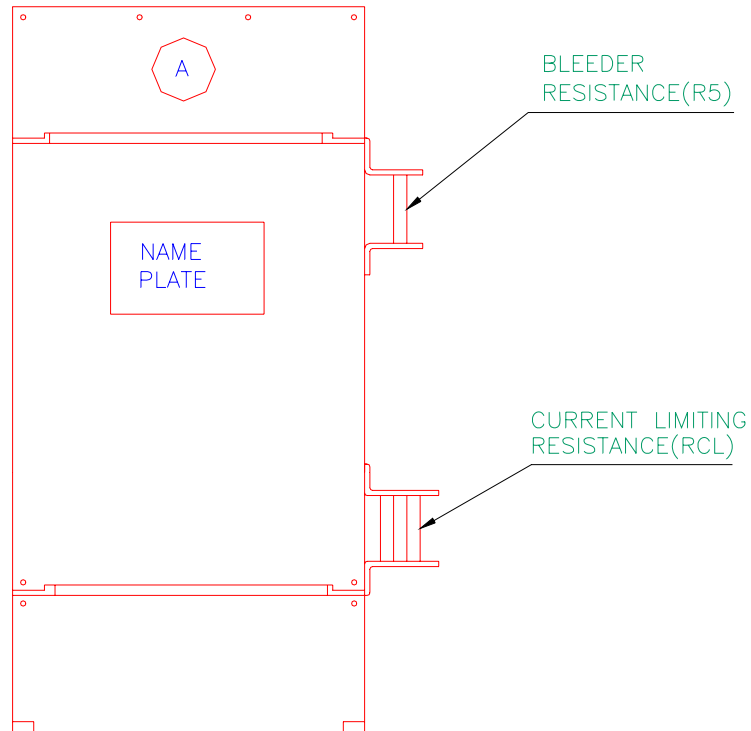
SKEL-3151

1.1 Railway have reported a number of failures of BCF7 battery chargers mainly due to failures of various components such as resistors, capacitors, transistors etc. On investigations it has been found that high ambient temperature around the components inside the charger is one of the contributory causes. To reduce the ambient temperature of air inside the charger it is proposed to shift the bleeder resistance (R'5) to a location outside the charger.

2.1 Shift bleeder resistor (R'5) presently mounted inside the battery charger to outside the charger and mount it on the side panel of the charger in the similar may as done on BCF6 chargers.
