MODIFICATION SHEET NO. RDSO/2009/EL/MS/0377 (Rev.0) , Dated 22.04.09.

Modification to voltage sensing circuit in WAP-5,WAP-7,WAG-9 & WAG-9H Locomotives.

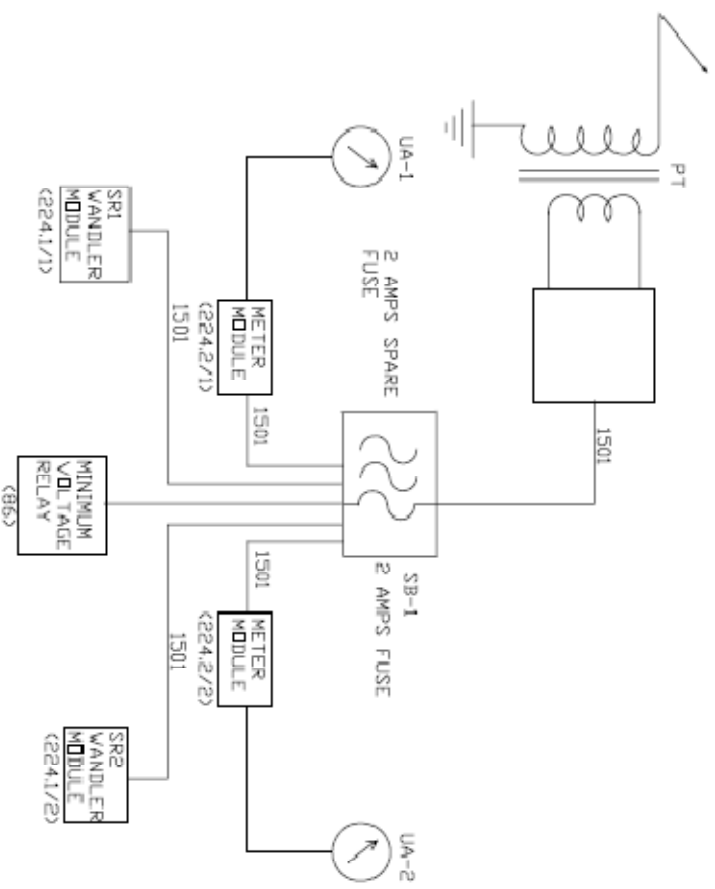
OHE VOLTAGE SENSING CIRCUIT (MODIFIED)

There have been reports of failure of WAG9 locomotives online due to potential transformer fuse blowing on secondary side (provided on loco roof) causing heavy detention of trains and dislocation of traffic since power block is needed to renew the fuse. This may happen due to failure of wandler module in SR-1&2, minimum voltage relay & meter module in cab-1&2.

A 2 Amps fuse is relocated to SB-1 in the locomotives provided with 2 Amps fuse in the secondary of potential transformer. In the old locomotive also where no fuse is provided on the secondary side of potential transformer on roof, one 2 Amps fuse should be provided in SB-1. Two spare fuse of 2 Amps should also be provided near the working fuse. The photograph of arrangement of the 2 Amps fuse in SB-1 cubicle is enclosed.

Modified circuit diagram is attached .
