No. EL/11.5.5/1 Date: 19.06.2009

# MODIFICATION SHEET NO. RDSO/2009/EL/MS/0378 (REV.0), DATED 29.05.2009

Modifications in NS/AS Controller Cards (PPA988B02) and Gate Unit of Power Converter of three phase locomotives.

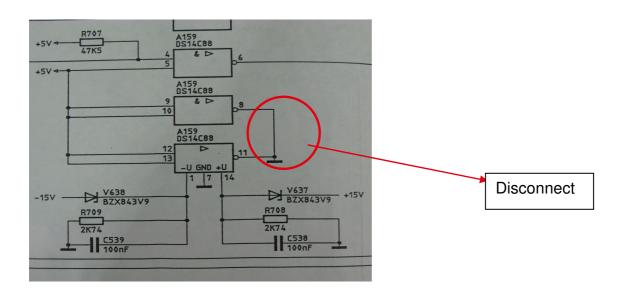
# Annexure-1

It has been observed that NS/AS controller card (PPA988B02) is contributing approximately 50% of the card failures of power converter of 3-phase locomotives in the recent years. This card is being imported by M/s. BHEL & M/s. NELCO and indigenised by M/s. BTIL since 2001. After make-wise failure analysis of these cards, it is seen that the failures (FRPCPY) in BTIL make cards is 23.2% as compared to 2.7% of BHEL. Based on failure investigation reports given by M/s. BTIL, it has been observed that majority of the failures are because of failures of IC14C88 and in some cases failures of these ICs are along with zener diodes V637 & V638. The matter was taken-up with M/s. BTIL and it was found that a modification in this IC was cut-in by the OEM in the year 1999, where Pin No. 8 & 11, which were connected to ground earlier, were disconnected from the ground. This was done to avoid failure of this IC and zener diodes. The details have been shown in Annexure-1.

4.1 Pin No. 8 & 11 of IC 14C88 in PPA988B02 card are to be isolated to remove grounding of these pins in M/s. BTIL make cards.

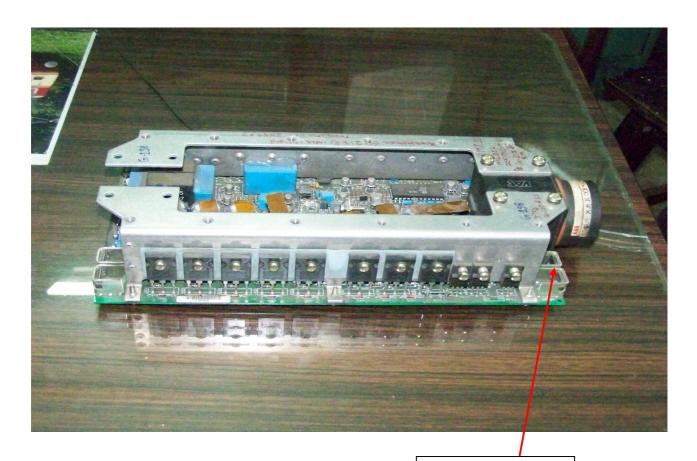
There are approximately 30% failures of Gate Unit which have been observed during last 06 years. M/s BTIL investigated and highlighted the cause of failure of Gate Unit (GVA578A01) due to lees clearance between Gate and Cathode terminal. This results in failure of GU of Power converter. In order to avoid this failure it is proposed to insert an insulating sheet between Gate and Cathode plates of gate unit.

No insulating plate

Existing Gate Unit without Insulating Plate
