Government of India - Ministry of Railways  
Research, Designs & Standards Organization,  
LUCKNOW – 226011  
Telex: 0535-2424 RDSO-IN  
Fax: 91-0522-2452581

**SPECIAL MAINTENANCE INSTRUCTION No**  
**RDSO/2006/EL/SMI/0240(REV. '1')**

Measures to improve the quality of smoothing reactors (SL-42/30) during manufacturing /maintenance.

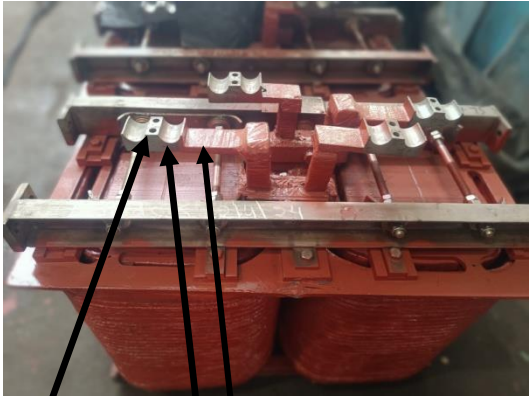
Recently a fire incident took place in one locomotive due to detachment of brazed fixed terminal cleat from connection bar attached with smoothing reactor coil end. Detached SL cable cleat was hanging inside SL cover leading to occasional shorting with other SL coil end. Henceforth, to avoid such incidences, the clause of resistance measurement has been modified and measurement of milli-volt drop has been introduced in addition to number of measures taken by the Railways to avoid failures of smoothing reactors. The measures, identified on the basis of failure analysis by the RDSO, for improving the quality are briefly summarized below:

<p><b>Braze fixed cleat      Connection bar</b> <b>Braze joint</b></p> <p>Picture showing fixed terminal cleat brazed on connection bar (161X50X10 mm thick) and connection bar with external coil end.</p>	<p>connection bar (161X50X10 mm thick) and connection bar with external coil end shall be made at ambient temperature through V/I method by injecting the rated direct current (1350 Amp for SL-30) through the coil.</p> <p>The measured resistance shall be corrected to reference temperature 115°C as per following formula:</p> $R_{115} = \frac{R_a \times 349.9}{234.5 + t_a}$ <p>Where, R<sub>115</sub> is corrected resistance at 115°C. R<sub>a</sub> is the resistance at ambient temperature and t<sub>a</sub> is ambient temperature. R<sub>115</sub> shall be 3.645 ± 0.056 milli-ohm</p> <p><b>The milli-volt drop corrected at 115°C = 4.92 ± 0.076 Volt.</b></p>

3	RDSO Technical Circular no. 42 dated 23.06.99 for retention of SL-42 while converting WAM4 locos to 6P combination of traction motors.	Change the material of cross bar assembly and stud from mild steel to stainless steel.
4	Measurement of coil resistance and milli-volt drop with fixed terminal cleat brazed on connection bar (161X50X10 mm thick) and	The measurement of resistance of each coil with connection bar having brazed fixed terminal cleat on

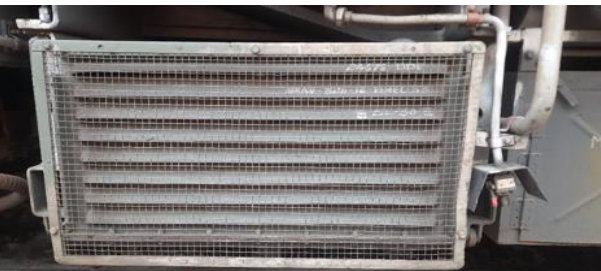
<p>The cover of SL is made of fibre which is sometimes found broken and foreign material are found stuck in SL, therefore Zonal Railways may provide one additional steel mesh to restrict the entry of foreign material in SL and to avoid damage due to external hitting.</p>

5.	<p>Provision of one additional steel mesh over fibre cover as per Zonal Railway recommendation.</p>
