INVESTIGATION REPORT

AXLE LOCK OF LOCO NO.33282/WAG-9/BSL/CR

No. RDSO/2021/EL/IR/0196 REV. '0'

JOINT INVESTIGATION REPORT DATED 09/11/2021 & 10/11/2021 OF FAILURE OF BEARING OF TM-4 OF LOCOMOTIVE 33282 OF ELS/BSL

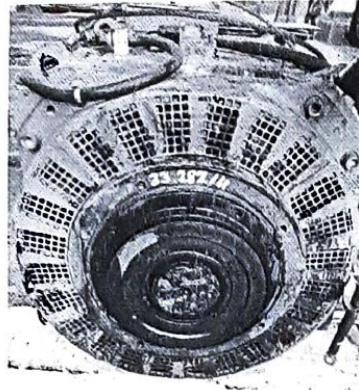
Failed TM No. DMW-834

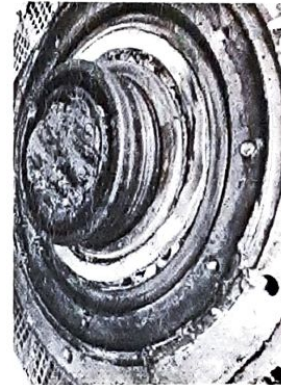
- 7) DE side end frame was removed from motor. One crack (through) was found on bearing inner racer.
- 8) Bearing cage found deformed and ribs (Brass Separator) found melted and its roller covered with thin layers of brass melted material.

Deformed Bearing Cage

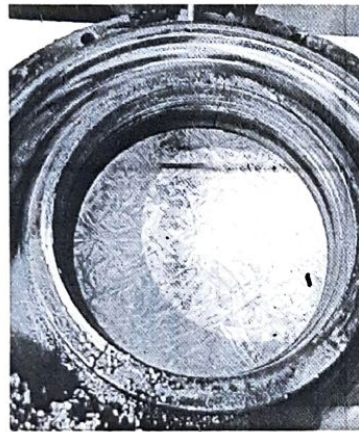
- 3) Outer labyrinth-DE removed from end frame with bearing outer cap.
- 4) Outer labyrinth -DE (SL-427 make Simplex Engg.) found crack at two place diagonally.

5. Since Outer labyrinth does not bear any load on it, still two cracks develop on it at diagonally opposite positions. This can happen due to excessive interference between outer labyrinth ID & Shaft OD. This excessive interference may be due to ovality in labyrinth ID or may be due to under size ID. DMW has submitted the measurement sheet in which measurement of ID of outer labyrinths of four TMs were mentioned. Outer labyrinth ID measurements of all four TMs are same (i.e, 179.783 mm). This is a rare possibility. So it seems that

bearing failure might have initiated due to excessive interference between outer labyrinth & rotor shaft OD.

Cracked Outer Labyrinth DE

1. Dimension of labyrinths are very critical. These labyrinths has to be machined on CNC & 100 % measurements has to be done by vendor on CMM. RDSO has advised that inspecting agency must inspect 20% quantity on CMM. These instructions has to be strictly followed to avoid occurrence of such failures. During assembly of TMs at PU/workshop/Sheds, measurements (rotor shaft OD, Labyrinth ID Bearing racers) has to be taken with proper tools.

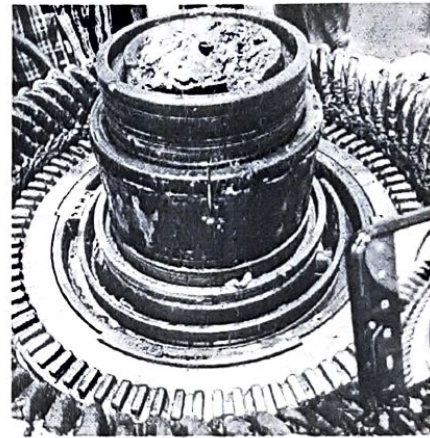
1. There is no sliding marks on inner labyrinth ID. Inner racer did not left its seating on rotor shaft OD. So, the possibility of failure of inner racer due to excessive interference is ruled out.

Cracked Bearing Inner Racer DE

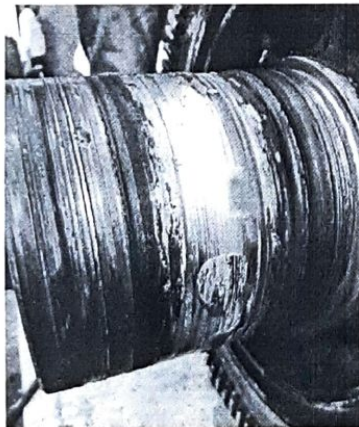
- 9) Bearing inner racer track having indentation marks of rollers.
- 10) After removing the Bearing inner racer it is found material deposited on rotor shaft.

- 11) Scoring mark observed on rotor shaft thoroughly
- 12) Bearing along with outer racer easily came out from end frame housing and bearing outer race has heating marks and scoring with slightly rotated.
- 13) NDE side bearing condition absolutely Normal
- 14) There are no rubbing marks observed on Stator & Rotor.
- 15) IR test conducted on stator & IR found 1000 megaohm with 1KV megger.

Metal Deposit & Rubbing marks on Shaft OD

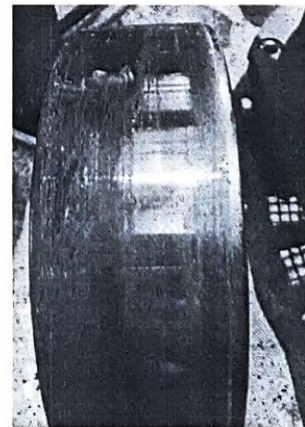
Rubbing marks on Outer race DE

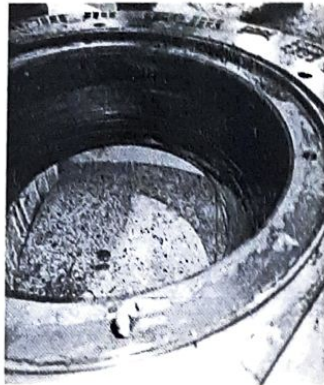
4. No major scoring marks/rotation marks observed on the DE side end frame Bore dia. Bearing outer racer was having heating marks on its OD & did not has major rotation/scoring marks. So possibility of failure due to rotation of outer racer inside endframe is ruled out.

Little rotation/Heating marks on End Frame

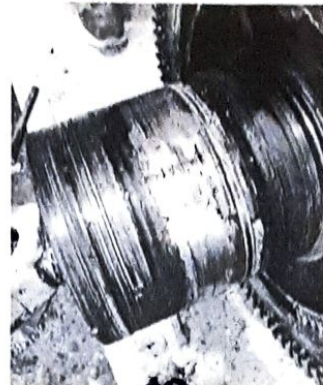
- 5) Outer bearing cap found overheated and make and serial were not visible.
- 6) DE side Rotor outer labyrinth seat diameter found scoring marks due to rotation of outer labyrinth.

Rotation marks on shaft at Outer/Inner Labyrinth Seating Area all around

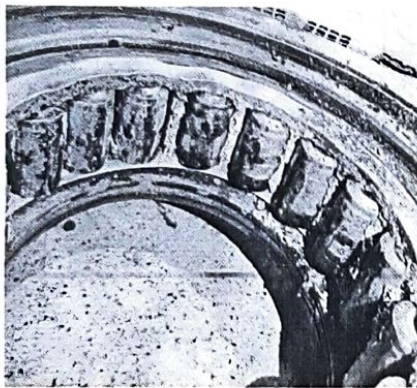
3. Brass Cage Broken: Cage as well as supporting ribs were not broken, they were melted due to heavy heat & get deformed. Cage is the weakest part of the bearing & likely to damage during such type of bearing failure cases. So this possibility of Cage breakage as a cause of failure is also ruled out.

Bearing Cage Ribs (Separators) melted

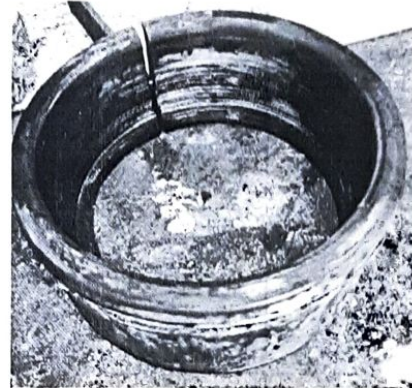
Cracked Inner Racer of DE Bearing

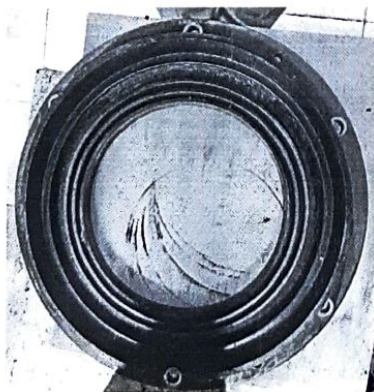
Excessive heating marks on Outer Bearing cap DE

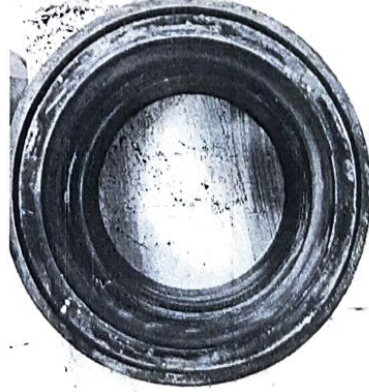
Rotation of Inner labyrinth DE
