***SPECIAL MAINTENANCE INSTRUCTION No. RDSO/2007/EL/SMI/0245 (REV 0)  
dt. 29.06.2007***

- 1.0 TITLE:  
Ultrasonic test procedure to detect cracks at the key groove portion of DJ flange shaft.
- 2.0 BRIEF HISTORY:
  - 2.1 Railways have reported cases of on line failures of locomotives due to breakage of flange & shaft assembly of DJ manufactured and supplied by M/s BT,Vadodara.

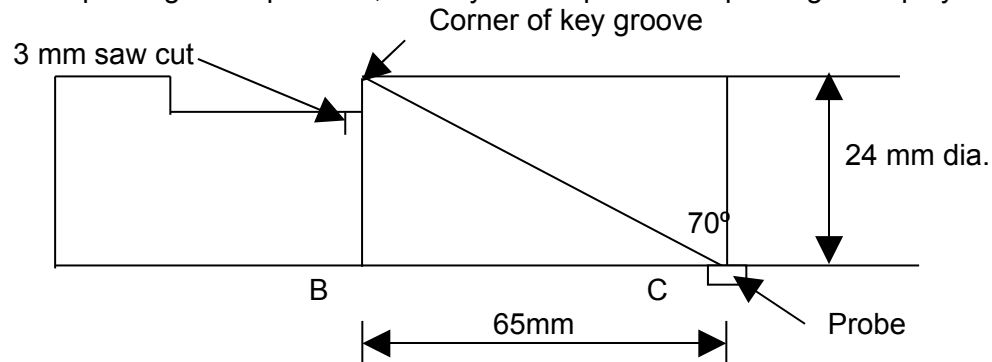
FIG. 1

a) Half skip distance (BC) - = dia. of shaft x tan 70°  
 = 24 x 2.74  
 = 65 mm

b) Beam path (AC)  
 = dia of shaft x sec 70°  
 = 24x2.92  
 = 70 mm

A high angle probe shall be place on the body of the shaft with probe index marking at 65mm (half skip distance) away from the key group corner as shown in fig.1. The probe shall be moved backward and forward longitudinally from the mean position and also circumferentially on the body of the shaft to obtain maximum amplitude of echo from the corner of key groove at about 7.0 div. (1msd=10mm) on the CRT.
