भारत सरकार - रेल मंत्रालय  
अनुसंधान अभिकल्प और मानक संगठन  
लखनऊ - 226 011  
EPBX (0522) 2451200  
Fax (0522) 2458500

**TECHNICAL CIRCULAR No. RDSO/2010/EL/TC/0106 (Rev. '0'),**  
**Dated 11.10.2010**

**Sub: Problem of excessive ramp up time of 180kVA SIV.**

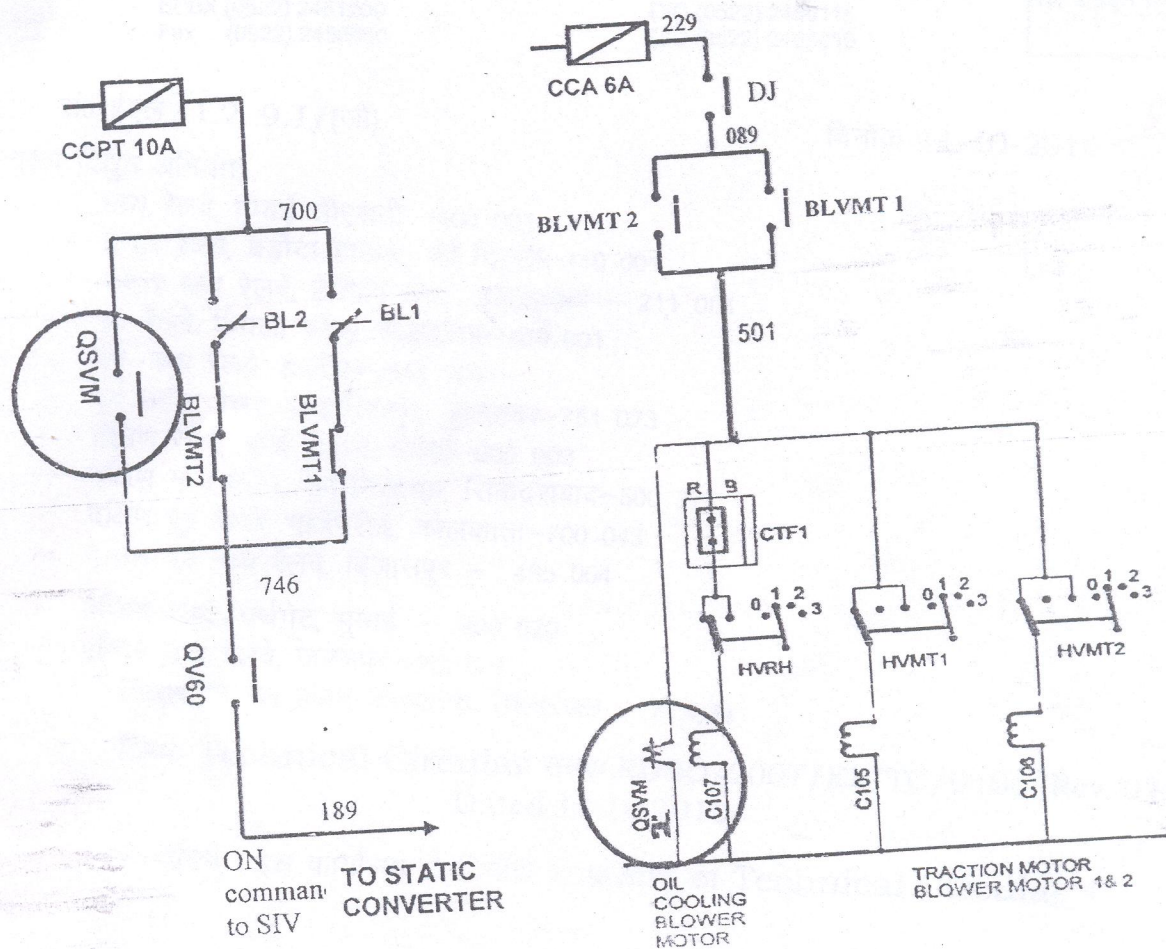
## Annexure-1

- iii. In regard to SIV ramp up time it may be noted that the total ramp up time (from pressing of BLRDJ to LSCHBA lamp off) also includes the on time delay of QSVM in addition to the ramp up time of SIV. It may also be noted that SIV gets ON command only after pick of QSVM relay as per circuit attached as Annexure-1. It is noticed that the time delay of QSVM relay provided in the software of MPCs is 5 sec. as against 2 sec. stipulated in RDSO Modification Sheet no. ELRS/MS/0335, Rev. '0' dated 28.01.2005. Hence after pressing the BLDJ & BLRDJ, the ON command to SIV will pass only after 5 sec. due to 5 sec. ON time delay of QSVM, which is causing delay in the ramp up of SIV.

After switching on the BLVMT, ON command at SIV will pass only when QSVM relay picks up & NO interlock of QSVM relay change it's position to close interlock.

- iv. The issue has been taken up with the manufacturers of MPCs and all the manufactures of MPCs have been advised vide this office letter no EL/4.2.15 dated 30.09.2010 to modify the software to reduce the time delay from 5 sec. to 2 sec. ON-time delay as stipulated in RDSO Modification Sheet. This will reduce the total ramp up time (from BLRDJ switch on to LSCHBA lamp off) by 3 sec. Trial of modified MPCs software has been jointly conducted at ELS/CNB on 23.09.2010 with M/s Medha, M/s AAL & M/s Siemens. During the trial it was found that the total ramp up time of SIV (from pressing BLRDJ to LSCHBA switch OFF) is around 17 sec. with modified FDCS during initial charging of locomotive (with DC link voltage as 0 volt). During the running of locomotive if DJ trips because of any reason / in the neutral section and loco pilot switches on BLDJ and BLRDJ, in that condition, total ramp- up time will be less than 15 sec. as rectifier section of SIV takes less time due to availability of residual DC link voltage.

In view of above, it is advised to get the software of MPCs modified by the manufactures and also in relay based locomotive, setting of QSVM relay

is to be ensured as 2 sec. ON-time delay. Loco pilots may also be counseled to take notch only when LSCHBA lamp extinguishes, otherwise first notch tripping will take place.
