Government of India-Ministry of Railways
Research Designs & Standards Organisation
Lucknow - 226 011
DID (0522) 2450115
DID (0522) 2465310

Technical Circular No. RDSO/2011/EL/TC/0111(Rev. 0)

Sub: Technical Circular on Method of Filling of Cardium Compound In The Gearcase of TM3701BY/BX Traction Motor for Kolkata Metro

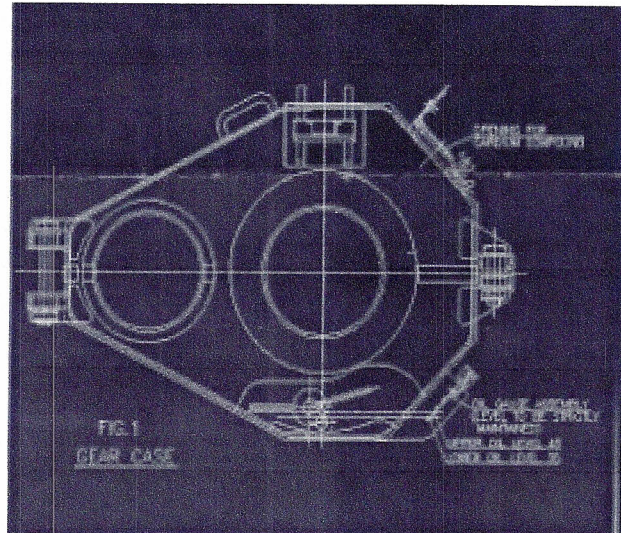
Fig.1

- 3.1. The gearcase of TM3701BY/BX is provided with an oil gauge assembly in the bottom half of gearcase, with markings of maximum and minimum levels. Filling of gearcase with cardium compound during schedule maintenance should not exceed the maximum mark indicated on oil gauge assembly of gearcase.

- 3.2. Whenever the level drops below the minimum mark on the oil gauge assembly, the gearcase should be topped up with cardium compound (in molten state). After topping up, level must be checked to ensure that the level does not cross the maximum mark provided on the oil gauge assembly. See the attached fig. 1 :

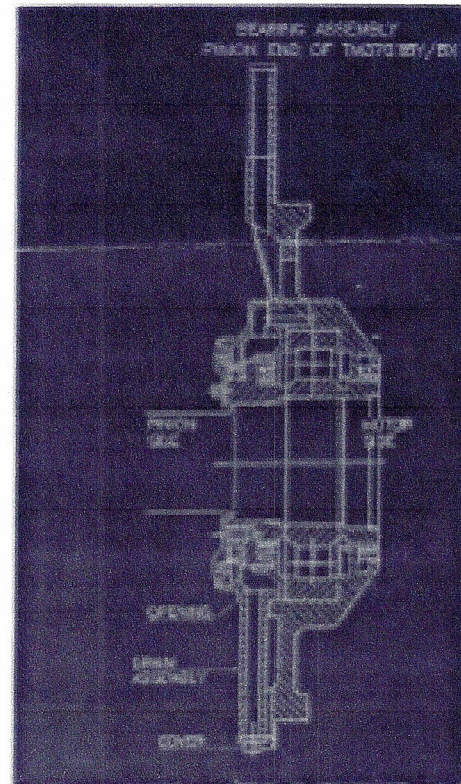
Fig. 2:

- 3.3. Damaged / worn out felt seals of gearcase result in inadequate sealing of gearcase and consequent loss of cardium compound from the gearcase. Replace any damaged / worn-out felt seal of gearcase, if observed during maintenance.
- 3.4. A drain assembly is provided in the bottom portion of Bearing Cover on Pinion End(PE) for collection of extra cardium compound, if it seeps in. It should be periodically emptied by opening the cover at the bottom which has been provided for this purpose. The drain assembly is connected to the bearing cover body through an opening. These should be thoroughly cleaned during routine maintenance. Thus extra cardium compound, if any , would flow out & the possibility of its ingress to PE bearing will be eliminated. See the attached fig-2.
