Sub: Technical Audit Report No. RDSO/2025/EL/TAR/0038 Rev. '0' dated 13.03.2025 on Traction motor (6FRA6068) maintenance at Electric Loco Work-Shop/Bhusaval.

**Technical Audit Report of Electric Loco Work Shop
/BSL for maintenance of three phase locomotive
Traction Motors (TM) type-6FRA6068**

Report No.: RDSO/2025/EL/TAR/0038 Rev '0'

Technical Audit report on 3-phase TM overhauling practices at POH/BSL

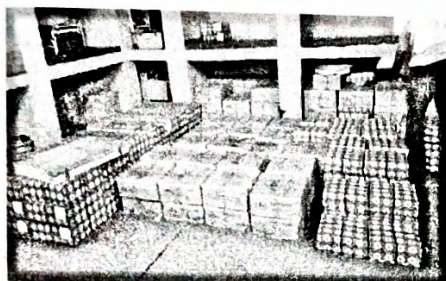
- i) Adjacent to the traction motor assembly area, the bearing storage room is provided. The room has provision of number of concrete shelves for storage of bearings. Bearing boxes were found lying on floor of the room instead of properly stacking in shelves. It was advised that practice of FIFO (first in first out) is being followed but no such demarcation has been done. The bearing storage room was provided with two number split AC's and both were found in working condition and the room was sufficiently cool.

Bearings lying on shop floor

Bearings placed in the corner

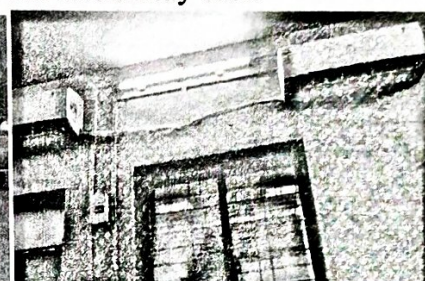
Two installed split ACs

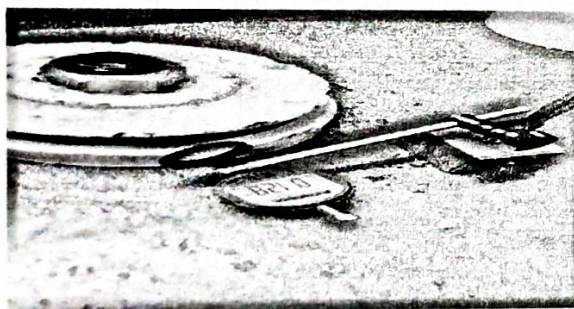
- ii) Free radial clearance of all bearings were checked using dial gauge with least count of 1 micron and noted before use of particular bearing.

FRC Measurement of NDE

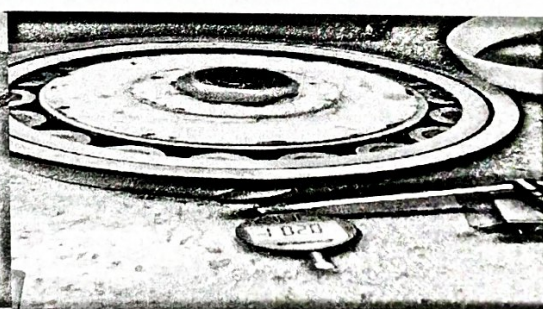
FRC Measurement of DE

- 2 ELW/BSL rejected 2 Nos of DE (NU2236) bearings on account of less FRC (Free Radial Clearance) of 159 & 161 micron of M/s NBC India (M.f.g- 09/2024) and two Nos FAG/India bearing due to overheating issues during light run test.

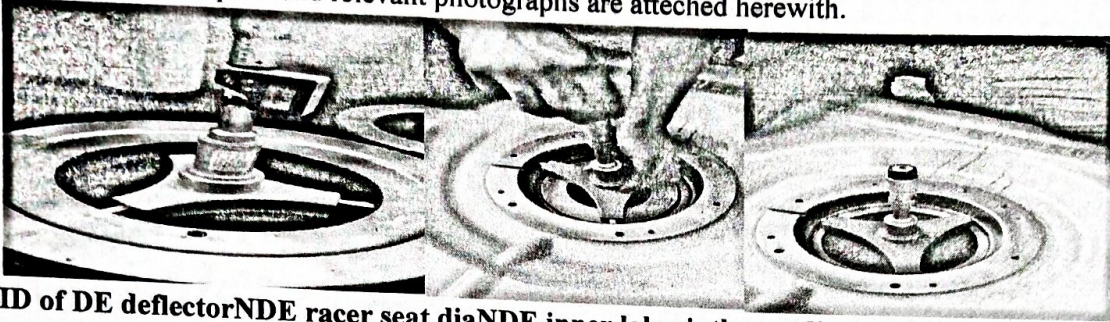
ID of DE deflector NDE racer seat dia NDE inner labyrinth seat dia

SNo	FRC limits as per check-sheet	Observed value
1	FRC of DE bearing NU-2236 (170 to 220 Micron)	201 micron
2	FRC of NDE bearing NH-320 (105 to 140 Micron)	128 micron

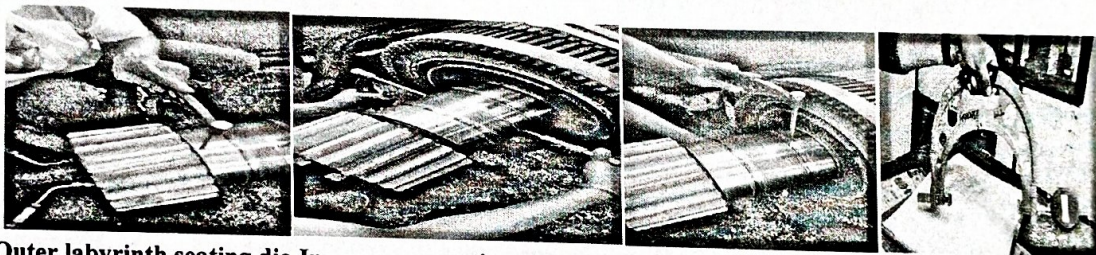
Name of item	Standard limit in mm	Measured dimensions in mm	Equipment used with LC	Remarks
DE end frame ID	319.950-319.990	319.957	Digital bore gauge (1 micron)	Dimension within limit
Outer labyrinth DE (ID)	179.748-179.783	179.756	Digital bore gauge (1 micron)	Dimension within limit
ID of inner racer DE	179.975-180.000	179.987	Digital bore gauge (1 micron)	Dimension within limit
ID of end frame NDE	214.948-214.970	214.949	Digital bore gauge (1 micron)	Dimension within limit
OD of outer racer DE	319.960-320.000	319.981	2 point micrometer (1 micron)	Dimension within limit
Shaft seating dia for (inner racer)DE	180.043-180.068	180.052	2 point micrometer (1 micron)	Dimension within limit
Shaft seating dia for (outer labyrinth)	179.843-179.868	179.846	2 point micrometer (1 micron)	Dimension within limit

Outer labyrinth seating dia Inner racer seating dia Inner labyrinth seating Snap dial gauge

- iv) Ensure availability of sufficient quantity of snap dial gauges with least count of 1 micron for measurement of OD of rotor shaft at various locations as advised by RDSO SMI/314. Available snap dial gauge was not in healthy condition henceforth measurement was getting done by two point outside micrometer.

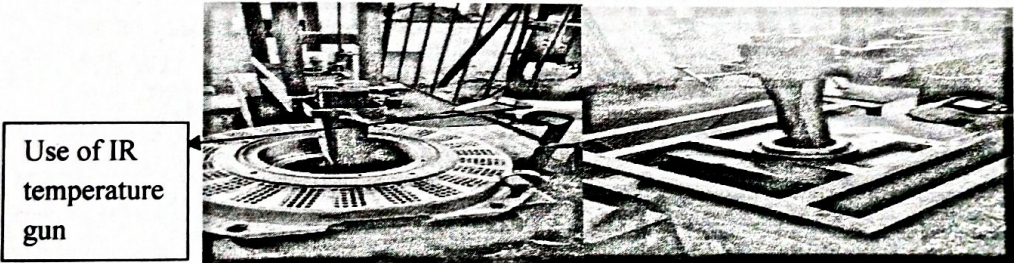
- i) Induction heater used for heating of various components during assembly of TM type 6FRA6068 was having no provision of temperature display and auto cut-off feature.
- ii) The temperature of various components during induction heating is getting monitored by using infrared temperature sensor gun. Which is not a correct practice because by measuring temperature using IR temperature gun actual temperature of job will be more than the reading recorded through IR temperature gun.

Use of IR temperature gun during induction heating

- i) Ensure availability of sufficient number of Induction heaters having provision of digital temperature display, auto cut-off and demagnetizing features as per RDSO SMI/301.

- v) The induction heater used for heating the various assembly components do not have provision of temperature display and cut-out features. Temperature of job is getting measured by using IR temperature gun which is not correct practice. Hence induction heater to be installed in required quantity having feature of temperature display, temperature setting, auto cut -off and de-magnetization as per RDSO SMI-301.

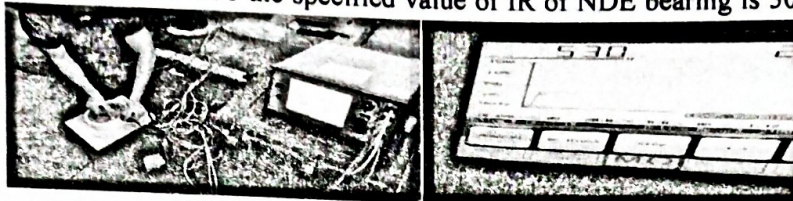
The Insulation resistance of insulated bearing coating were getting recorded with respect to earth at 530 Volts instead of 1 KV megger as prescribed vide RDSO SMI/278.

- i) Insulation resistance of NDE bearing was measured at 530 V and came out 176 M-Ohm as per RDSO SMI/278 the specified value of IR of NDE bearing is 50M-Ohm at 1000 Volts.

NDE bearing IR measurement at 530 Volts

- xii) Insulation resistance of NDE bearing shall be measured as per RDSO SMI/278 the specified value of IR of NDE bearing shall not be less than 50M-Ohm at 1000 Volts.

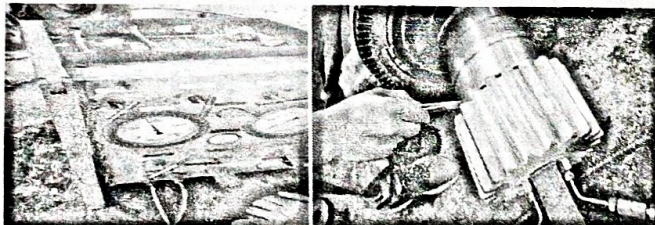
- i) The pinion was inserted inside the rotor after applying a pressure of 1900 bar.
 ii) After insertion of pinion the OD of the shaft at various location was getting measured within 5 minutes after insertion of pinion. However the immediate value may be more by a few micron due to increased temperature by pinion insertion (by 5-7°C). It is recommended to take OD of rotor shaft at various location (DE & NDE) after actual pinion insertion under ambient temperature for measuring correct predetermined better interference.(CLW WI: W21.410 Para 4.3.11)

Pinion insertion and gap measurement between shaft and pinion

- vii) The fitment of inner racer, labyrinth should be undertaken only after cooling of rotor shaft up to ambient temperature based on OD of rotor shaft (DE & NDE) measured after pinion fitment under ambient temperature condition as per guideline /Work instruction (CLW WI:W21.410 Para 4.3.11).

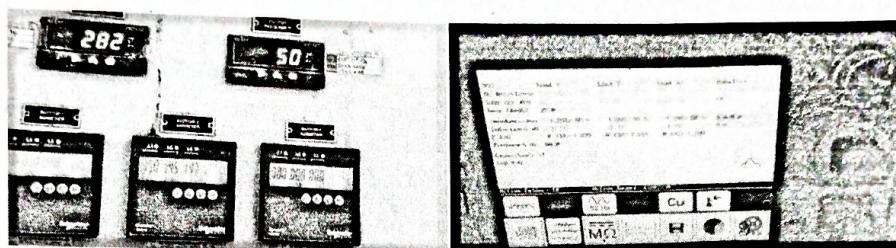
- ii) Tests on Rotor:- To detect the broken bar of a rotor, growler test is also performed on the rotors as informed by POH/BSL.
- ii) Light Run test on assembled TM:-
During the light run test first the Traction Motor is rotate at lower of 200- 400 rpm for 5 minutes .Thereafter the TM was run at 1000 rpm with 50Hz supply. During the light run test the phase currents were 15.0 A, 14.5A,14.7A . The Traction motor was run in clockwise as well as anticlockwise direction for one hour (01 hour) each and bearing temperatures at the end of the light run tests were observed. As per POH/BSL the bearing temperature rise shallremains less than ($< 25^{\circ}$ Ambient).

VVVF drive for light run test

Inductance measurement of assembled TM

- i) During the light run test the TM shall be run at 100 rpm for 5-10 minutes so that the grease is uniformly distributed along the entire bearing . Thereafter the TM shall be run on 1000 rpm and not beyond this point vibration and bearing temperature shall be monitored. Vibration and noise shall be as per IEC 60349-2 values. Preferably the TM shall be run in both the directions upto 30 minutes.

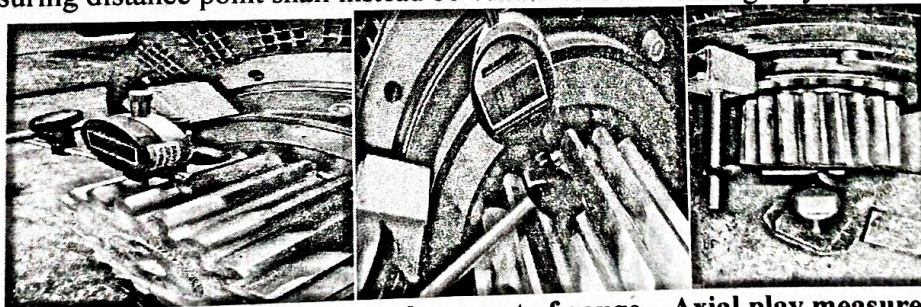
The axial clearance of the assembled TM was measured as 327 micron and is within the range of 200-400 micron as per RDSO check sheet dated 02.12.2024. While measuring the radial clearance of the assembled Traction Motor it was observed that the radial clearance was being taken at a place 80 mm away from the rotating labyrinth. The measuring distance point shall instead be 40mm from the rotating labyrinth.

Wrong placement of gauge Right placement of gauge Axial play measurement

Recommendation: SMI/278 needs to be followed and measurement of radial clearance shall be done at a distance of 40mm from the rotating labyrinth end. RC of 153 micron was observed when measured at a distance of 80mm and RC of 152 micron was observed when measured at a distance of 40mm.

- x) Assembled TM Radial Clearance not taken at required distance of 40mm. The radial clearance of the Traction Motor shall be taken at an axial distance of 40mm from the rotating labyrinth. The detailed procedure of RC measurement of assembled TM with permissible limit is mentioned in RDSO SMI/278, same needs to be followed by POH/BSL.
