Technical Investigation Report of Axle seizure due to Bearing failure of Traction Motor type 6FRA6068 fitted in Locomotive No. 30549/WAP-7/SRC on 24.04.2019 between Bhusawal –Badnera section on Bhusawal division.

No. RDSO/2019/EL/IR/0186 Rev. '0'

**ELECTRICAL DIRECTORATE
RESEARCH DESIGNS & STANDARDS ORGANIZATION
MANAK NAGAR, LUCKNOW-226011**

Investigation Report of Loco No. 30549 WAP-7, SRC failed due to wheel set-5 locked on 23/24.04.2019

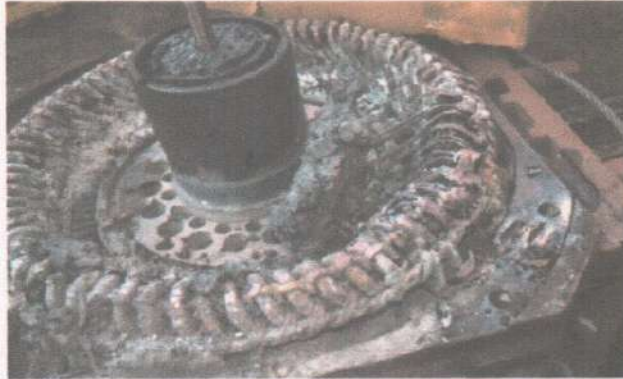
Fig 1 : DE side winding badly melted on overhang filling stator and rotor gap

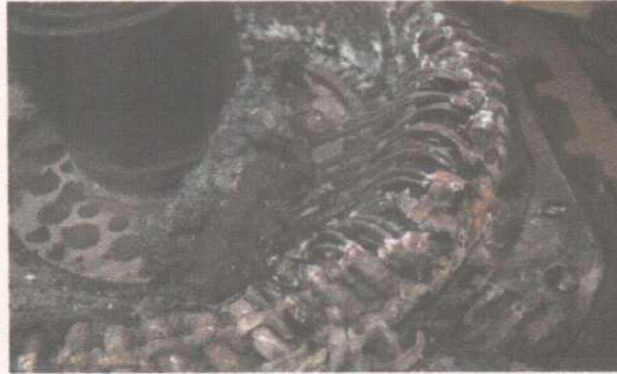
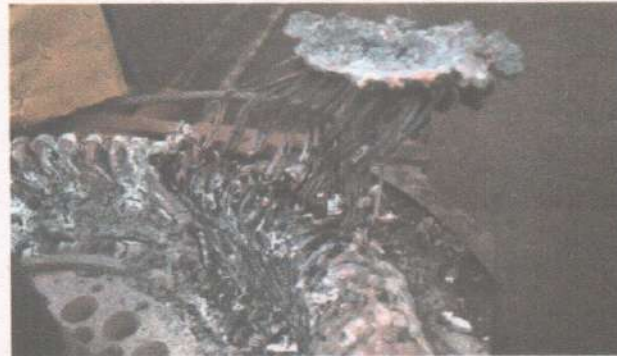
Fig No. 2&3 : Molten copper stuck on coils of winding on DE overhang

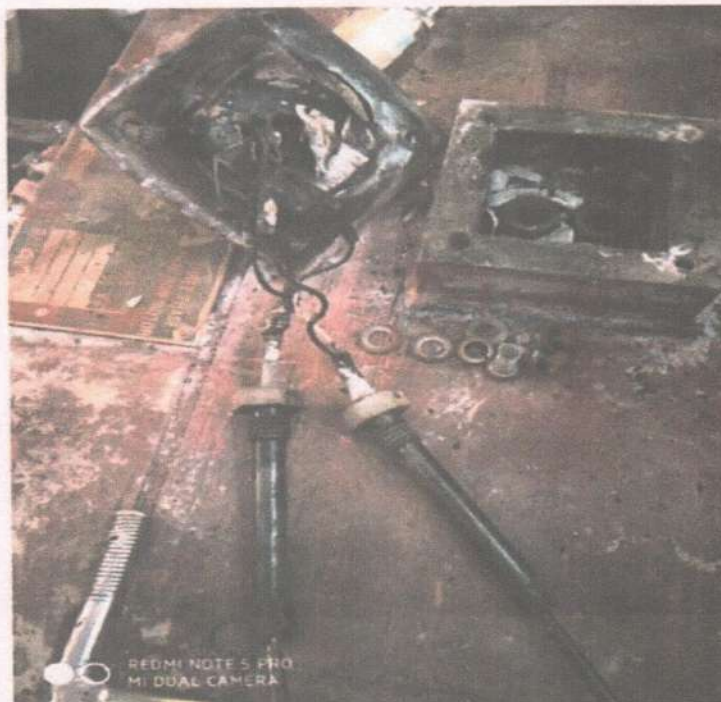
Fig. No. 4 : Badly overheated temperature sensor assembly

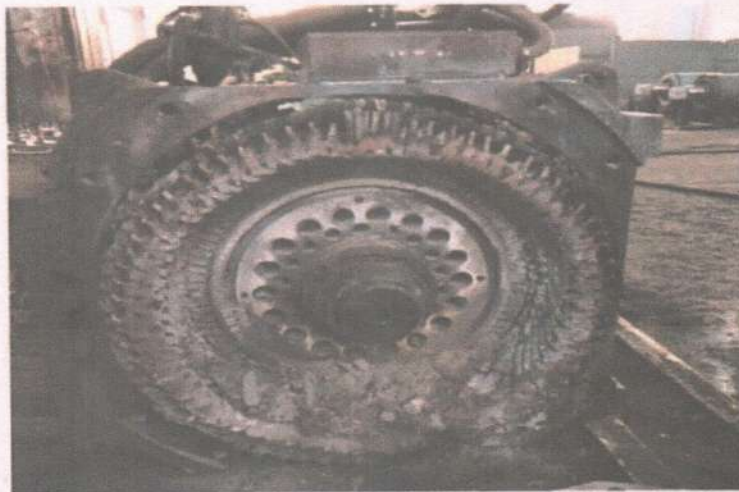
Fig. No. 5 : Molten copper and ash on NDE overhang

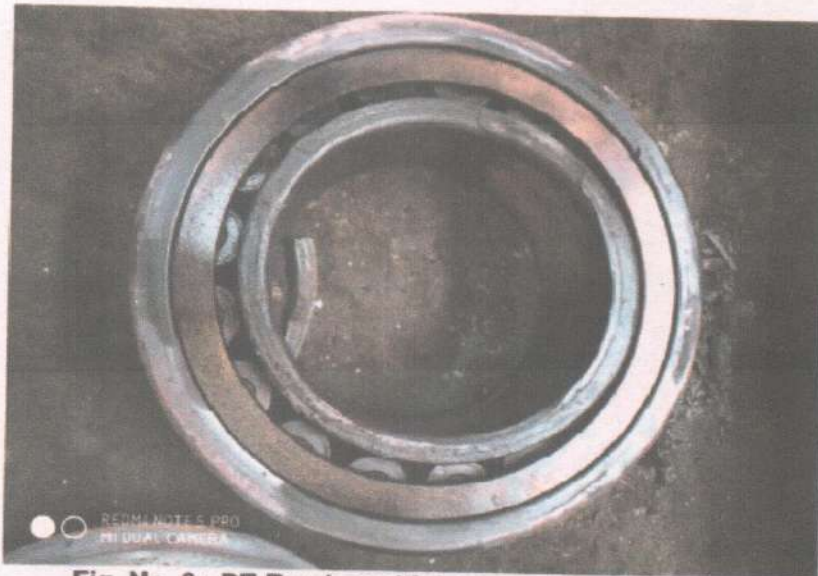
- iii. Seizure of DE bearing :- The driving end bearing is found in seized condition, however its rollers & cage were intact. The problem of oil ingress was reported in this traction motor. However the DE bearing seizure can't be attributed to starvation of grease as last greasing was done on 05.04.2019. From the observations, it appears that DE bearing seizure is after effect of NDE bearing seizure as damage of NDE bearing is much more than DE bearing.

Fig. No. 6 : DE Bearing with inner racer stuck inside

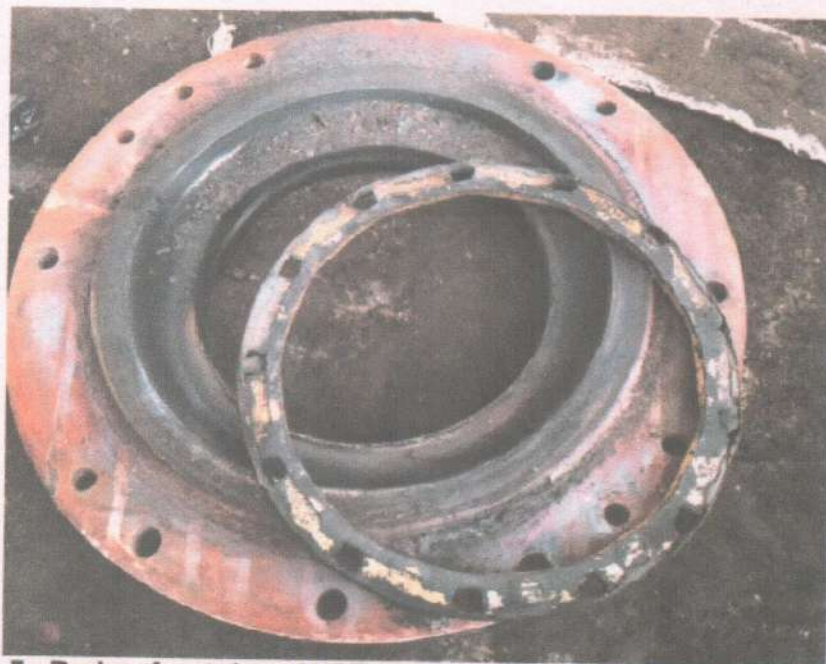
- iv. Seizure of NDE bearing :- NDE bearing also found in seized condition, its rollers were dislocated & cage had broken. From the observation it appears that NDE bearing seizure is root cause of the incidence. From the measurements carried out, it is evident that diameter of NDE bearing main seating area found 214.914/ 214.920/ 214.951mm at different locations compared to prescribed diameter of 214.948 to 214.960mm. The less diameter of end shield will result into higher interference than prescribed. It is suspected that high interference of NDE bearing is probable cause of seizure of NDE bearing. CLW had started measurements of mating components from February'2018 & this traction motor was manufactured in January'2017.

Fig. No. 7 : Broken front ring of NDE bearing brass cage and NDE grease cover

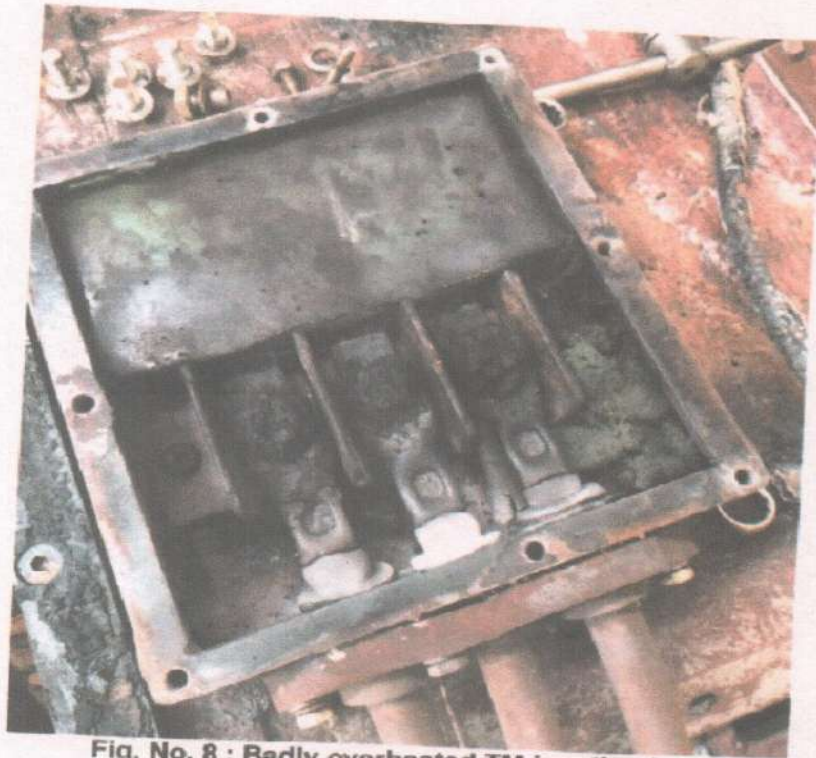
Fig. No. 8 : Badly overheated TM junction box

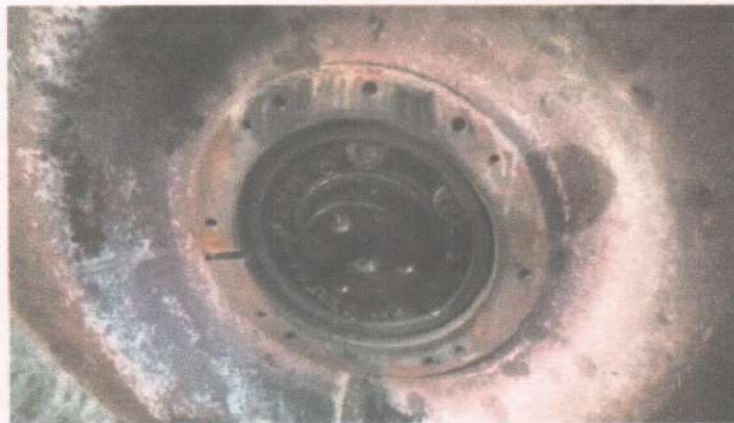
- 4.2) NDE end shield bolts were opened but end shield was not coming out. NDE side bearing was also found in seized condition & its rollers were dislocated. Rollers had jammed with inner racer & outer racer due to which end shield can't be taken out even after removal of end shield bolts. Rollers were taken out one by one by gas cutter & end shield removed thereafter. Inner racer was also removed by gas cutter. The NDE bearing was in much more damaged condition compared to DE bearing. NDE side stator overhang portion insulation found burnt & damaged. The rotor could not be taken out from the stator & rotor is physically locked & entangled with stator. The photographs of damaged TM parts are attached at **Annexure-II** (05 pages).

Fig. No. 11 : NDE bearing after dismantle

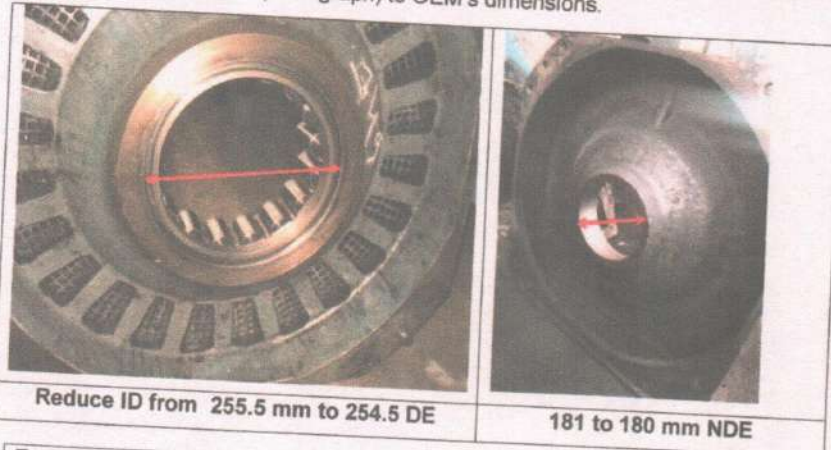
- 5) ELS AQ also requested to change the back side inner dia of DE and NDE end shield. (As shown in the photograph) to OEM's dimensions.

Reduce ID from 255.5 mm to 254.5 DE

181 to 180 mm NDE
