Government of India-Ministry of Railways  
Research Designs & Standards Organisation  
Lucknow - 226 011  
DID (0522) 2450115  
DID (0522) 2465310

MC/CTRB/Defects

Date: 29.03.2019

**Sub:** Attention to Wheels and CTRBs of the LHB wheelsets observed with heavy wheel shelling.

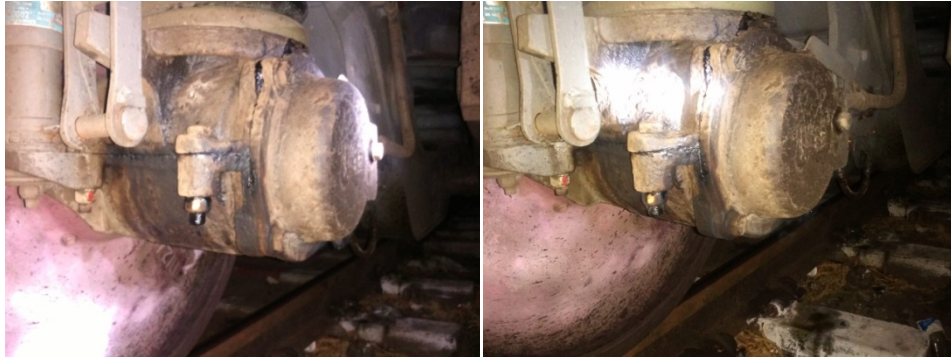
1. Heat marks found on axle end cover and both control arms of reported axle box No. R6 . Slight rubbing marks found on upper control arm bore.

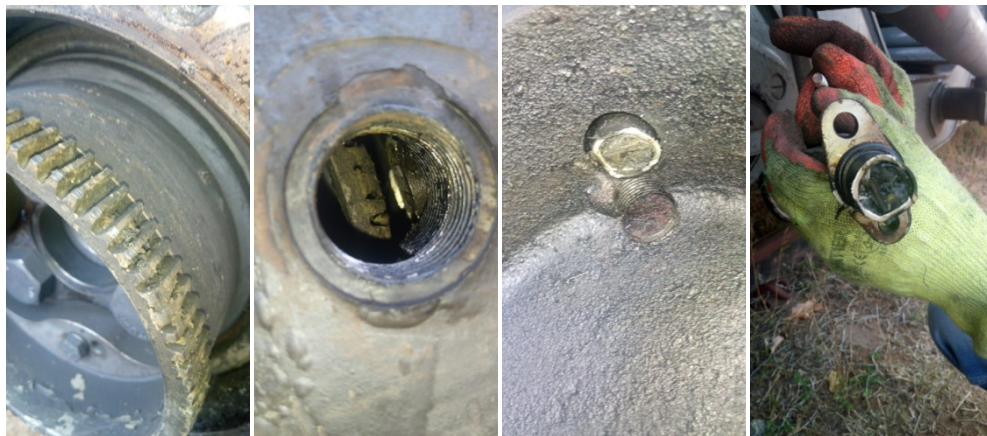
2. The phonic wheel teeth found with slight rubbing mark with speed sensor due to bearing failure. The speed sensor was also found in completely damaged and melted condition.

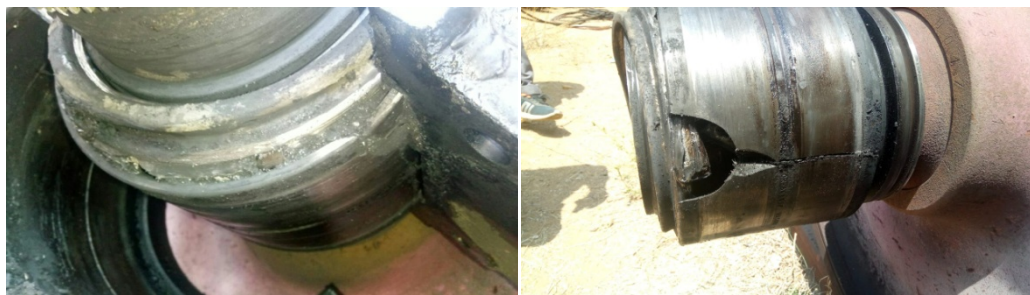
3. Bearing found in seized condition and Bearing cup found in broken condition at 3 'O' clock position on entire length i.e. 160 mm. Half moon crack found on Bearing cup at outboard side.

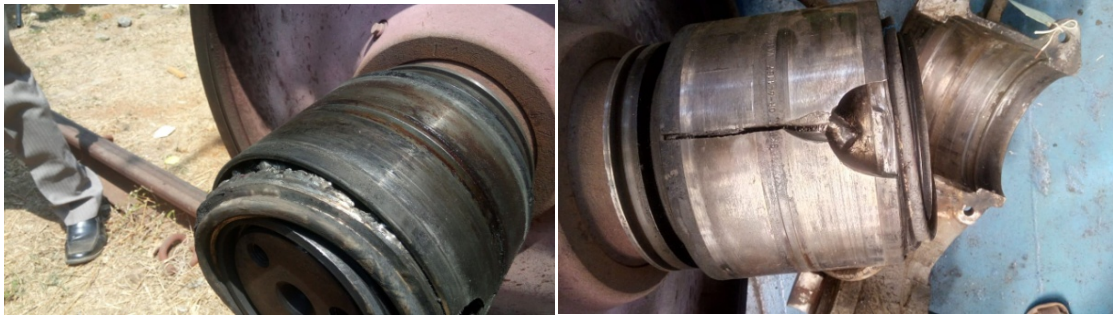
4. Outboard side seal found in broken, completely damaged and melted condition.
5. Bearing could not be initially dismantled from axle journal with bearing dismantling press. After gas cutting of outer cup and heating of cones, the bearing components were dismantled from axle journal with help of bearing dismantling press.

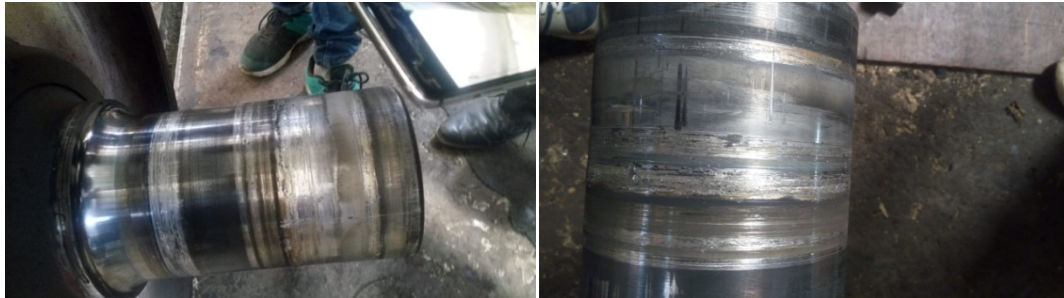
6. Rubbing and heating marks were found on axle journal surface.

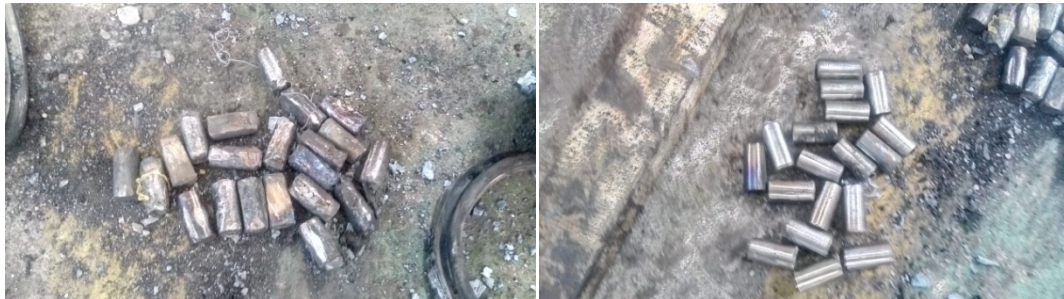
7. Rollers of outboard side cone assembly were found smeared, melted and deformed. Rollers of inboard side cone assembly found in good condition comparatively.

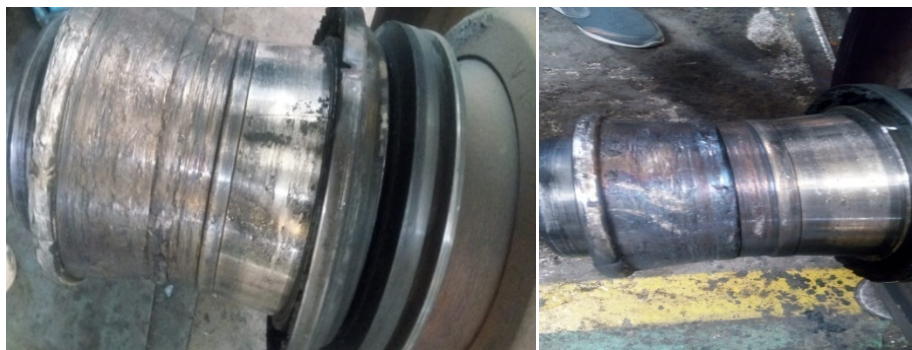
8. Outboard side cone was found badly rubbed & having heat marks with metal flows. Inboard side cone also had rubbing marks. In board side cone found in cracked condition (linear fresh hair crack) over whole width.

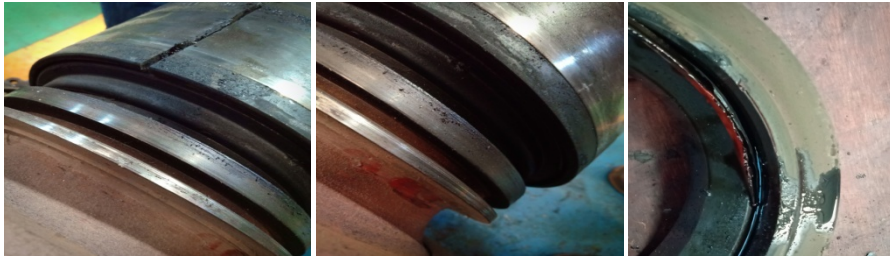
9. Inboard side grease seal found in intact condition but grease oozing found at this side.

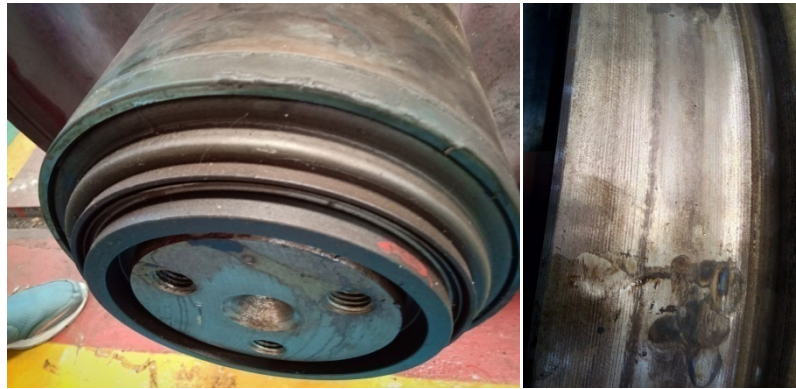
10. The other end bearing No. 02 16 83540 was found in good condition and rotating freely onto the axle journal without any abnormal noise during hand rotation.
11. All wheels found Ok and no shelling marks were observed. However, affected wheel-set has some heat marks due to wheel skidding after bearing seized.
