Sub: En-route detachment of LHB Coach No. SER 182374 LWSCN from Train No. 12860 due to hot axle at BSL Railway Station of Central Railway on 07.02.2019.

Joint Inspection Note

Findings:

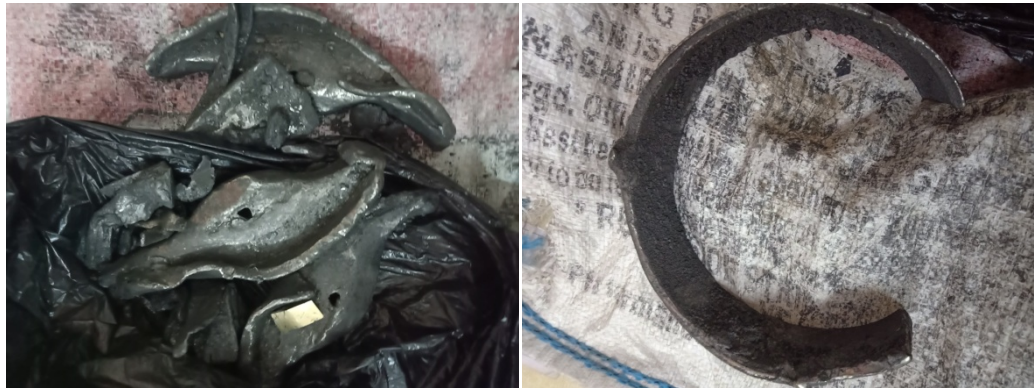
1. The axle end cover of reported axle box no. 2 (phonic wheel end) was opened for inspection. Phonic wheel was found damaged and broken into pieces and the teeth of phonic wheel had worn out.

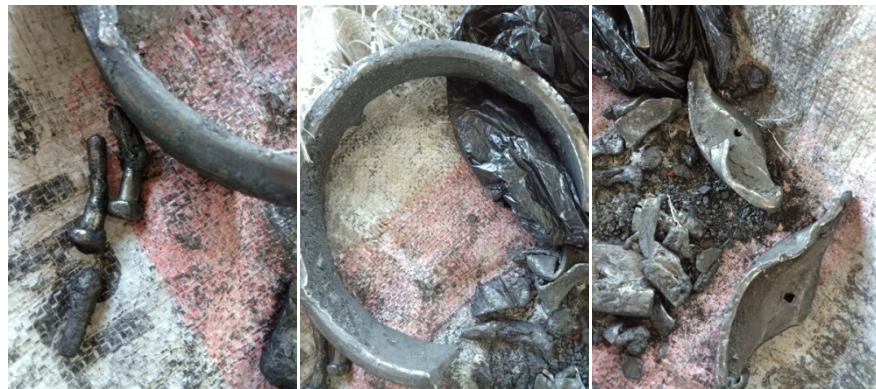
2. Speed sensor was not found inside the axle box as the speed sensor had completely damaged and melted due to rubbing with phonic wheel and M8 bolts.
3. The all M8 bolts were found in worn out and damaged condition. Out of 03 M8 bolts, head of one bolt was not found inside the axle box. Remaining 02 M8 bolts & half M8 bolt were found in rubbed & damaged condition inside the axle box.

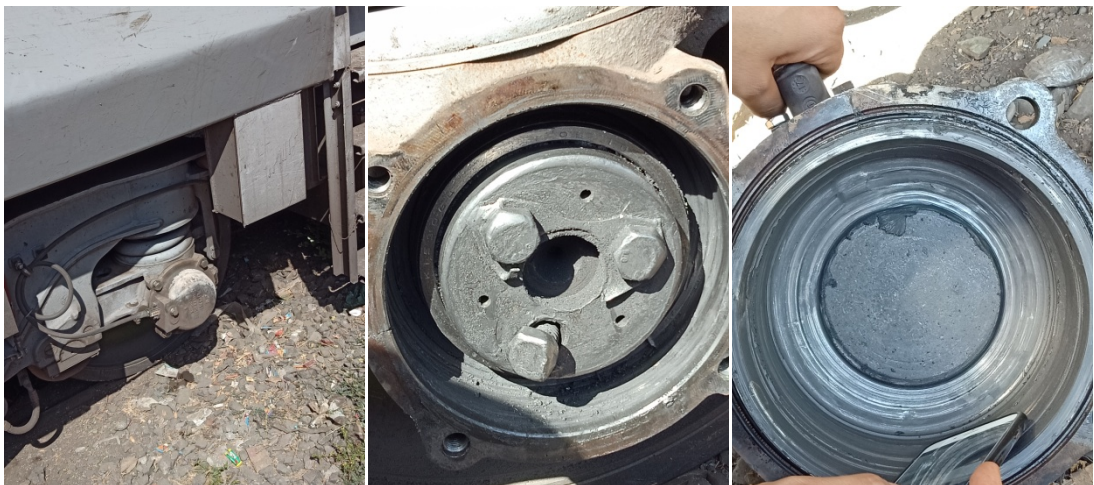
4. Heads of all M20 screws were deformed/worn. One M20 screw was bent & partially unscrewed.

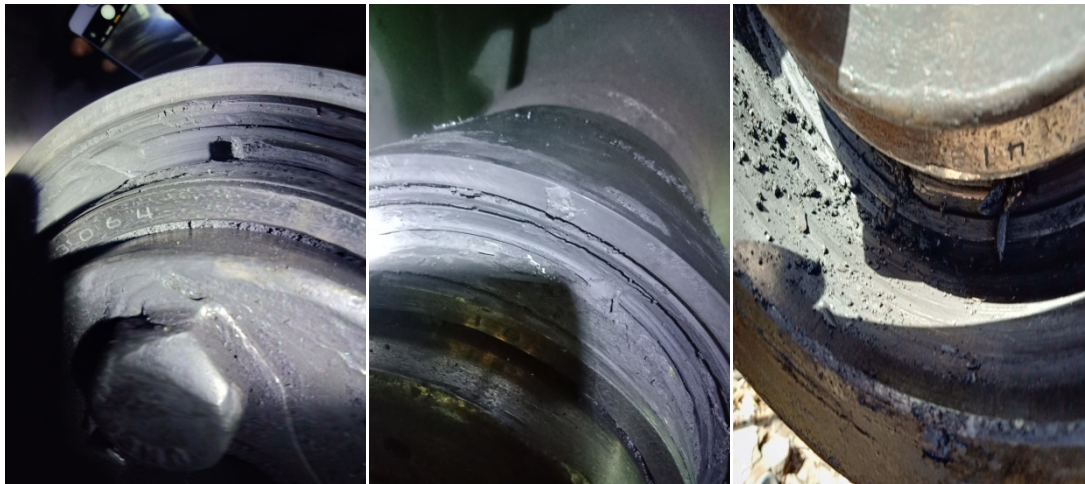
5. Part of locking plate was damaged and missing at partially unscrewed M20 screw position. Remaining locking plate at rest of 02 M20 screw positions was found intact but in rubbed condition.

6. Rubbing marks & grooving were found at inside surface of the axle end cover.
7. The outboard side grease seal of the bearing was found in damaged condition.

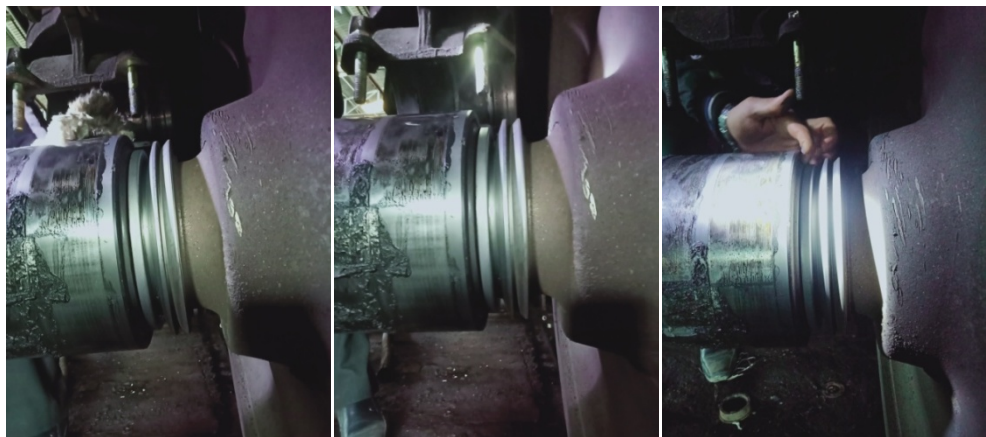
8. The coach was lifted in Sick Line. Outboard side grease (front side) seal of the reported bearing serial no. 06-18-13487 was found damaged and rubber lip had melted and deformed. Rubbing marks were observed on the out board side grease seal.
9. The inboard side grease seal and backing ring were found ok and intact. No damage found on the inboard side grease seal and backing ring of the reported bearing.

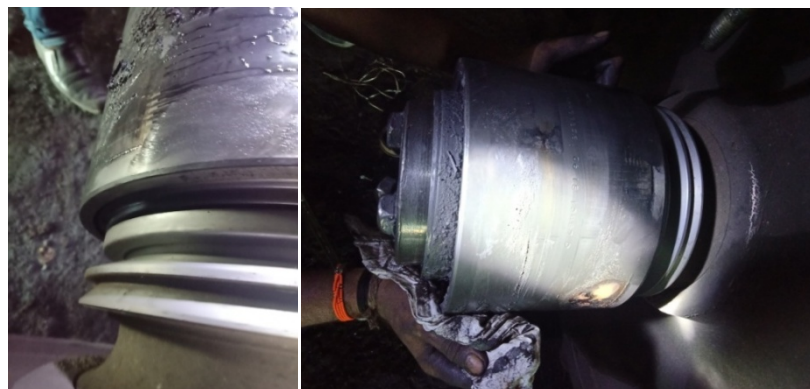
10. Bearing OD surface was found in good condition and no heating mark was found on the bearing OD surface.
11. The reported bearing was rotating freely onto the axle journal during hand rotation and no abnormal noise was observed during rotation of bearing.
12. Some amount of grease was found on the reported bearing Cup OD surface at outboard side and on the bore of the control arms (lower and upper half).

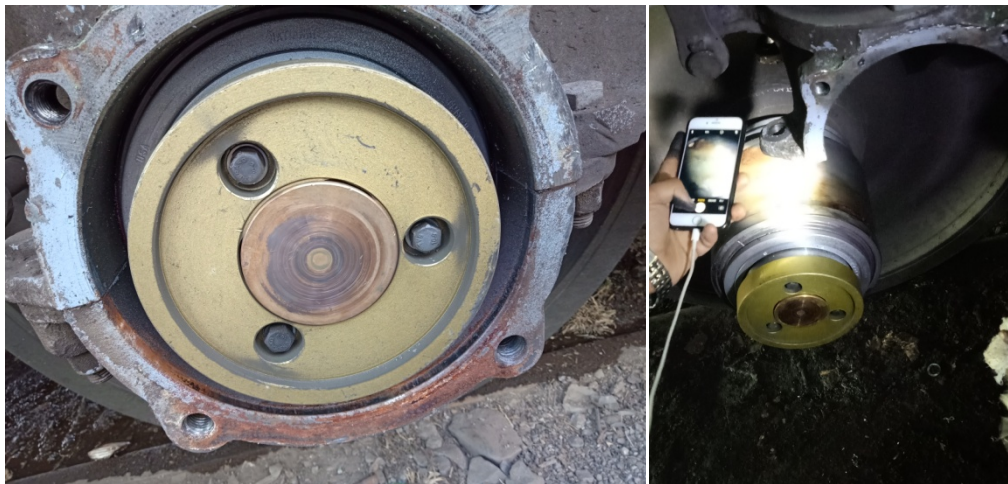
14. At the other end (axle box no. 1), bearing 06-18-13507 was found in good condition.
