Sub: En-route detachment of LHB Coach No. NWR 13453/C LGS from train no. 12715 (NED-ASR) Sachkhand Exp. on 12.06.2019 due to hot axle at BSL Railway Station of Central Railway.

In reference to above, joint inspection of reported bearing of Coach No. NWR 13453/C LGS by representatives of RDSO, South Central Railway, Central Railway and M/s Timken was carried out on 15.06.2019 at Coaching Depot, Bhusawal. The observations of joint inspection are enclosed as Annexure-I. From the observations, following can be inferred:

Findings:

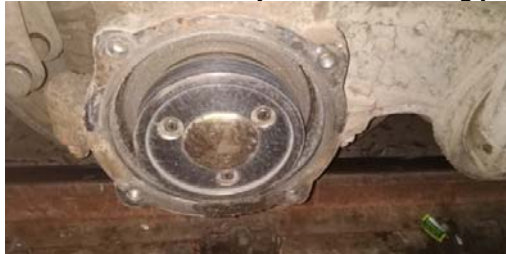
1. The axle end cover of reported axle box no.R8 (earthing device end) was missing at arrival at BSL Railway Station & during joint inspection.

2. **D2 & D3 schedule of the coach has not been done even once since 24.12.2018.** Axle end covers of LHB coaches should be opened in D2 schedule to inspect the earthing equipment for wear of slip assembly/carbon bars and for monthly/quarterly inspection of WSP equipment to be carried out as per Para no. 12.3 of Maintenance Manual for LHB Coaches. All fasteners should be torqued with specified torque values during their fastenings.

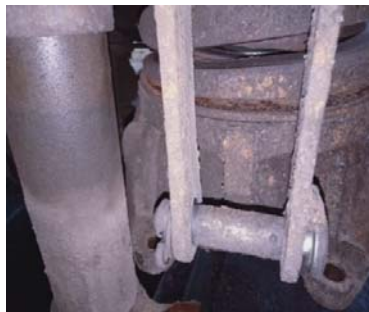
2. Earthing cable of axle box (R8) found in damaged condition. The 02 nos. threaded holes of the control arm were found worn out.
3. Control arm (R8) lug found in broken condition. Opposite side primary damper found in leaky condition.

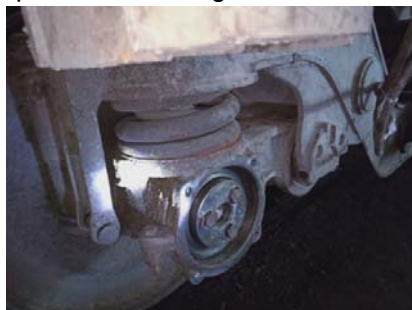
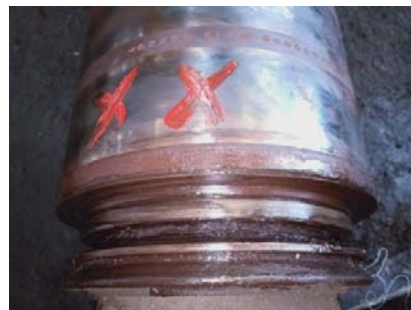
4. Oiler ring of earthing device found in intact condition. Rubbing/hitting marks found on eye piece of oiler ring.

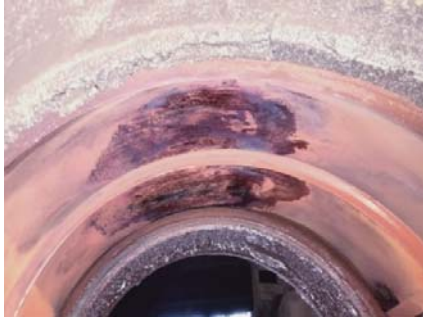
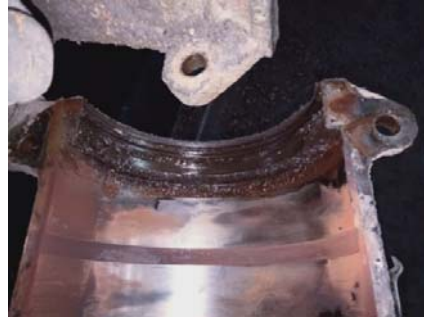
5. Grease oozing found at the inboard side of the affected bearing (03-13-02229 (TIL/027/06-17/AJR R1) and slight grease oozing at outboard side end. Grease found inside the bore of upper & lower half of the control arm.

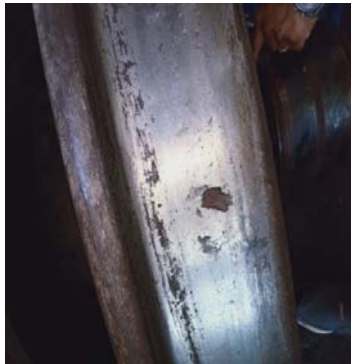
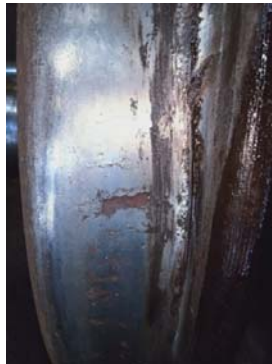
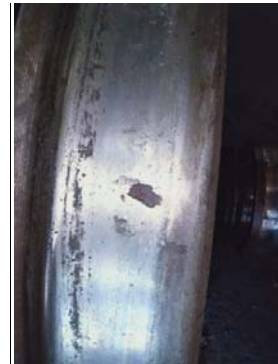
1. **It is clear that cage of inboard side cone assembly broken first due to wheel shelling beyond permissible limit**, which creates chances of cage breakage due to extreme torsional vibration arising from rail – wheel interactions. Wheels having shelling beyond limit i.e. depth-1.5mm & length-40mm should be removed from service and sent for tyre turning.

6. During rotation of the bearing unusual sound noted from the bearing due to cage breakage. Bearing grease seal found in good condition and no damage found on the grease seals.
7. The wheel shelling marks found on the wheel and the shelling depth and length is more than the specified limit.

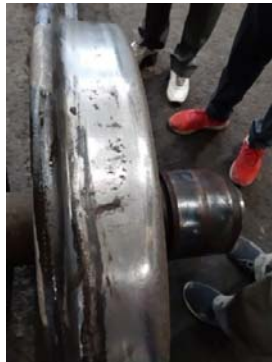
8. The other end bearing (09-12-05321 (TIL/049/04/17/AJR R1) having slight grease oozing at outboard side. Shelling marks found on other wheel tread as well.
