Sub: En-route detachment of coach No. SR 16802/C LWCBAC from Train No. 12625 TVC-NDLS (KERALA EXPRESS) at Itarsi (ET) Railway Station of West Central Railway on 30.06.2019.

Sub: Attention to Wheels and CTRBs of the LHB wheelsets observed with heavy wheel shelling.

Sub: Cases of failure of control arm of LHB coaches.

Sub: Preventive measures for failure of control arm in LHB coaches.

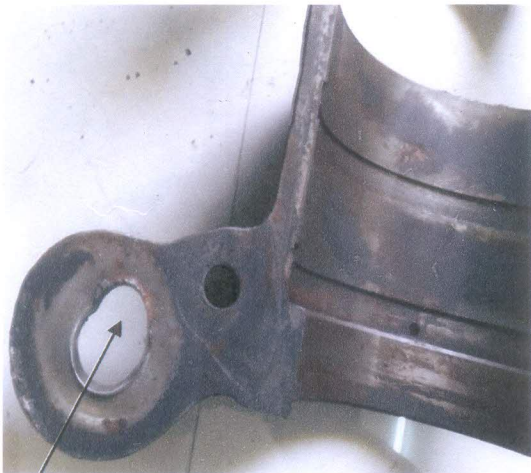
As per records available with Workshop, the detached coach no. ER 05067/C LWACCW was manufactured during 2005 and the control arm was fitted in 2012. Thus, it has been in service for about 6 years. The bolt holes in control arm were found elongated (Figure 1 of Annexure- I) showing that the bolt loosening has taken place. This is likely as it was fitted with plain washers. The damper is fitted on lower control arm, hence load sharing with upper control arm is only through bolts. Once it is loosened, heavier impact will be caused due to 'On-loading' & 'Off-loading' on run. Heavy shear stresses generated at the collar would cause it to shear (Figure 2 of Annexure- I). Once this happened, the full load will come on lower control arm causing heavy bending stresses in lower control arm which have exceeded the yield point limits causing failure (Figure 3 of Annexure- I). This appears to be the mechanism of failure in the present case. However, it will be confirmed only once the M&C report is available.

— Elongated hole in Lower C/Arm Part
(Figure: 1)

The deficiencies noticed in the maintenance of this coach were already taken note of while formulating maintenance instructions issued vide reference (ii). A copy of these maintenance instructions is being enclosed herewith again as Annexure- II. It is requested that these instructions may be implemented in the right earnest to avoid such failures.

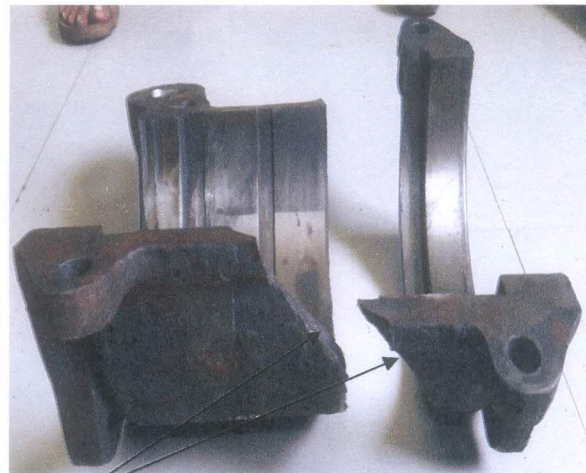
— Control Arm Lower Part fresh broken
(Figure: 2)

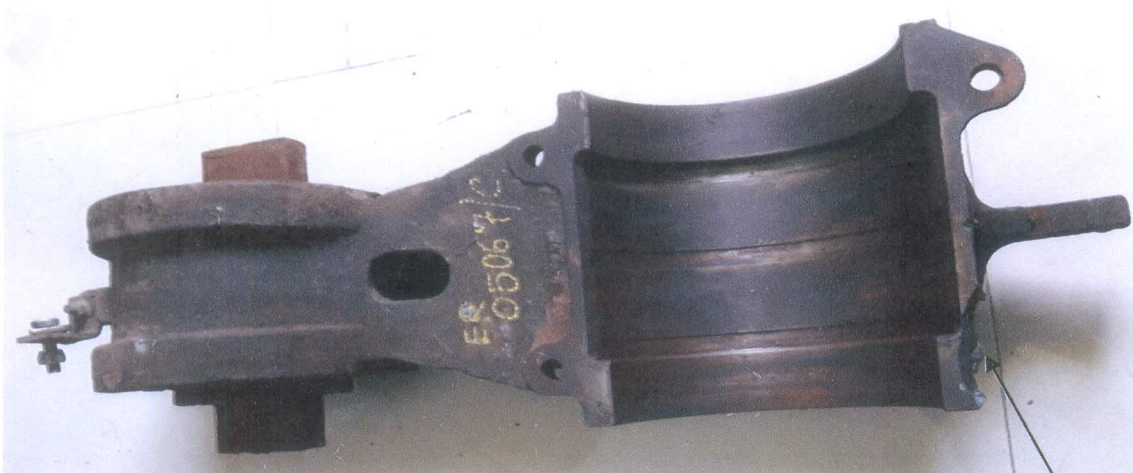
Control Arm Upper Part – Bolt mounting bracket fresh broken
(Figure: 3)

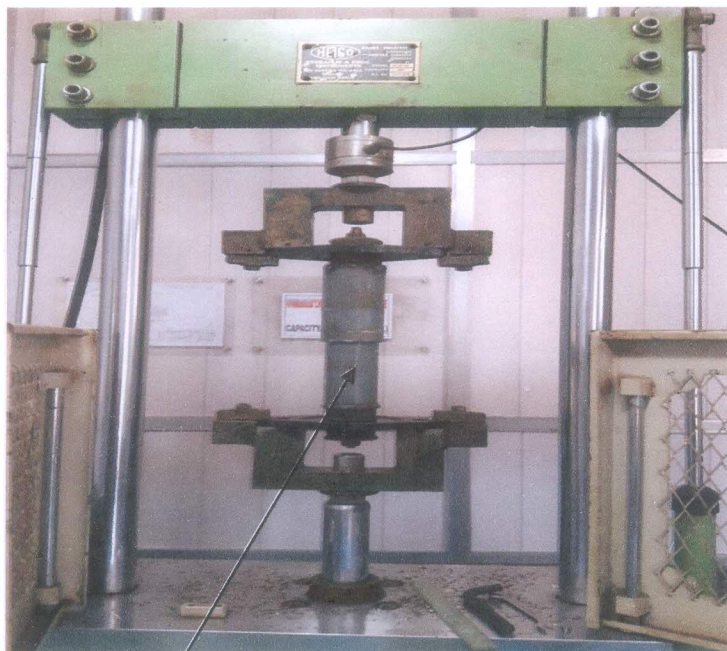
- 1) The primary damper was found defective during testing on Damper Testing Machine available in the shop.
- 2) The Damper Testing Machine available in the shop was not calibrated while the machine is overdue for calibration. The Damper Testing Machine needs to be calibrated.
- 3) Plain washers were being used despite repeated instructions for use of self-locking washers in the fastening systems of control arms.
- 4) Torque wrench tester was not found available in the shop so as to regularly test the torque wrench before it is taken in the field.
- 5) Torque wrench calibration certificates were not available.

— Damper Testing on M/C
(Figure: 4)
