MC/CTRB/Defects

Date: 29.08.2019

**Sub:** En-route detachment of LHB Coach No. SCR 18254/C LWSCN from train no. 12715 (NED-ASR) Sachkhand Exp. on 24.08.2019 due to hot axle and abnormal sound at BSL Railway Station of Central Railway.

**Findings:**

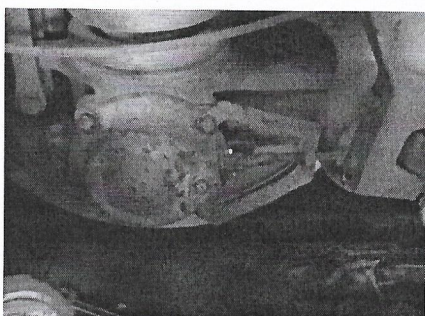
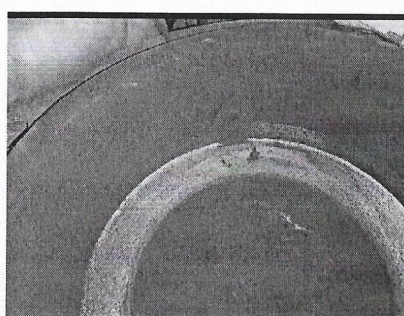
1. Rubbing marks found on inner surface of axle end cover and heat marks observed on external surface of axle end cover.
2. The phonic wheel had dismounted & was found in rubbed, deformed & damaged condition.

- i. **All fasteners of phonic wheel, earthing device, security disc, axle end cover & control arm should be torqued with specified torque values as mentioned in Maintenance Manual for LHB Coaches during their fastenings. Apply thread sealant (LOCTITE 572/RITE LOKPS 65 of 3M/DARBOND 2572/MYTLOK 172R) on hex. head bolt M8x35 as per para no. 4.4.4-6 of Maintenance Manual for LHB Coaches.**

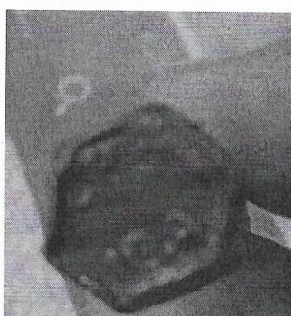
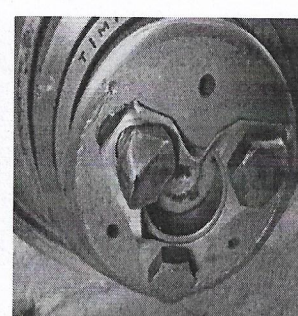
3. All M8 bolts were found deformed and in unscrewed condition inside the axle box housing. Two M8 bolts found in sheared off condition.
4. Heads of M20 screws had deformed/worn out. One screw was in bent and partially unscrewed condition.

- ii. **Quality of fasteners for axle box components is to be ensured in terms of RDSO letter No. MC/CTRB/Genl. dated 06.07.2015. Threads of screws/bolts and security disc/axle end holes should be checked with thread ring gauge and thread plug gauge respectively before applying screws/bolts.**
