MC/CTRB/Defects

Date: 11.03.2019

Sub: En-route detachment of LHB Coach No. CR 14059/C LWACCW from Train No. 12171 due to hot axle at BSL Railway Station of Central Railway on 25.02.2019.

Joint Inspection Note

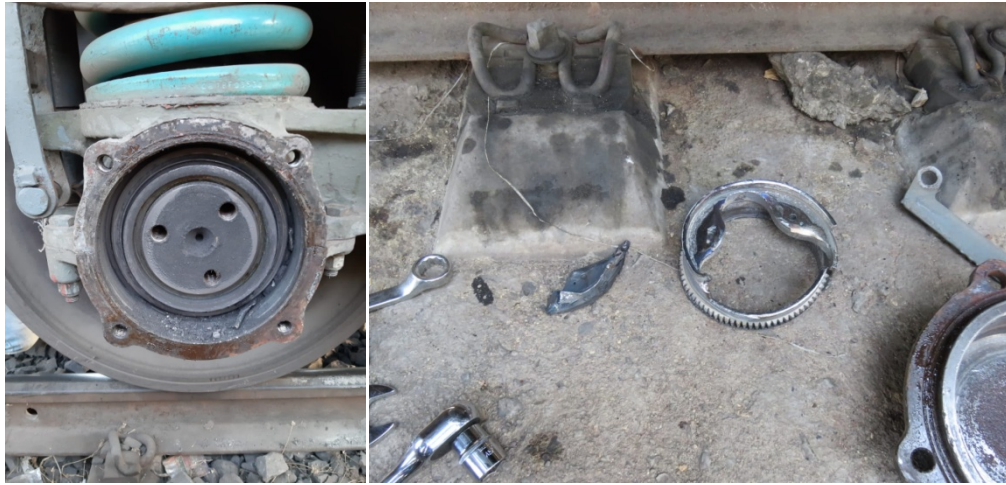
It is clear from above that the phonic wheel of the affected axle box L2 wasn't secured properly during SS II, due to which phonic wheel worked out from its location, got broken into pieces and rubbed with other axle box components. The phonic wheel damage led to the bearing seal damage and grease loss, resulting in hot axle.

1. The end cover of reported axle box no. L2 (phonic wheel end) was opened for inspection. The phonic wheel was found damaged & broken condition.

It is concluded that the M8 bolts unscrewed first during service and then phonic wheel freed from its position & rubbed inside the housing with bearing and other components, damaging the bearing seals, leading to loss in grease and consequentially causing temperature rise.

It is again requested to ensure that the instructions already issued for maintenance of axle box components of LHB coaches are scrupulously followed in the workshops, to conduct audit of maintenance practices for axle box components at the workshops maintaining LHB coaches & to submit the audit reports.

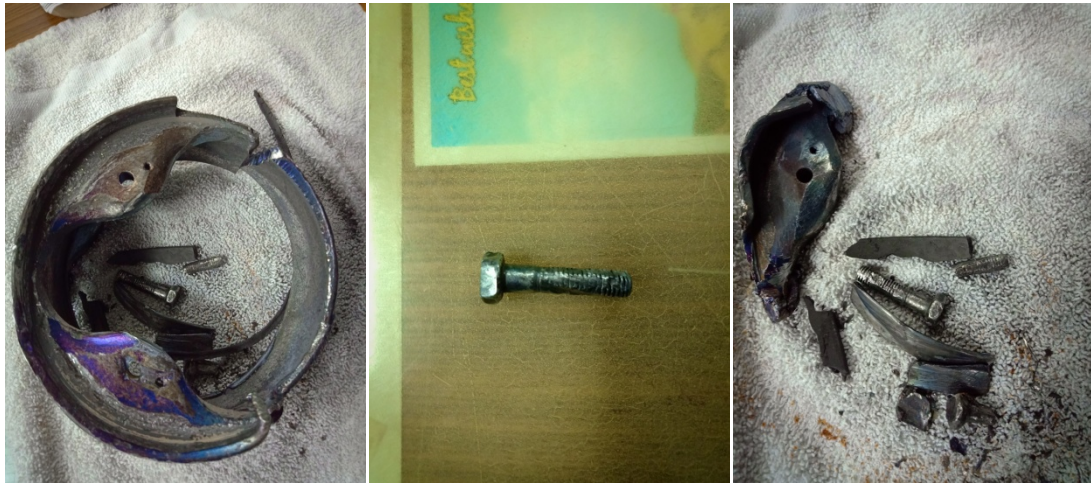
2. One M8 bolt of phonic wheel was missing. Second M8 bolt was found in unscrewed and rubbed condition inside axle box. Third M8 bolt was found in broken, unscrewed & rubbed condition inside axle box.

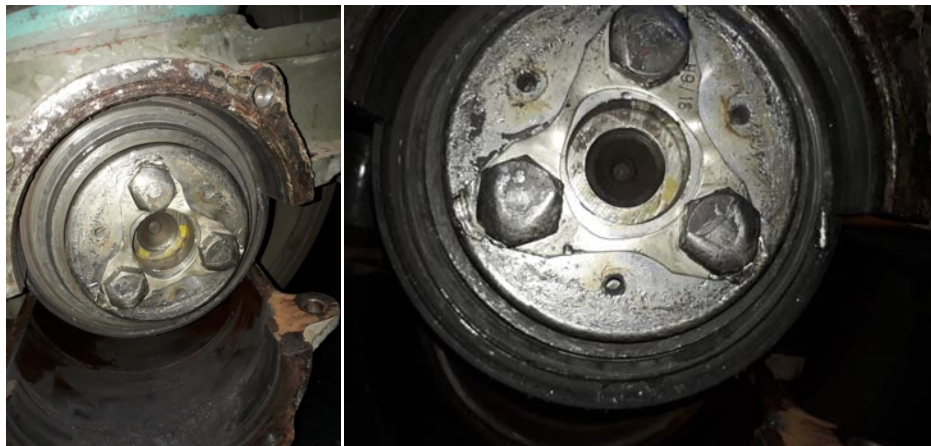
3. Heads of M20 screws of axle end (fastened with security disc) had deformed with rubbing marks. Locking plate was found intact with rubbing marks.

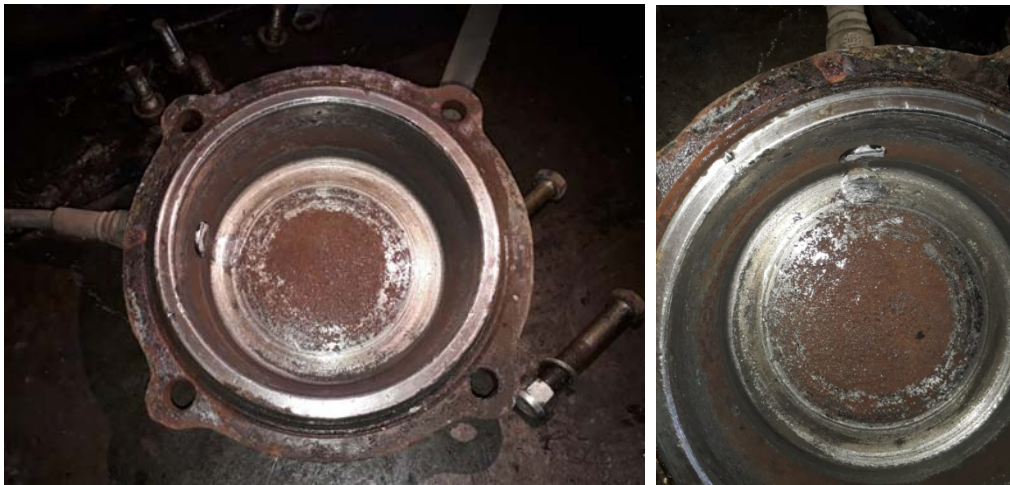
4. Rubbing marks & grooving found inside the axle end cover. Metal powder was found inside the control arm.

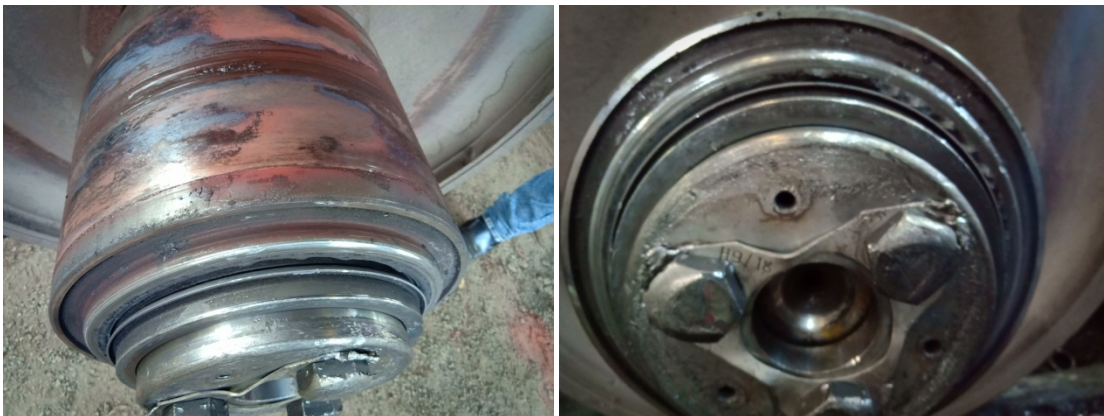
5. The speed sensor had damaged and melted.
6. WSP fault code noted as 3101 & 3201 / 1101 & 1201. Sheet containing information regarding condition of axle box components of the LHB coach is attached as Annexure-II.
7. The outboard side grease seal of the bearing was found in damaged condition.

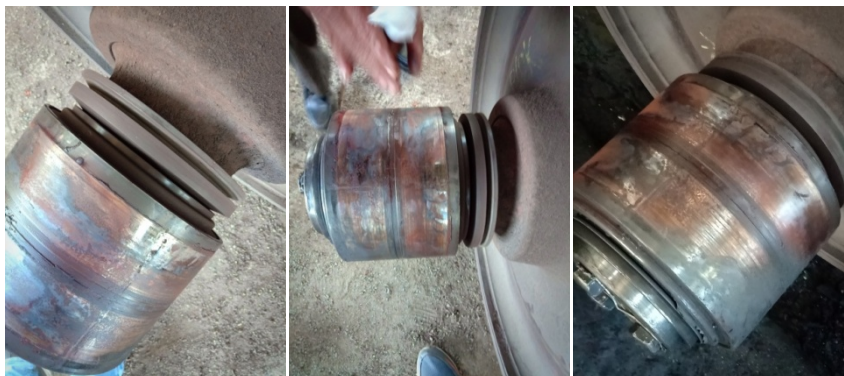
8. The coach was lifted and the bogie was rolled out for wheelset change. Casing and rubber lip of outboard side grease seal (front side) of the bearing serial no. 12 14 02716 R38/16-8-18/R1 (SKF) was found damaged and deformed.
9. The inboard side grease seal and backing ring were found ok and intact.

Based on the visual observations it seems that rise in temperature of bearing has occurred due to the bearing outboard side grease seal damage. This seems to be effect of rubbing with phonic wheel and M8 bolts causing temperature rise and grease oozing out from bearing resulting in lubrication starvation condition and metal to metal contact. The phonic wheel damage lead to the bearing seal damage. The bearing was rotating onto the journal freely but abnormal noise during rotation was observed.

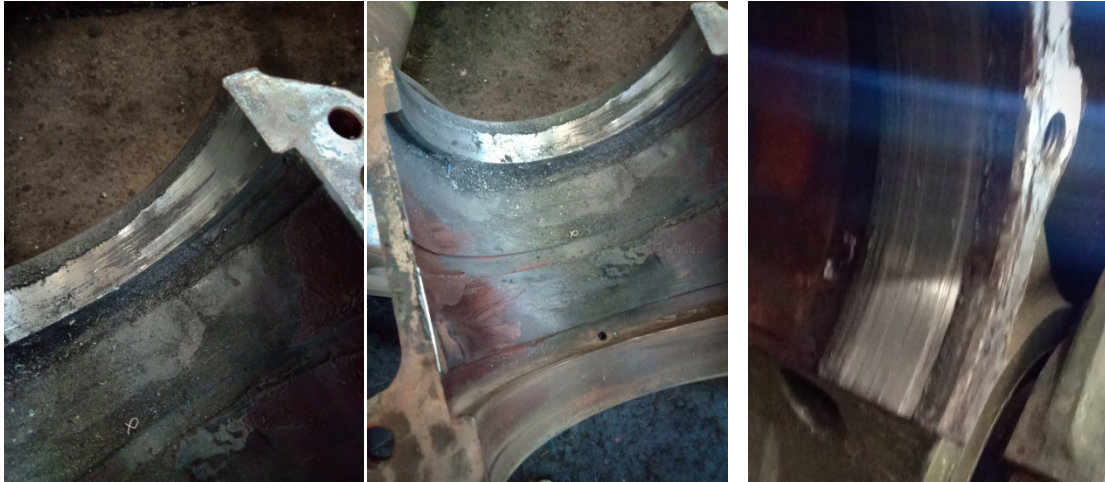
10. Bearing outer cup was found in good condition. No heating mark noticed on the bearing cup OD.
11. The bearing was rotating freely onto the journal but abnormal noise was observed during rotation due to grease loss.
12. Rubbing marks found inside the upper & lower control arm at outboard side only.
