**MC/CTRB/Defects**

**Date: 24.05.2019**

**Sub:** Audit of Maintenance Practices of CTRB of LHB Design Coaches

Accordingly, RDSO official has audited CTRB maintenance practices followed at Mechanical Workshop, Dibrugarh, Coaching Depot, Puri & Carriage Repair Shop, Tirupati. The common deficiencies observed in the workshops are attached as Annexure-A and specific deficiencies observed in workshops & coaching depot are attached as Annexure-B.

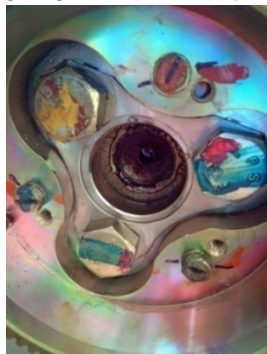
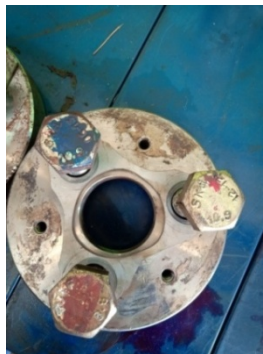
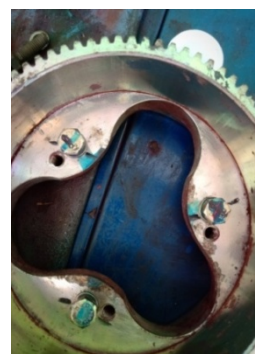
- viii. In locking arrangement of phonic wheel & oiler ring of earthing device on security disc, M8X35 bolts & M8X25 bolts of proper property class and authorized makes (TVS, LPS & UNBRAKO) are not being ensured. Threaded holes of security disc & threads of M8 screws/bolts are not being checked by GO NO-GO thread plug gauge & thread ring gauge respectively.

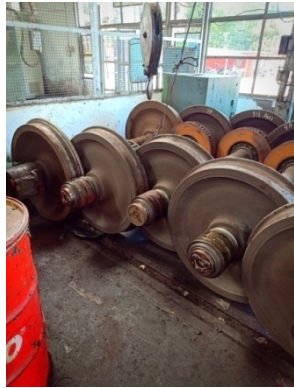
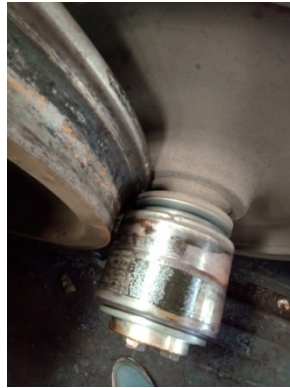
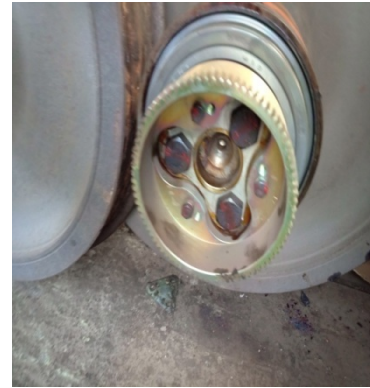
- i. Some of the LHB wheelsets with mounted bearings were found stored adjacent to each other, with flanges of wheels touching bearings of other wheels, which might damage bearing seals and initiate crack in bearing cup or some internal damage.

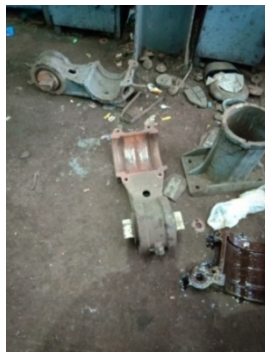
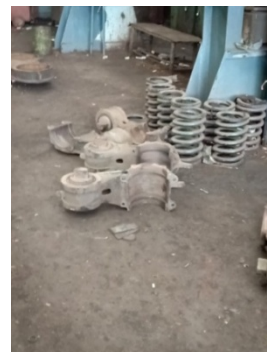
- iv. The dismounted control arms are not stocked in pair and their dimensions are not measured. As mentioned in Para no. 4.4.3 of Maintenance Manual for LHB Coaches – “The control arm should be stocked in pair and its dimensions should be mentioned as per maintenance manual.”

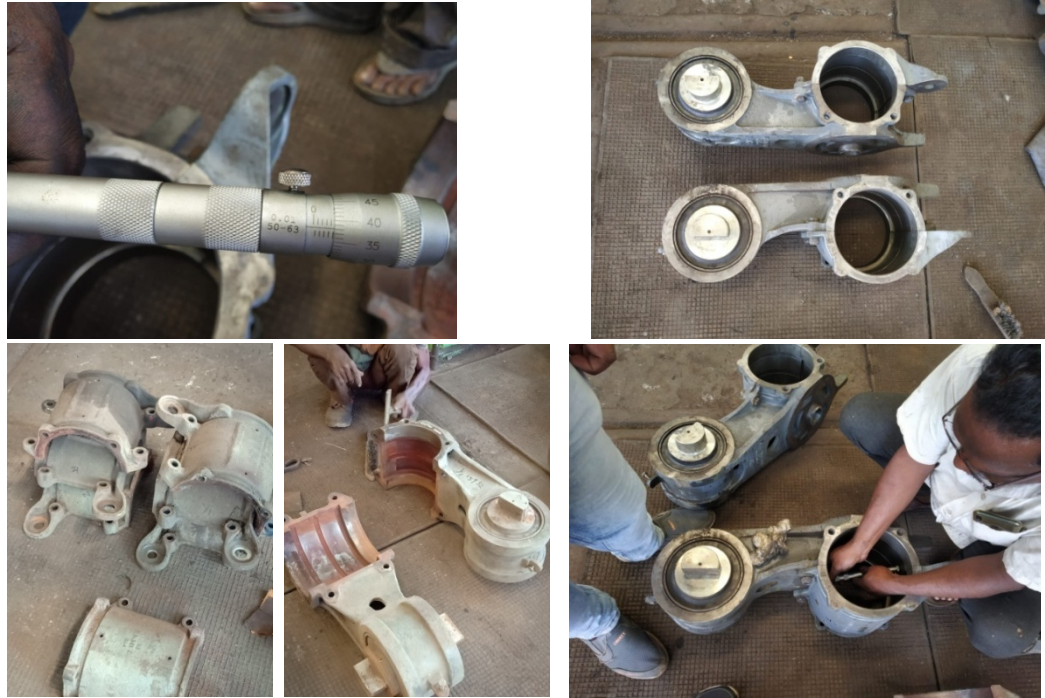
- i. The dismantled control arms are stocked in pair and their dimensions are being measured with 2-leg inside micrometer having least count of 0.01mm instead of 3-leg inside micrometer having least count of 0.001mm.
