भारत सरकार - रेल मंत्रालय
अनुसंधान अभिकल्प और मानक संगठन
लखनऊ - 226011
Government of India - Ministry of Railways
Research, Designs & Standards
Organization, LUCKNOW - 226011

No. EL/11.5.5/5

MODIFICATION SHEET NO. RDSO/2010/EL/MS/0393 (Rev.0), Dated 22.11.2010

Modification to address failures of Auxiliary converter cards.

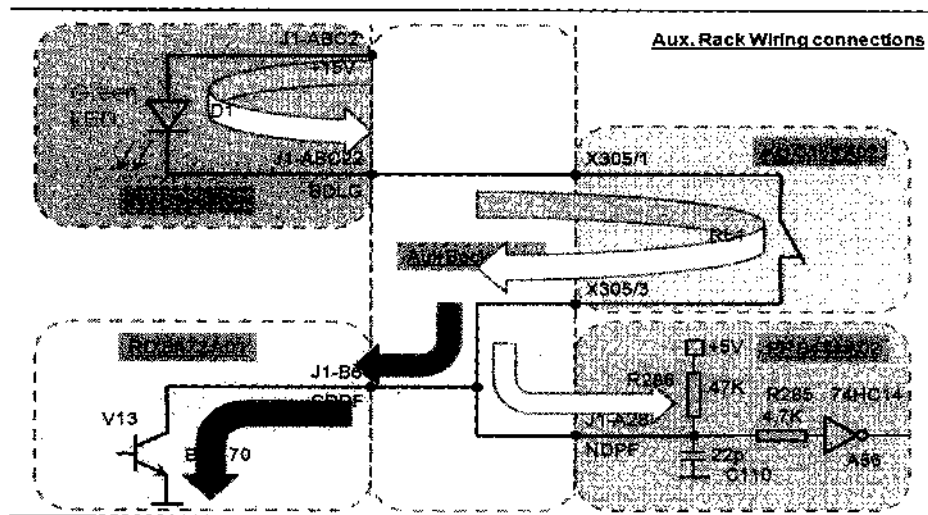
Figure-2

- 2.2 It has been reported by TOT partners that some of the failures occurs during functional testing also without any apparent reason.
- 2.3 On analysis of these failures it has been noticed that reversal of connector X305 in the back plane of KUC153 A01 card is leading to the wrong connections and consequently failures are taking place. This connector is no mechanically coded and has only two wire connections. When connector X305 is wrongly connected (connected upside down), the circuit formed is shown in figure 1. In this case +15 Volt supply connects via green LED on KVB993 card to relay RL1 on KUC153 card. The other end of this connects to the collector of transistor V13 on RDB 472. Sometimes transistor V13 gets turned on before relay RL1 is completely opened therefore leading to a short circuit of +15 V supply to ground for a short duration. As a result of this the voltage output of KUC153 may fall and this could lead to an interruption of the life sign from auxiliary converter rack to the VCU. This may also interpreted as a problem of "life sign missing" with KUC 153 card or PPB471 card. In some cases transistor V13 on RDB 472 also fails. The flow of current is shown in figure-2.

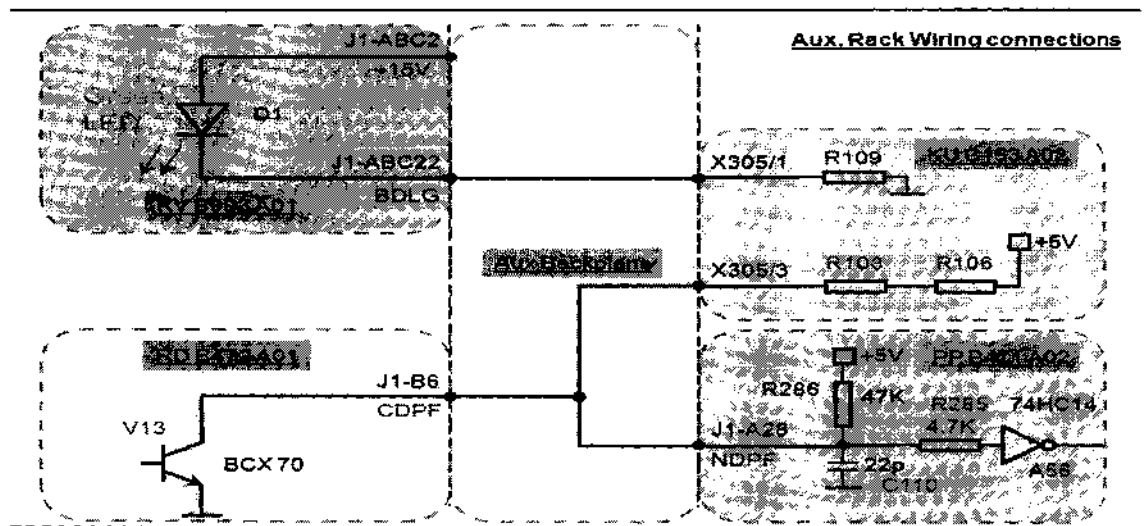
Figure-3

- 2.4 When the connector X305 is connected properly, the circuit is different and removes the connection of the relay from the circuit. The circuit in this case is described in figure-3.

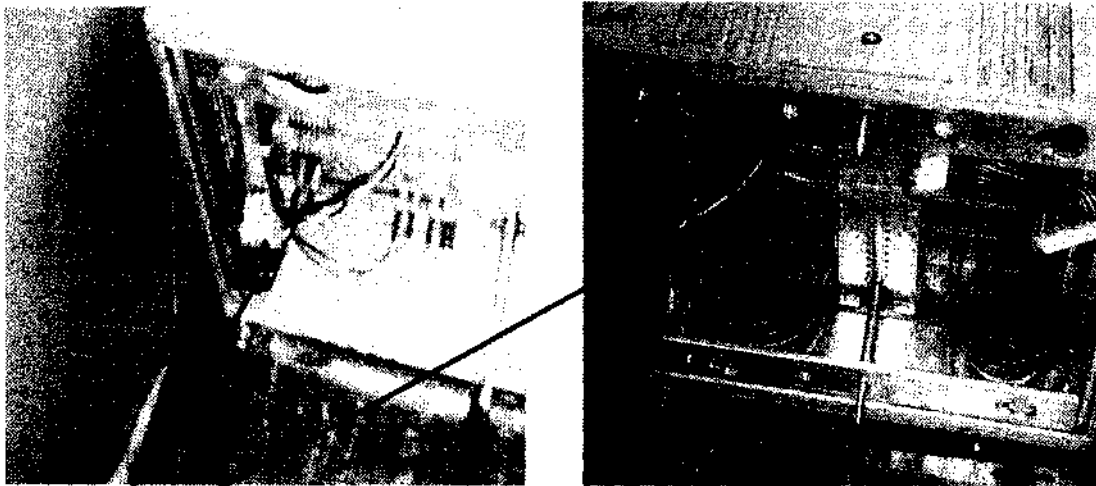
Figure-6

- 2.5 In older cards, a blue colour marking was done on connector X305 to avoid wrong connection which is shown in figure-6.
