भारत सरकार—रेल मंत्रालय  
 अनुसंधान अभिकल्प और मानक संगठन  
 लखनऊ-226011  
 Government of India - Ministry of Railways  
 Research, Designs & Standards  
 Organization, LUCKNOW – 226011

No. EL/3.2.61/3

**MODIFICATION SHEET NO. RDSO/2018/EL/MS/0471, Rev '0'**

Modification in the bottom plate of M/s Schneider make Single bottle VCBs.

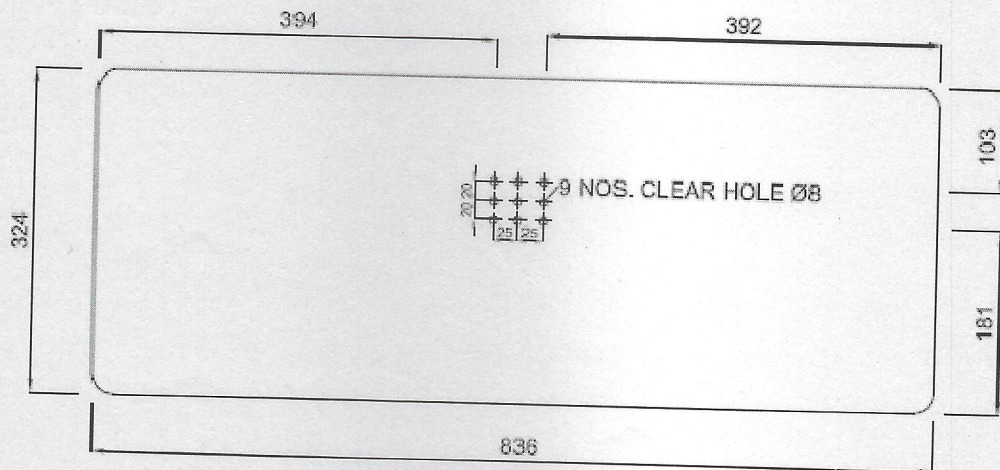
Modification Sheet No-RDSO/2018/EL/MS/0471 Rev '0'

Zonal Railways have experienced failure of M/s Schneider make single bottle VCBs due to ingress of water in VCB. The ingress of water is due to reasons as follows.

- a) Leakage from joints of top and bottom insulator
- b) Leakage from joints of bottom insulator and VCB housing.
- c) Moisture in inlet air.

Nine hole of 8 mm diameter are to be drilled in the bottom plate of VCB as shown in drawing No. RDSO/2018/EL/MS/0471, Rev '0' in annexure A
