Metallurgical Investigation Report No. 49/19

Sub: Metallurgical Investigation of broken traction motor support lug of loco no-30382/WAP7/GZB.

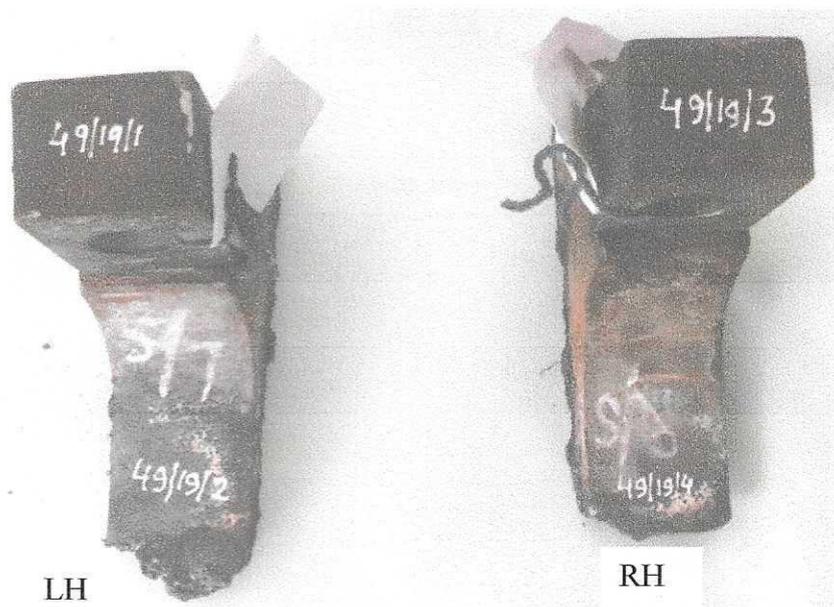
Both the fractured LH & RH side traction motor-3 support lugs pieces were reconstructed as shown in **fig.1**.

Fig.1: Photograph showing fractured LH & RH side traction motor-3 support lug pieces in as received condition.

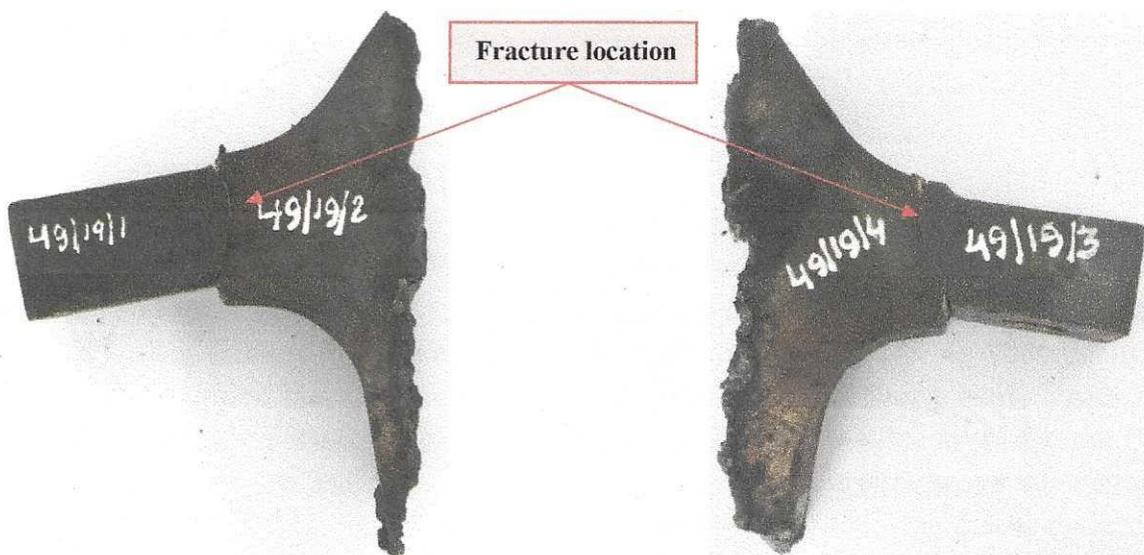
Fig.2: Photograph showing fractured location of LH & RH side traction motor-3 support lug pieces.

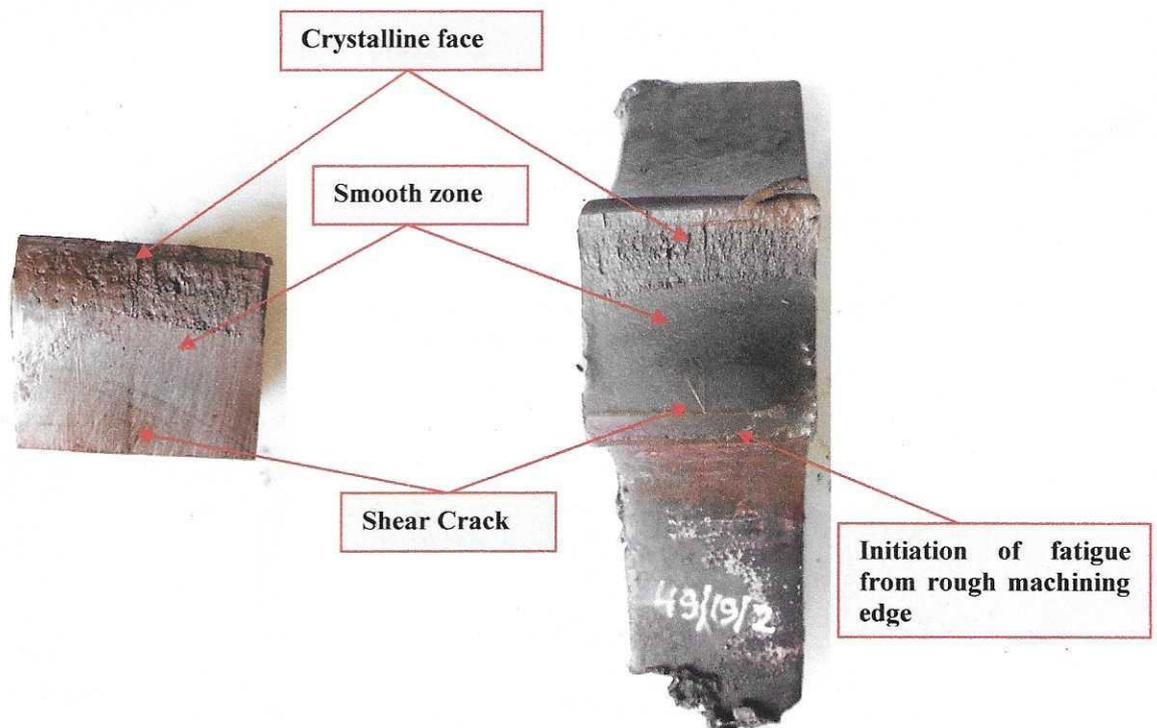
Piece No. 49/19/1 & 2

Visual examination revealed that LH side traction motor-3 support lug, having gas cut at one end, had broken near bolt hole position in fatigue manner from inner side of transition area (fig. 3). The fracture had taken place in transverse manner (fig. 2 & 3). Topography of fracture face revealed that fracture had initiated from rough machining marks present at inner side of transition zone. The other end of fracture face is crystalline in appearance (fig. 3). Smooth fracture face indicates that the fracture had initiated in slow progressive fatigue manner. About 35% of fracture face is crystalline in nature (fig.3). Shear crack is noticed in the smooth zone which appears to be connected with fatigue initiation point towards surface (fig.3).

Fig.3: Photograph showing fractured initiation in fatigue manner from rough machining edge of inner LH side traction motor-3 support lug piece.

Visual examination revealed that both LH & RH side traction motor-3 support lugs had broken near bolt hole position in fatigue manner from inner side of transition area. At the inner side of transition area rough machining marks were present and fracture had taken place in transverse manner. Fatigue had initiated from rough machining marks present at inner side of transition zone. Smooth fracture face indicates that the fracture had initiated in slow progressive fatigue manner. Fracture initiated from inner side of transition area and covering about 65% & 85% in fatigue manner and remaining about 35% & 15 % in crystalline manner respectively in LH & RH side traction motor-3 support lugs. Shear cracks noticed in the smooth zone which appears to be connected with fatigue initiation point towards surface

It is evident from above that, Traction motor -3 Support lugs have broken near bolt hole position in fatigue manner from inner side of transition area. The fracture had initiated from rough machining area which resulted in progress of fracture in fatigue manner.

1. Rough machining marks shall be avoided which are very prone for generation of fatigue cracks.
2. The Specification No. IS;8500-1991, which is specified in the furnished drawing, does not exist on date. This IS;8500-1991 specification has already been merged with IS;2062-2006. The revised specification shall be incorporated in the relevant drawing no. 1209-01-112-121.

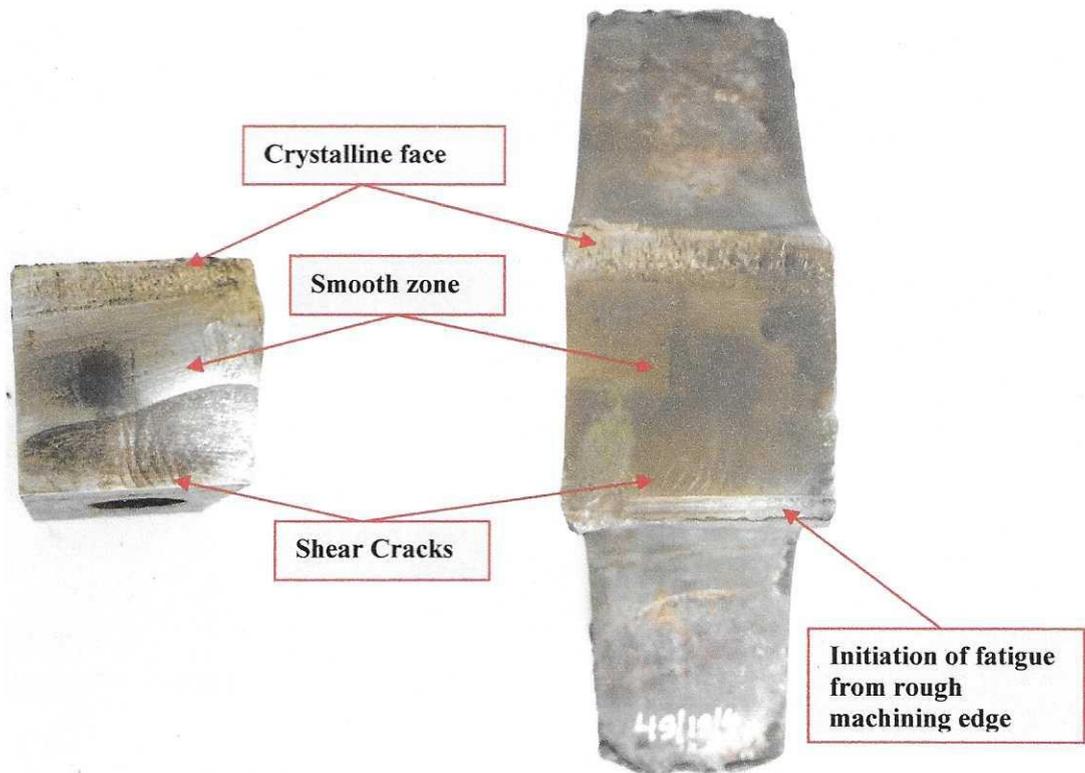
Piece No. 49/19/3 & 4

Visual examination revealed that RH side traction motor-3 support lug, having gas cut at one end, had broken near bolt hole position in fatigue manner from inner side of transition area (fig. 4). The fracture had taken place in transverse manner (fig. 2 & 4). Topography of fracture face revealed that fracture had initiated from rough machining marks present at inner side of transition zone. The other end of fracture face is crystalline in appearance (fig. 4). Smooth fracture face indicates that the fracture had initiated in slow progressive fatigue manner. About 15% of fracture face is crystalline in nature (fig.4). Shear cracks noticed in the smooth zone which appears to be connected with fatigue initiation point towards surface (fig.4).

Fig.4: Photograph showing fractured initiation in fatigue manner from rough machining edge of inner RH side traction motor-3 support lug piece.

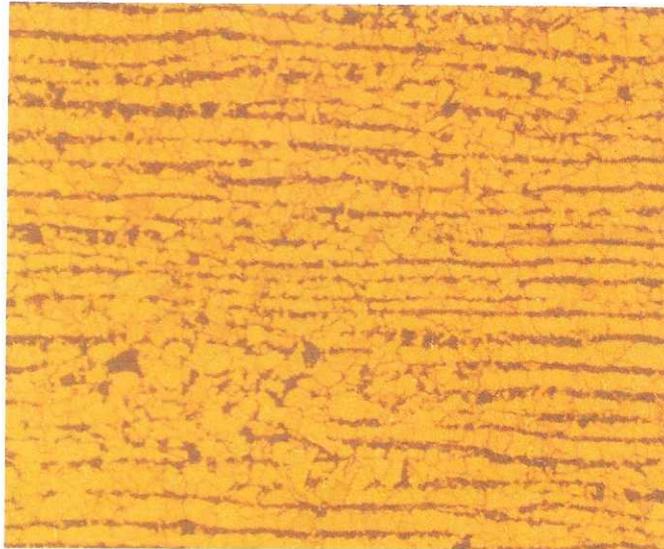
Sample No.	Observation
49/19/2	Revealed ferrite pearlite structure with Average ASTM Grain Size 7 (fig. 5).
49/19/4	Revealed ferrite pearlite structure with Average ASTM Grain Size 7 (fig. 6).
Specified as per IS: 8500-1991 Fe540B	Not specified

Fig.5: Photomicrograph showing ferrite pearlite structure; Sample no. 49/19/2.

Micro structure is having ferrite-pearlite structure, Microstructure is not specified, however may be considered satisfactory.

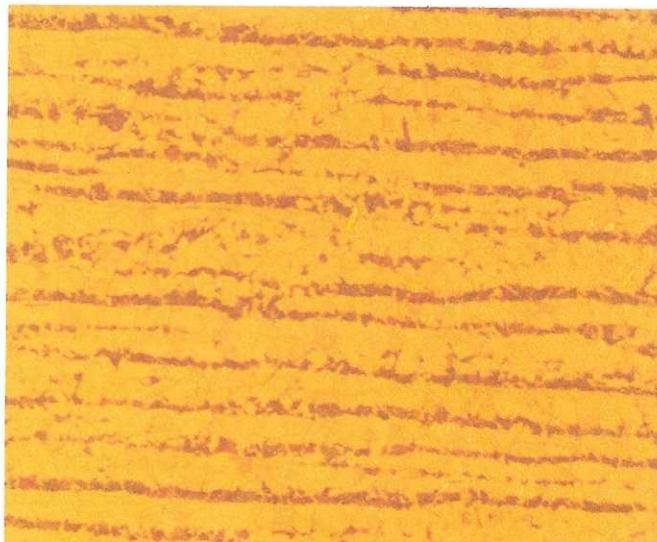
Fig.6: Photomicrograph showing ferrite pearlite structure; Sample no. 49/19/4.
