**Government of India
(Ministry of Railways)
Research Designs & Standards Organization
Manak Nagar, Lucknow-226 011**

**SPECIAL MAINTENANCE INSTRUCTIONS
NO.RDSO/ELRS/SMI/0237 (Rev.'0')**

Modified layout of cables from TFP to RSI blocks to avoid chances of on line failure/ fire in conventional Electric Locomotives.

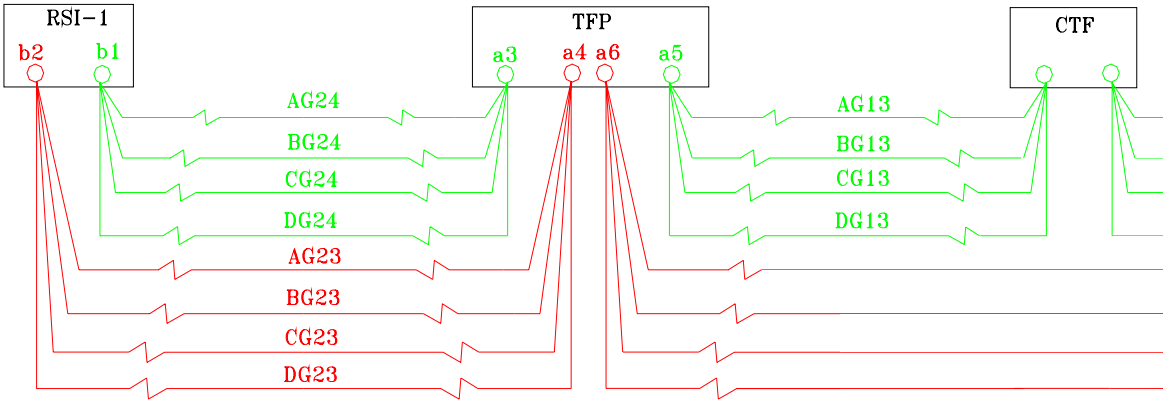
EXISTING CABLE LAYOUT IN ELECTRIC

Cases of overheating and burning of insulation of power cable from TFP to RSI block in electric locomotives have been reported by the Railways. The cables have been found burnt/damaged at the places of clamping/cleats. The insulation and sheath of the E-beam/ Elastomeric cables were found with pressed marks of clamps and on removing the insulation, discoloration of the conductor has been noticed. The failed sample of cable has been got tested at school of Materials Science and Engg. Bengal Engg. & Science University, Shibpur, Howrah and it has been concluded that the temperature of failed cable has reached to the level of more than 600 deg.C and burnt the insulation and sheathing of cable without propagating the fire to the adjacent layers of cable. In the existing cable layout, four cables of 240/300 mm² thin walled E-beam/Elastomeric cables are connected in parallel from each terminal of transformer secondary winding to RSI block and they are supposed to equally share the load during starting and run. On measuring the current carried by each cable, it has been observed that load distribution amongst the four cables is not uniform and varying from cable to cable. A detailed investigation has been carried out on no. of locos of ELS CNB, LGD and MGS including measurement of load current loco working coaching trains in Mughalsarai- Dhanbad section of ECR. The pattern of current distribution, as a result of testing is enclosed in **Annexure-I**.

- a) One of the cable out of four carries abnormally high current and the cables do not share equal current and draws unbalanced current.
- b) Use of flat metallic cleats and metallic bolts causing eddy current and over tightening of cleats & tight wrapping of cables with rubber sheet have caused

inadequate heat dissipation/cooling of cables, which have resulted into overheating / burning of insulation.

- c) Cables are laid in very congested manner in which all types of cables are bunched/clubbed together without having any inter spacing between them. In this types of arrangement the current carrying capacity of cables do derate maximum and cannot carry rated current.
