**Technical Audit Report of Electric Loco Shed,
Lallaguda, for maintenance of bearings of three phase
locomotive Traction Motors (TM) and Motor
Suspension Units (MSU)**

Report No.: RDSO/2016/EL/TAR/0003 Rev '0'

Issue Date: 29.03.2016

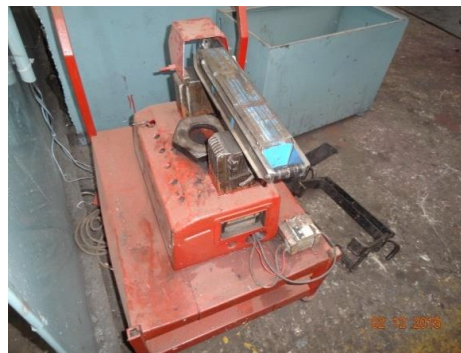
(vii) **Heating the bearing inner rings & the End frame:** Bearing inner rings are heated with the induction heater kept in an open atmosphere and the end frames are heated in the heating oven. The induction heater used is very old Inventum make without having the basic facilities like temperature display, temperature hold, auto cut off & de-magnetization. Temperature of the rings was measured by hand held temperature gun which was also not calibrated.

It is also observed that during placing the inner ring over the induction heater edge, the racer was not suspended fully & rubbing with the metal base.

Photo 1: Old Induction Heater

Recommendation: ELS/LGD has been advised to procure and use induction heater having basic features of temperature display, temperature hold, auto cut-off & de-magnetization.

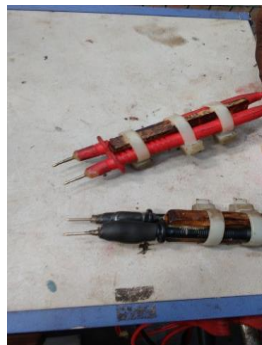
- (i) Commutator profiler is lying defective.
- (ii) Drop test procedure was seen and the staff and supervisor were counselled for following the proper procedure as given in SMI-51. The staff was not aware about significance of placement of current and potential probes. It was also advised to use a proper probe having current and potential leads spaced apart 20mm.

Photo 2: Drop Test Probes

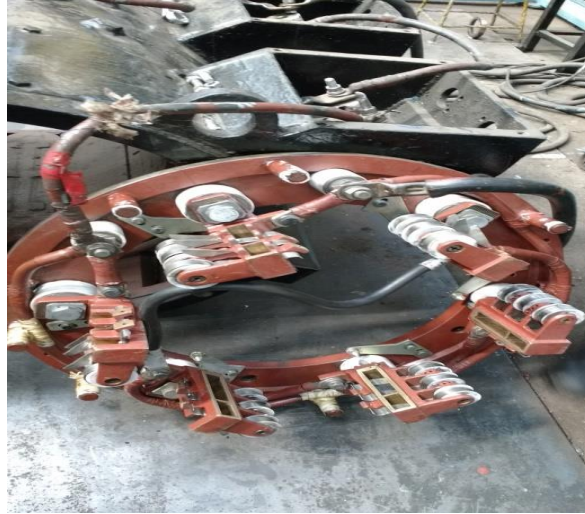
- (iii) It was informed that ELS/LGD had stopped using Bactol Red and TVA1410 is used.
- (iv) It is observed that shed is varnishing the brush box holders. It should be stopped with immediate effect. The painted brush boxes should be cleaned at the first available opportunity.

Photo 3: Varnished Brush Holder

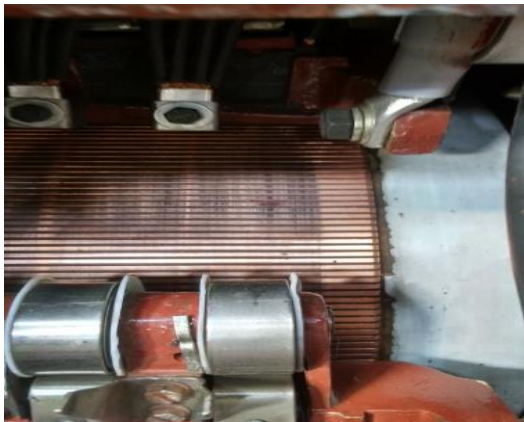
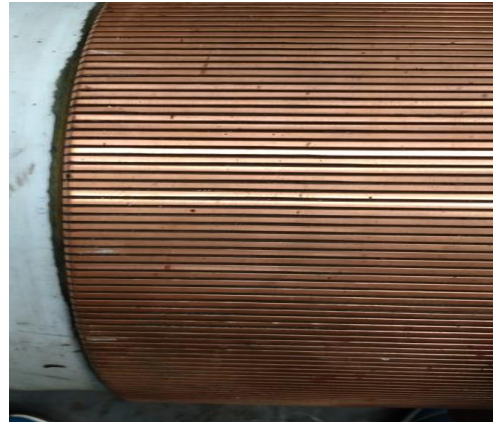
- (v) V-grooving (End Chamfering) is not being done on commutator segments after machining; it may leads to flashing of TM due to accumulation of carbon dust. Shed is advised to follow the Special Maintenance Instruction No. RDSO/ELRS/SMI/31 dated 24.10.78 for undercutting and chamfering of Traction motor Commutators completely.

Photo 4 & 5: Commutators without V- grooving
