**Technical Audit
of
Wheel Pressing Procedure
for
Electric Locomotives**

Report No.: RDSO/2016/EL/TAR/0007 Rev. '0'

Issue Date: 03.06.2016

Issued by
Electrical Directorate
Research, Designs and Standards Organisation
Manak Nagar, Lucknow-226011

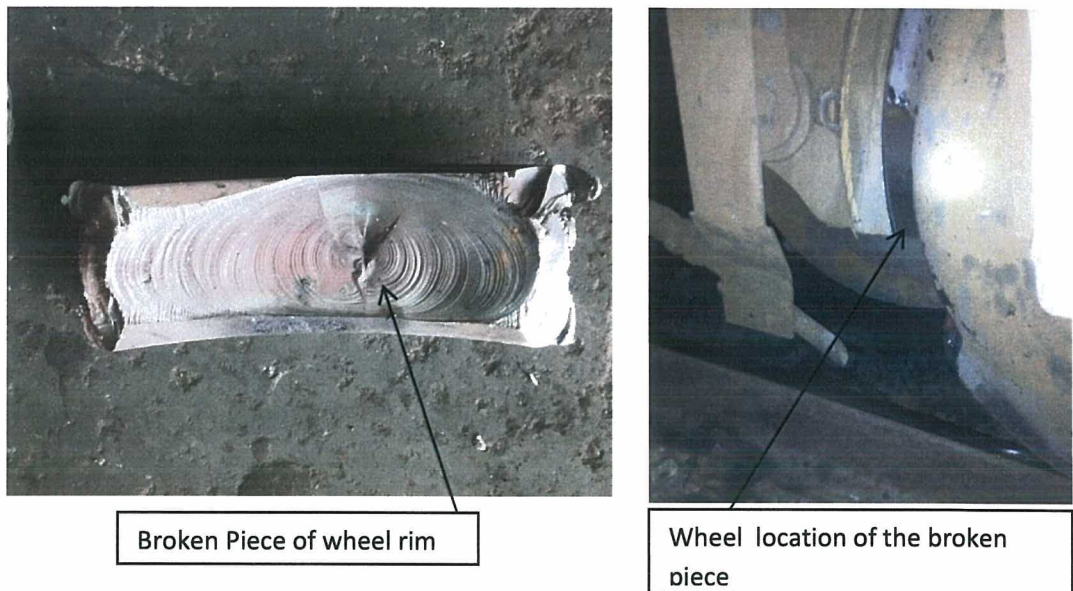
Fig 1 : Breakage of wheel disc at rim in Loco. No 27555

- 1.2. The investigation of Loco no 27555 was carried out by M&C directorate and it has reported that the wheel disc had failed due to shattered rim cracking which is caused by rolling contact load on tread surface resulting in tangential Hertzian stresses at subsurface level. This creates crack when stresses exceed yield strength which propagate in a fatigue manner. Further, no heat affected area was observed on macroscopic examination after etching.
- 1.3. During the course of investigation it was observed that the manufacturer's serial number was not available on the wheel disc. It was informed by Electric Loco Shed, Erode that Loco works, Perambur machined the hub face which carried the manufacturer's serial no after pressing-in the disc and punched their own serial number. Further, no record is being kept at the workshop for original

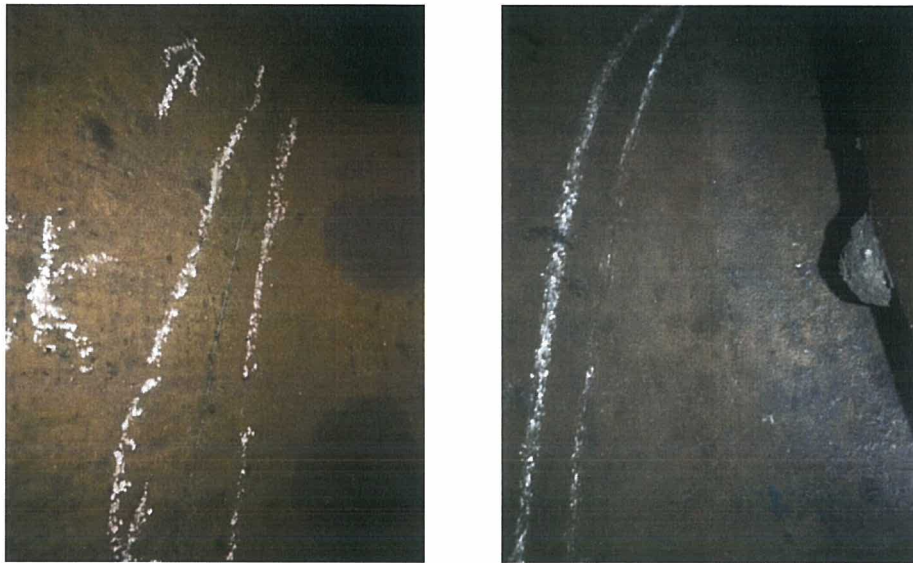
- 1.4. The breakage in wheel disc of Loco no 27489 was in the web portion circumferentially outside the hub and the wheel disc was sent to Perambur Loco Works for analysis. The circumferential crack suggests stresses developing in web portion of the disc. This could be due to manufacturing defect or may be due to improper wheel pressing resulting in high residual pressure in fillet portion. The metallurgical investigation of this wheel is awaited.

Fig 2 : Circumferential crack in the web portion of wheel disc close to hub in Loco no 27489

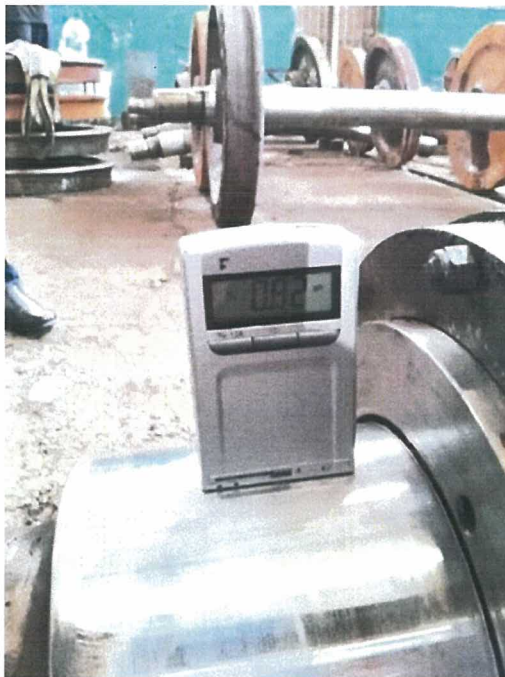
3.3. None of the workshops were measuring surface finish. Loco Works, Perambur started measuring the surface finish since end-March when the workshop was visited. However, the records available, since the measurement started, show that the surface finish is often out of prescribed range both for wheel seat and wheel bore. This measurement is recorded in the rough register and still not recorded in the wheel record. The workshops informed that they do not have the facility for honing of the axle with mounted bull gear and so surface finish cannot be controlled at the time of rediscing.

Fig. 5 : Measurement of surface finish of axle at wheel seat

- 4.5. Surface finish of the wheel bore and wheel seat area of the axle should be measured and maintained as given in the relevant drawings. Suitable arrangement should be made so that the axle mounted with bull gear can be honed in order to achieve the required surface finish on the wheel seat. A record of actual measurements of the same shall be maintained.

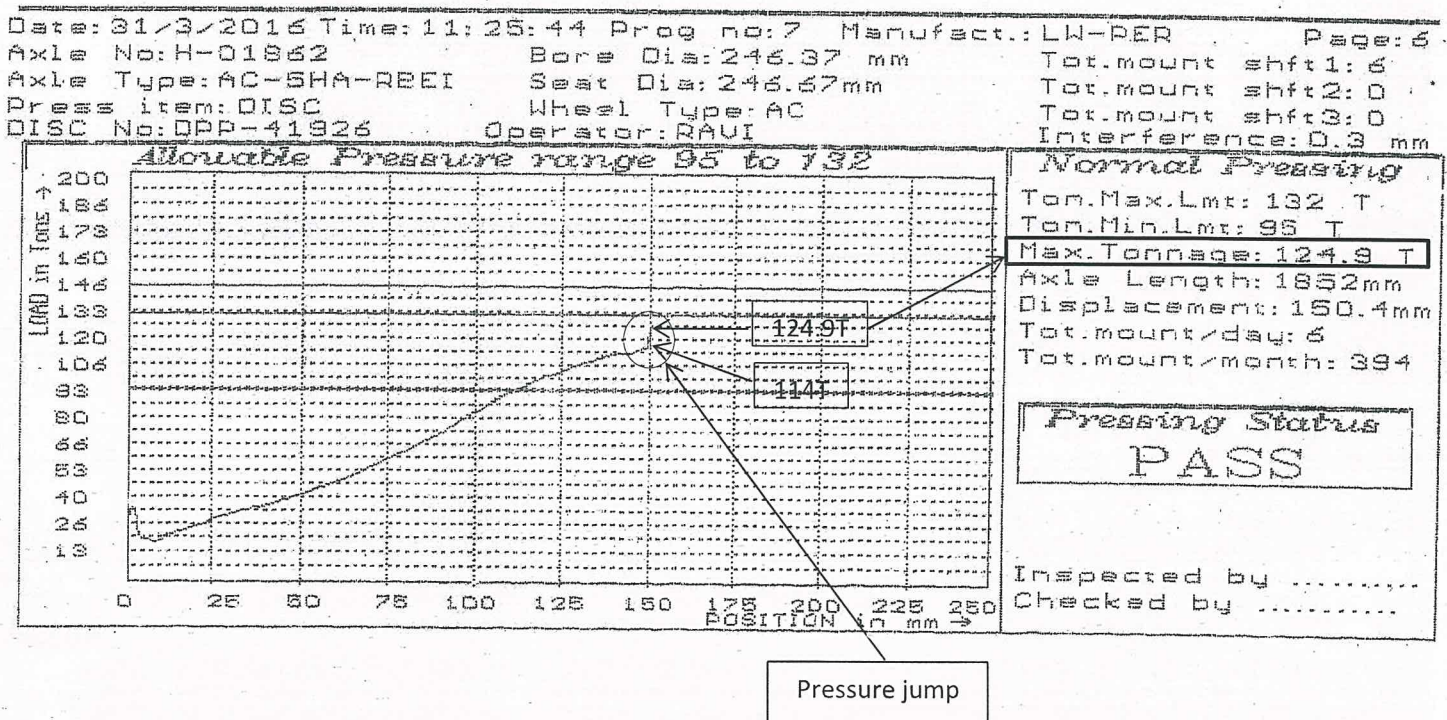
3.7.1. The wheel disc is pressed by the operator while another observer notes the distance of Motor Suspension Unit (MSU) from the wheel disc and given instruction to the operator to terminate pressing-in once the wheel disc touches MSU. However, this results in delay and the wheel disc gets pressed against the MSU shown by the sudden rise in the pressure at the time of contact before the pressure is removed. It can be seen from the graph below (Fig. 7) that the pressure suddenly jumps from 114T to 124.9T at a displacement of 150mm without any change in displacement. This is a result of pressure being exerted by the wheel disc on the MSU and is not related to the pressure being due to interference. This results in the pressure recorded by the automatic recorder at a higher value than the actual press-in pressure (124.9T instead of 114T as shown in Fig 7). Additionally, this would also introduce compressive stress in MSU and its bearings, which would result in net outward force on wheel disc.

Fig. 7 : Sudden rise in pressure due to contact of wheel disc with MSU

- 4.10. It should be ensured that the wheel disc doesn't press Motor Suspension Unit at the time of processing. Suitable arrangement for automatically switching off pressure, once disc touches MSU or completes its movement is desirable to reduce dependency on manual skill and reflexes.

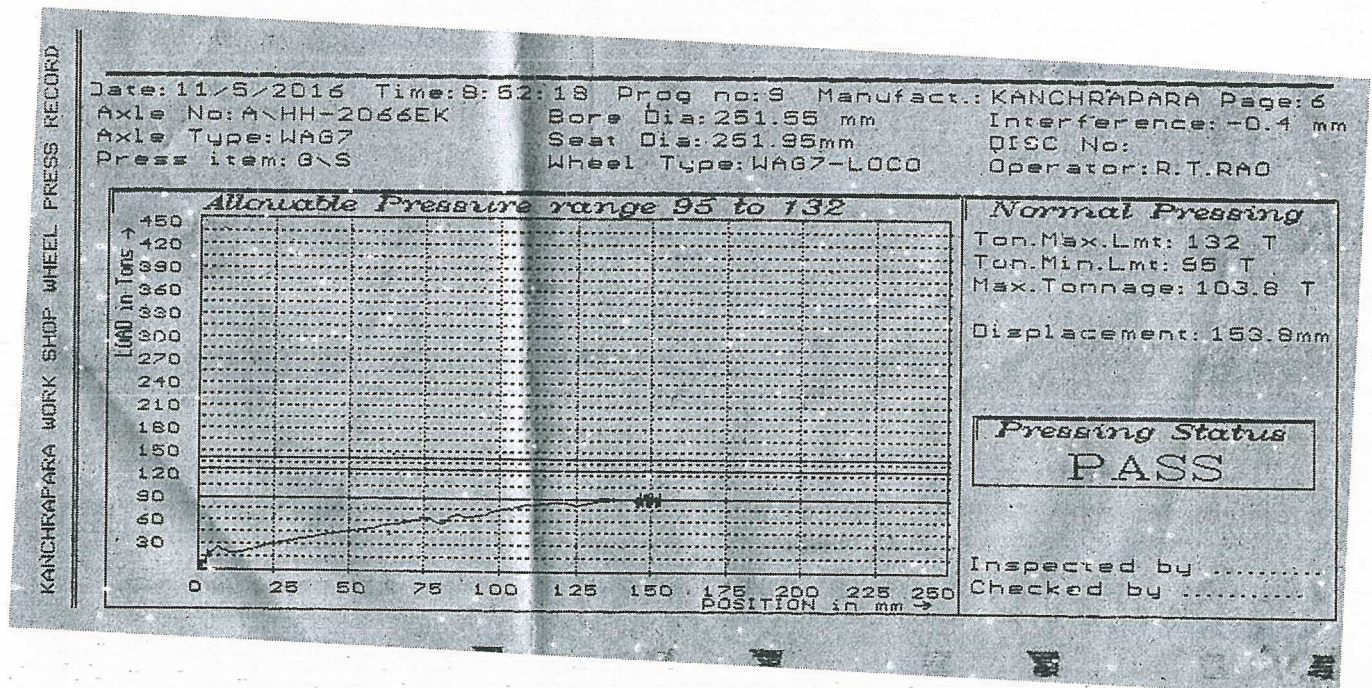
3.7.2. In the wheel pressing graph shown below as Fig 8, it can be seen that the pressing-in pressure is below 95T for most of the displacement and there are sudden erratic fluctuations in pressure towards the end and the final pressure is recorded as 95T. The graph represents 'knocking in the end' in the wheel mounting pressure curves as per the Technical Circular. However, the status is reported as "PASS" as the maximum tonnage is recorded as 103.8T.

In this case the interference is kept as high as 0.4mm which is within limits (0.23mm to 0.43mm for wheel seat dia of 251.95mm) but the pressure recorded is on the lower side which The scale of the graph is from 0 to 450T which should be reduced to 0-200T so that the graph can be manually inspected and such fluctuations of around 20T can be noticed.

Fig 8 : Low pressure and knocking at the end (Not recommended)

- 4.9.1. The pressing-in pressure should start rising before the displacement of wheel on the wheel seat reaches 20 mm.
- 4.9.2. The pressing-in pressure shall gradually and smoothly increase with the displacement of the wheel, until a maximum value is reached which shall not exceed the maximum specified value as per the relevant drawing.

- 4.9.3. This maximum recorded value should not fall during the pressing-in operation by more than 5 ton and any such fall should not result in a value less than the minimum pressure specified in relevant drawing, nor the pressure drop should occur prior to the final 25 mm of displacement.

- 4.9.4. The final pressing-in pressure should lie between the stipulated pressing-in pressure as per the relevant drawing.
- 4.9.5. This plot should be inspected and compared with the reference plots given in technical circular to arrive at a decision regarding correctness of wheel pressing instead of merely looking at the "PASS" or "FAIL" reported by the machine.

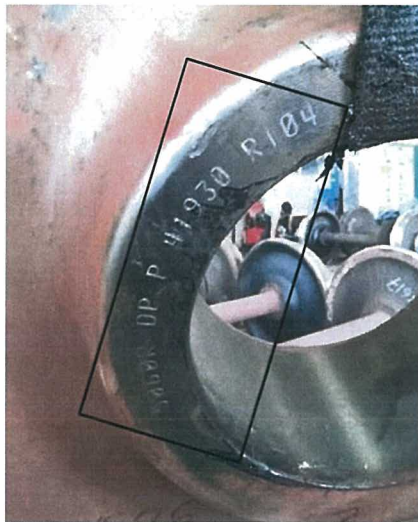
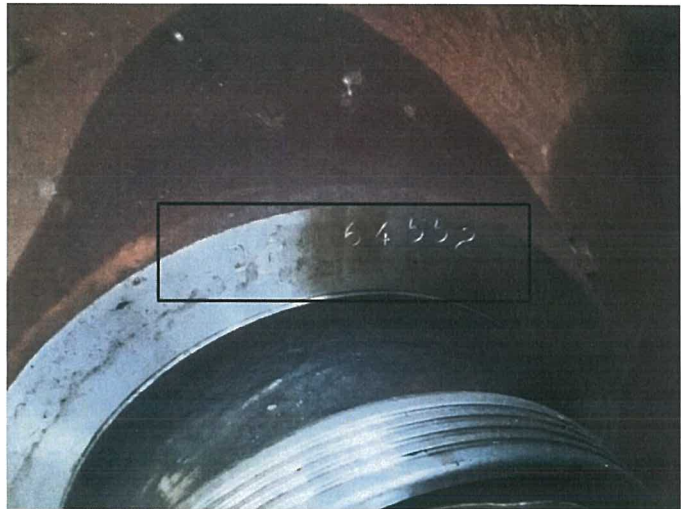
3.8. The face of the wheel disc is machined to achieve the required clearances for axle box mounting. As this surface contains the identification mark of the supplier of wheel disc, the information is lost while machining. However, the workshop was noting part of the Serial number and punching it back after machining. It can be observed from Fig. 9 below that a substantial part of information is lost and only middle part of original punch mark is re-punched. This doesn't serve the purpose and workshop agreed to re-punch the entire number to ensure traceability.

Fig 9 : Punched Identification Marks on Wheel Hub

- 4.11. The manufacturers' serial number should be properly noted down before machining of hub face. After machining the same serial no should be punched again on the hub to ensure traceability of the wheel discs. This will permit proper investigation in wheel disc failures particularly those in which problems are noticed in a particular source/batch/heat.

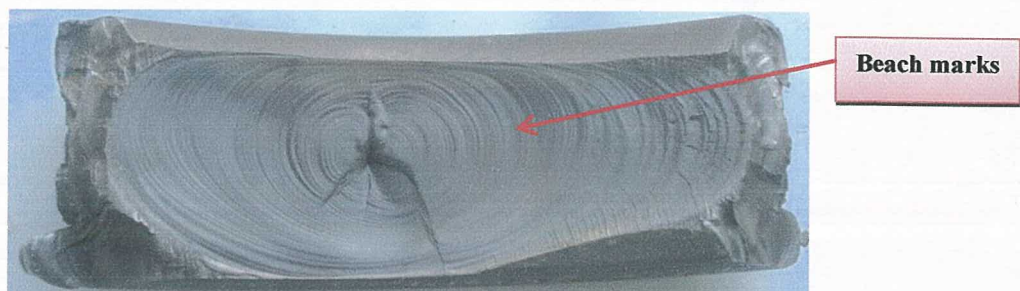
A fractured piece broken out from rim portion containing the tread part having 400 mm circumferential length & thickness about 38 mm is received (**fig.1**).

The broken piece has fractured faces on either ends and opposite end to tread surface. Visual examination revealed that the piece had broken due to shattered rim phenomenon. The fracture had initiated at a depth of about 35 mm from existing tread surface. The fracture had progressed horizontally on either side parallel to tread surface with the formation of beach marks. On one side the horizontal fatigue had progressed 131 mm from origin & other side 200 mm (**fig.1**). After wards the fractured had changed the orientation towards either ends & progressed in a transverse manner (Radial) causing breakage of the piece from rim portion.

Fig.1 Photograph of broken piece from wheel tread portion in as received condition.

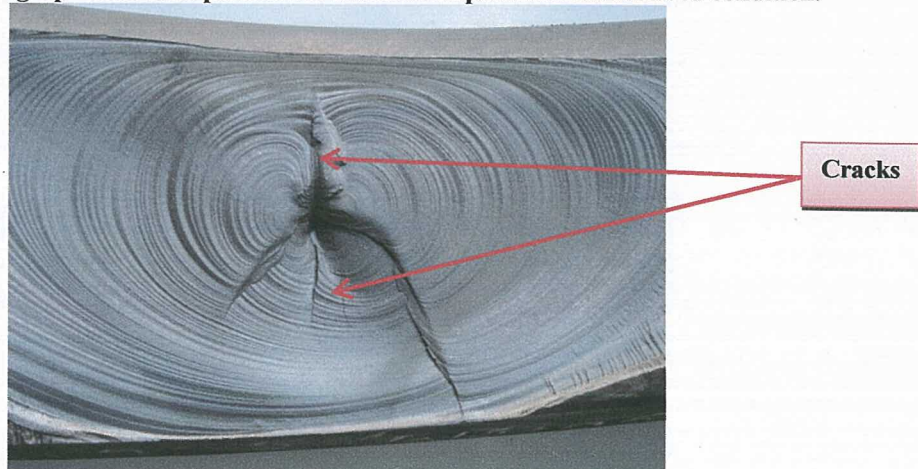
At initiation zone crack extending towards the front rim side is about 46 mm & back rim side is about 34 mm width (**fig.2**).

Fig.2 Photograph showing location of crack towards front rim side & back rim side of tread.

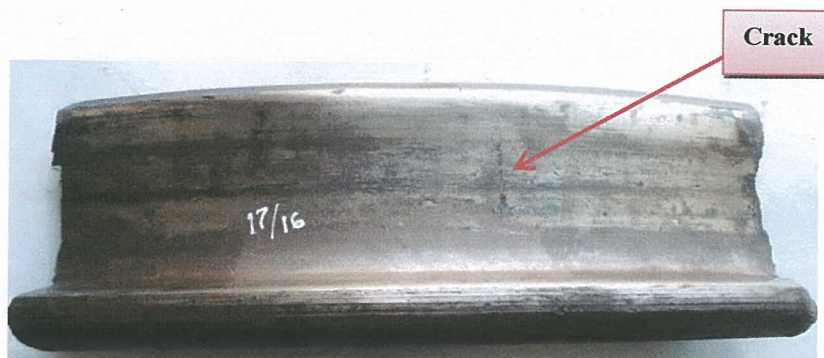
At corresponding location of fracture initiation zone which is having a crack in subsurface, a crack having width 55 mm is noticed on the tread surface (**fig.3**).

Fig.3 Photograph showing location of crack on wheel tread at corresponding location of fracture initiation zone.

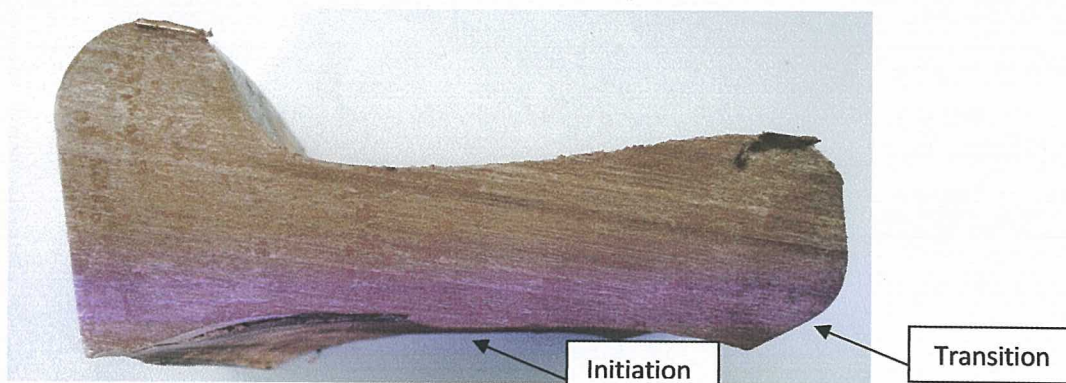
The counter fracture piece was not received. From the geometry of received piece, it appears that initiation point was almost located to near tread web transition (**fig.4**).

Fig.4: Photograph showing location of crack initiation and transition area

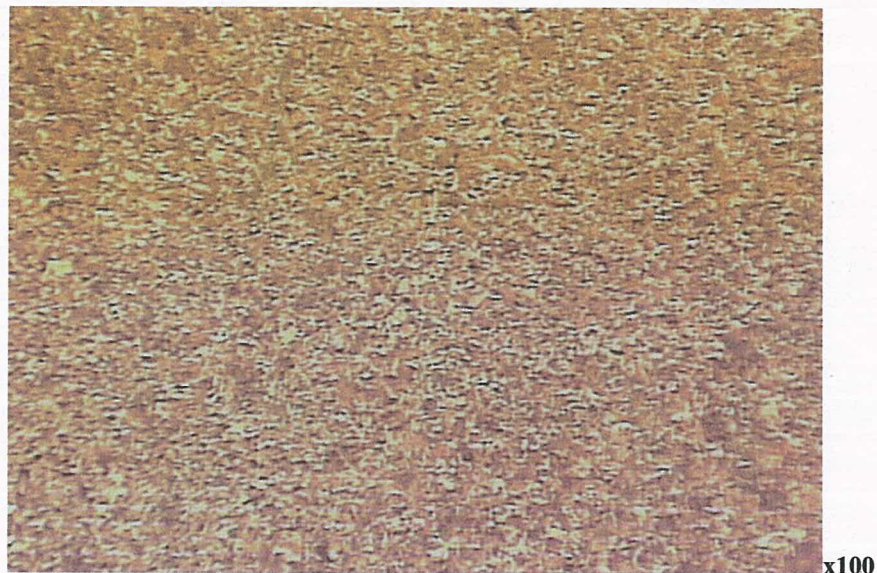
- a) Microstructure was conducted on a sample taken from the existing tread portion. Micro examination revealed fine pearlite within thin & broken network of ferrite having ASTM grain size varying from 6 to 7 (fig.5).

Fig.5 Photomicrograph showing grains of fine pearlite within Thin & broken network of ferrite.
