Technical Audit Report

Maintenance/Manufacturing Process of Elastic Ring

Report No.: RDSO/2018/EL/TAR/0015 Rev. '0'

Technical Audit at CLW/CRJ**Date: 09.11.2017****1. INTRODUCTION:**

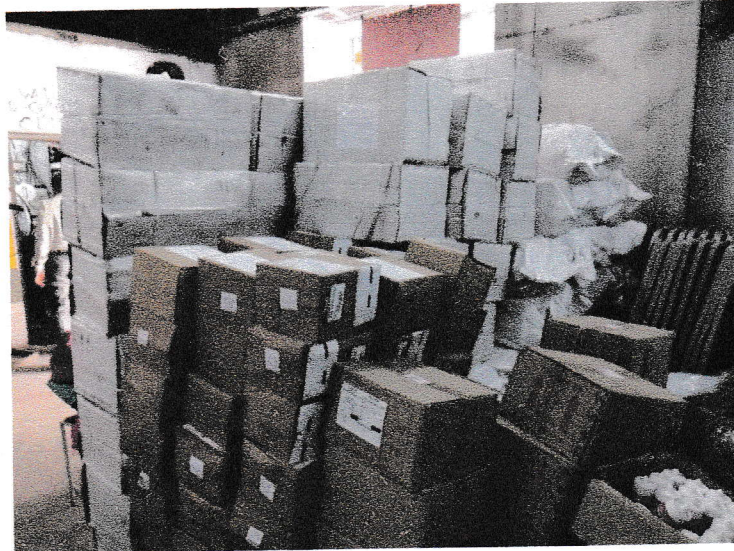
- Elastic ring was being purchased as per latest specification from the approved sources.
- Elastic ring was being stacked in non-air conditioned atmosphere.

Fig.1: Storage of Elastic ring in main store at CLW (not recommended)

- Elastic ring should be stored in air conditioned room as it is a rubber item. Also in the store depot, system should be there to ensure first in first out to avoid storage for a long time and use of material before expiry of shelf life.

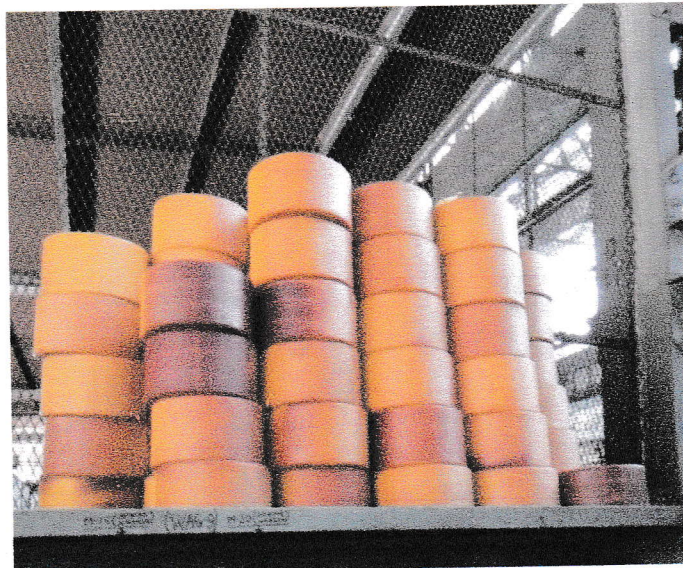
Fig.2: Storage of Elastic ring in shop at CLW (not recommended)

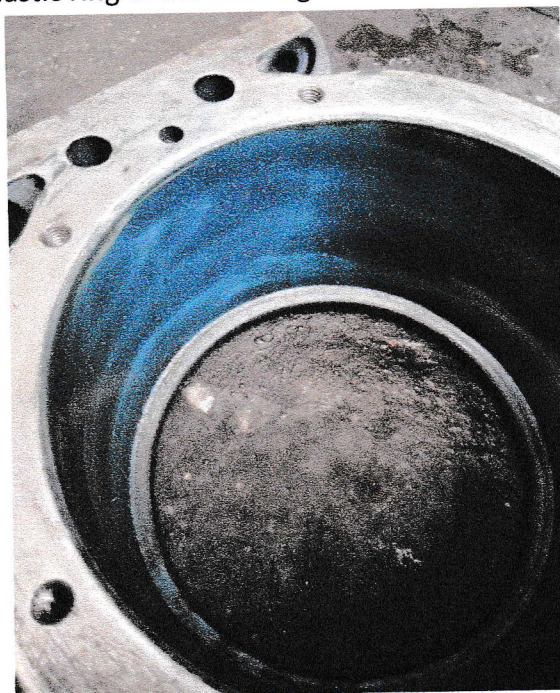
- Anti-rust solution was not being removed from inner surface of pivot housing before fitment of Elastic ring in the housing.

Fig.3: Anti-rust solution was not removed before fitment

- Removing of anti-rust solution and cleaning of pivot housing is essential in all cases. It should be ensured that the pivot head is free from all burrs and have a smooth surface.
- Spare hydraulic press with working pressure gauge should be provided in the section and pressure during pressing of Elastic ring on the pivot head should be maintained as per SMI no. RDSO/2017/EL/SMI/0316 Rev '0'.
- As per SMI no. RDSO/2017/EL/SMI/0316 Rev '0' it should be ensured that there is a small gap between retaining plate and Elastic ring. This can be ensured with the help of Feeler gauge.
- Manufacturing date should be punched in all makes of elastic ring. CLW/Zonal Railways may ensure this during inspection of material against purchase order.

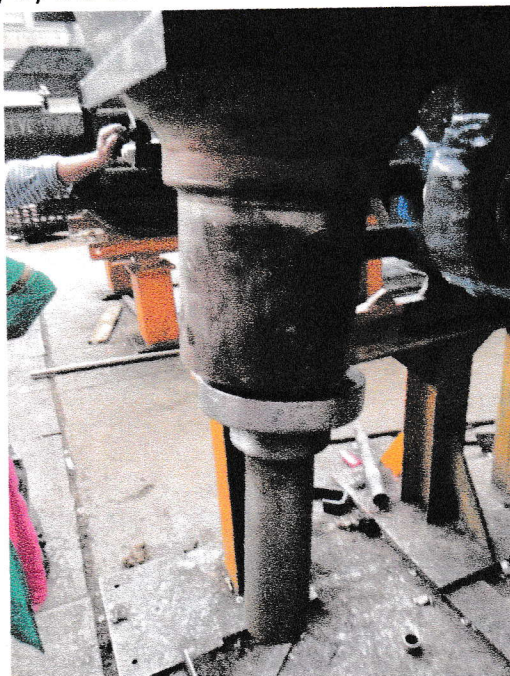
- It was found that pivot head was not smoothened properly and Elastic ring was being fitted. Only after asking for the smoothness of pivot head it was smoothened properly by the staff.

Fig.4: Pivot head was not smoothened properly before fitment of Elastic ring

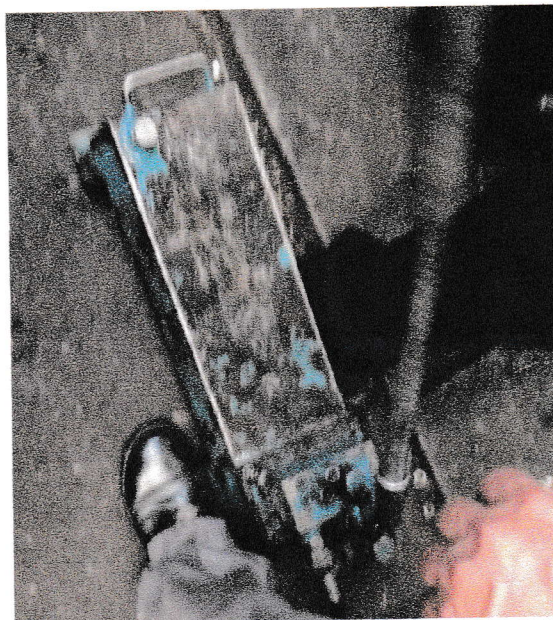
- There were two hydraulic press machines in the shop. Out of two, pressure gauge was available in only one of the hydraulic press which was not in working condition during the visit. Other hydraulic press without pressure gauge was being used.

Fig.5: Hydraulic press without pressure gauge being used for fitment of Elastic ring at CLW

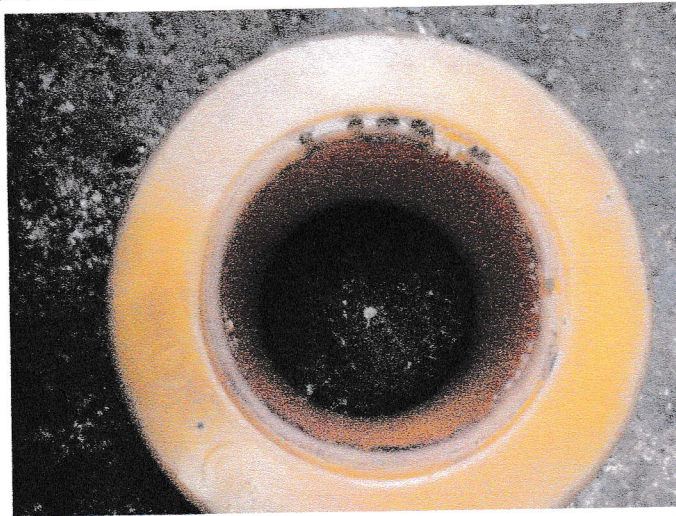
Fig.6: M/s Avadh rubber make Elastic ring failed at CLW during fitment

It got bulged during the fitment itself. It seems that there is some problem in Elastic ring.

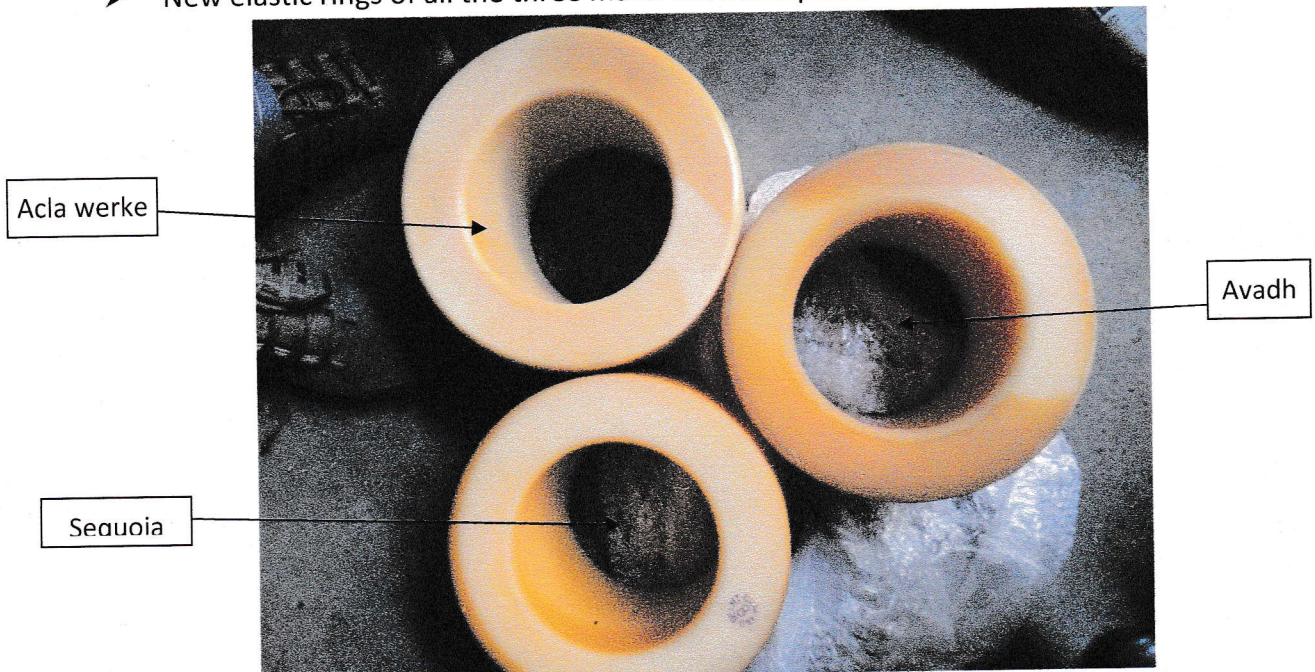
Fig.7: New elastic rings of all the three make supplied to CLW

It was found that surface finish of Elastic ring were at variance with each other.

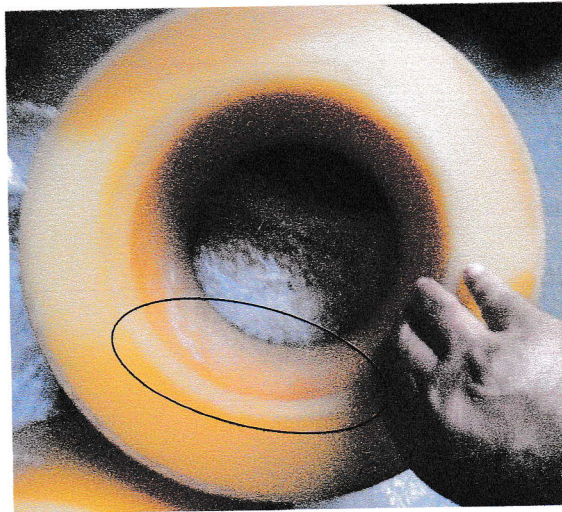
Fig.8: Improper surface finish of Elastic ring found during Inspection at CLW

- CLW was advised to ensure proper inspection of Elastic rings. Any visible defects should be pointed out at the time of inspection and material with defect should not be accepted.
- In view of the failures reported, a comprehensive quality audit was carried out at manufacture's works. The brief of report is enclosed at **Annexure-A**.

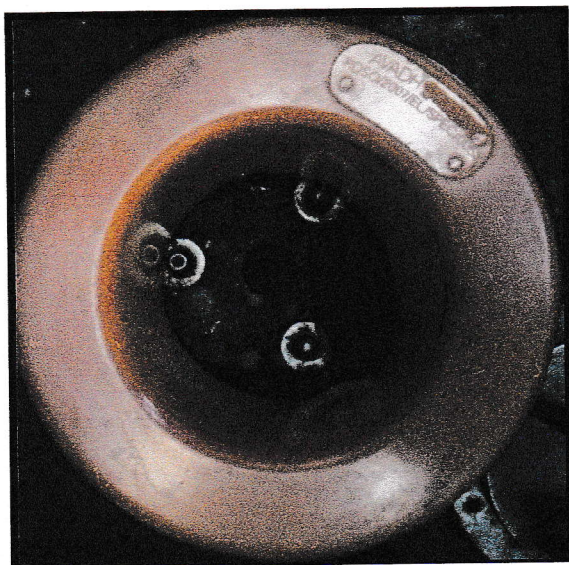
5.1 It was observed that batch number i.e. manufacturing month/year was not punched on the Elastic rings. Only name of firm & Specification were mentioned as shown in figure-11 below. Firm was advised to punch batch number, manufacturing month/year on the rings. Firm has started punching lot number/ batch on the rings as shown in figure-12. As per punched lot/batch on the ring, manufacturing month/year can be traced in internal record of the firm.

Fig.11 No marking of batch number
AVADH
RDSO/2007/EL/SPEC/0053

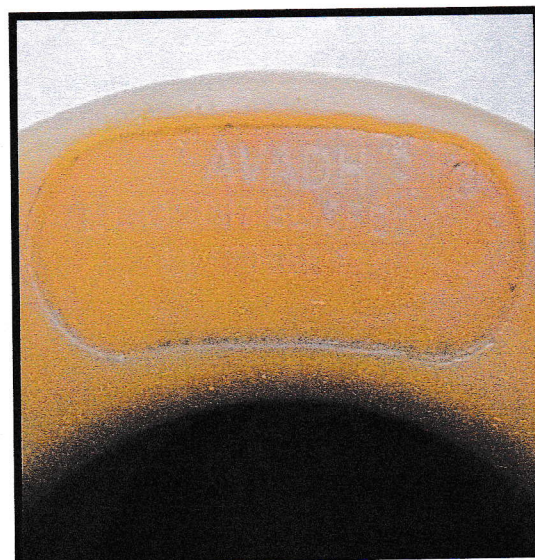
Fig.12 Batch number marked
AVADH
RDSO/2007/EL/SPEC/0053
LL170666/5650
