**Sub**: Minutes of meeting on Reliability related issues of CCB Brake System provided in 3-Phase Electric Locomotives.

Minutes of the meeting held at RDSO on 28-02-2024 on Reliability issues of CCB System of 3-Phase Locos.

### Intermediate Check and Cleaning of CCBII System EBV LT Switch

<u>Sub:</u> Precautions to be taken on CCB during Meggering/Welding on 3-phase Locomotives.

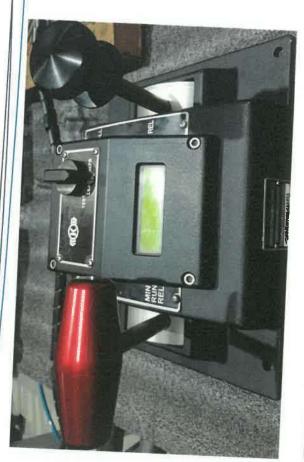
Turn OFF Power Supply to CCB

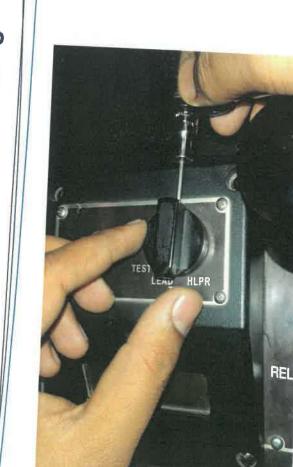
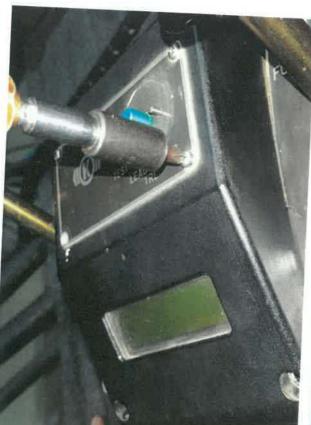
Using 5/64" Allen key, remove the LT Switch knob

4 screws of LT Switch Decal Plate & Using Philips Screw Driver, remove remove Decal Plate

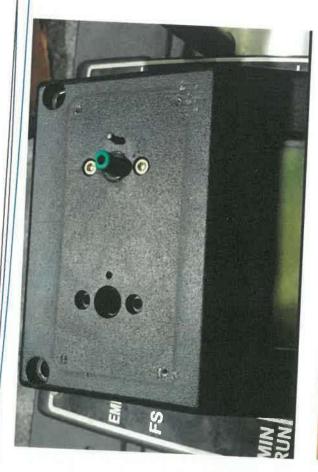
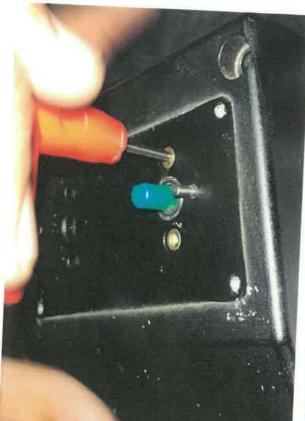
Using 2.5mm Allen Key, remove 2 screws of LT Switch & remove LT Switch

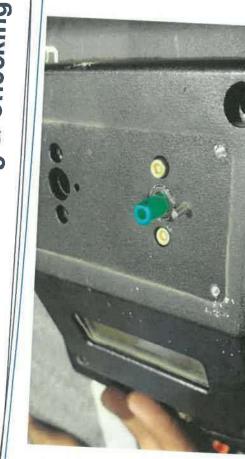
Slowly pry out the EBV top cover and lift to remove the LT Switch

Carefully turn the EBV top cover as shown

display connector & LT Switch lifting/turning the top cover to avoid any damage/stretch to Care to be taken while wiring Slowly take out LT Switch & verify.

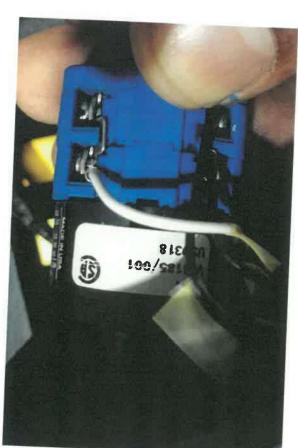
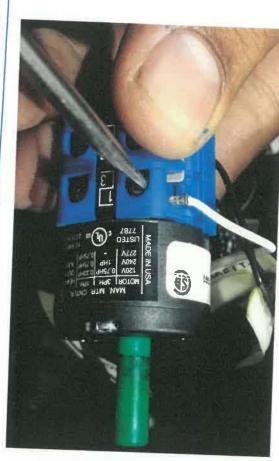
At terminal 1 White wire is installed at the left side of the Securing Screw.

At terminal 1 wire is installed at the left side of the Securing Screw.

This may lead to improper contact of shorting plate & causing the problem of logging "EBV Currently Inactive" washer plate of the screw with the message.

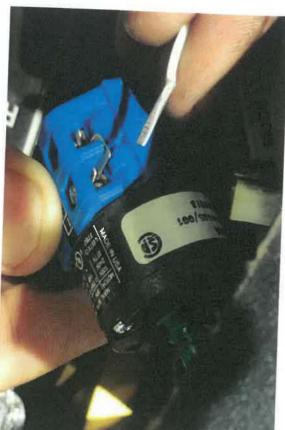
Using Screw Driver, slacken the wire at Terminal 1& disconnect.

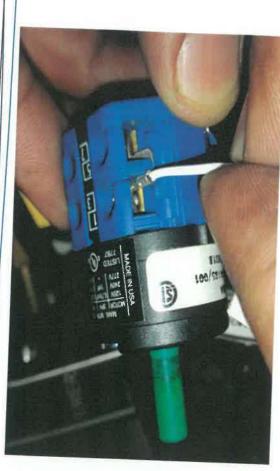
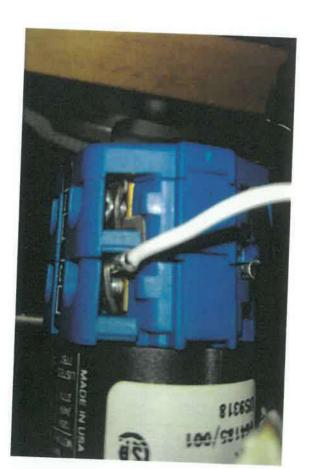
side of the Securing Screw placing the wire over the shorting plate & tighten Insert the wire at Terminal 1 on right the Securing Screw using a Screw Driver.

This will ensure positive contact of the wire with the shorting plate.

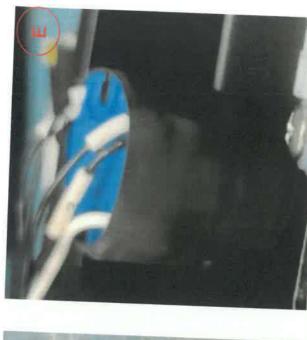
One more Improvement suggestion from KB India to protect the LT switch contacts from environmental

- Rotary Switch assembly (A)
- Tubing Shrinkable Size 45 mm (B)
- Inserting Tubing Over LT switch assembly (C)
- Shrink tubing over LT Switch using Hot Air Gun -

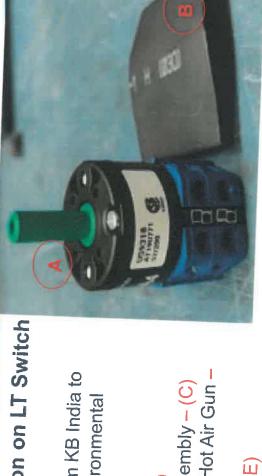
Using 2.5mm Allen Key, fix 2 screws of LT Switch & tighten

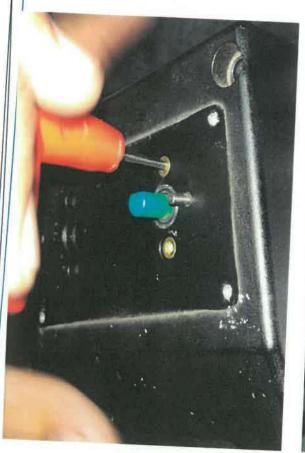
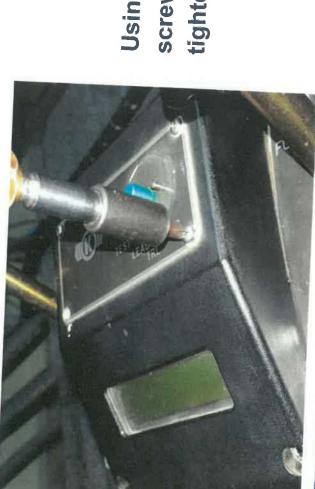
screws of LT Switch Decal Plate, Using Philips Screw Driver, fix 4 tighten and fix Decal Plate

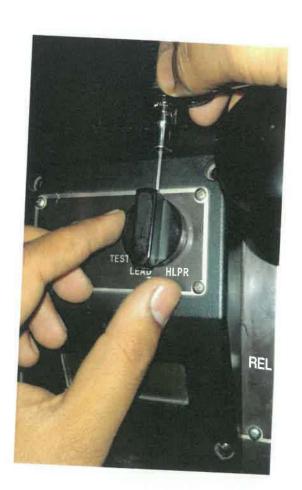
Carefully turn the EBV top cover as SC2 shown

display connector & LT Switch lifting/turning the top cover to avoid any damage/stretch to Care to be taken while wiring

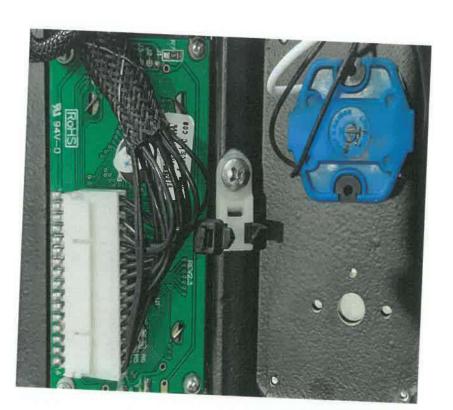
### Turn ON power supply to CCB

Ensure no sparking/shorting

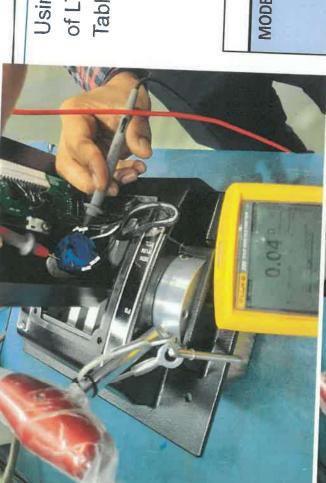
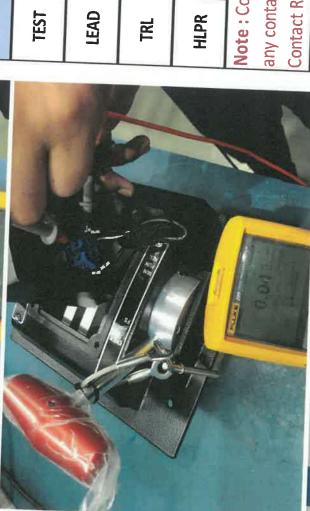
Using Multimeter, Check Contact Resistance of LT Switch at 4 different Positions as per Table -1 given below:

MODE Multermeter Blac Probe at Pin No.	LT - Switch Resistance Checking Chart	hart
TEST 1	Multermeter Black Multimeter Red Probe at Pin No.	Resistance Value
1	8	0.04 ohm
	9	0.04 ohm
LEAD 1	œ	0.04 ohm
	4	0.04 ohm
TRL 1	9	0.04 ohm
	2	0.04 ohm
HLPR 1	2	0.04 ohm
	4	0.04 ohm

Note: Contact Resistance should not be more than 2 Ohm at any contact position of the LT Switch. Replcae LT Switch if Contact Resistance found >2.0 Ohms

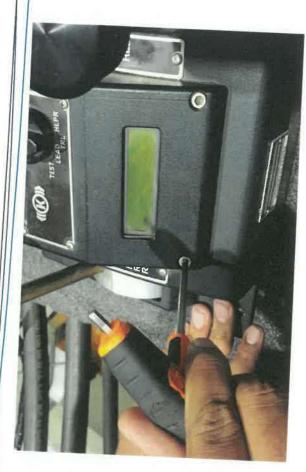
With electronic component cleaner nozzle aimed on the terminals of LT (Make - Stanvac, Model - 8376 or equivalent) and spray it with its Switch.

Cleaning compound dried up, check once again Contact Resistance of LT After some time after ensuring the Switch contacts as mentioned in earlier procedure. Replace LT Switch with new one if no proper connection of the wires at the terminals as per the wiring diagram. improvement found and ensure

Using 4mm Allen key & tighten 4 Fix the top cover of EBV Screws
