**Technical Audit of Wheel Pressing Procedure for  
Electric Locomotives at Electric Loco Shed Kanpur,  
Electric Loco workshop Bhusawal & Kancharapara**

Report No.: RDSO/2023/EL/TAR/0031 Rev. '0'

## Technical Audit of Wheel Pressing Procedure for Electric Locomotives

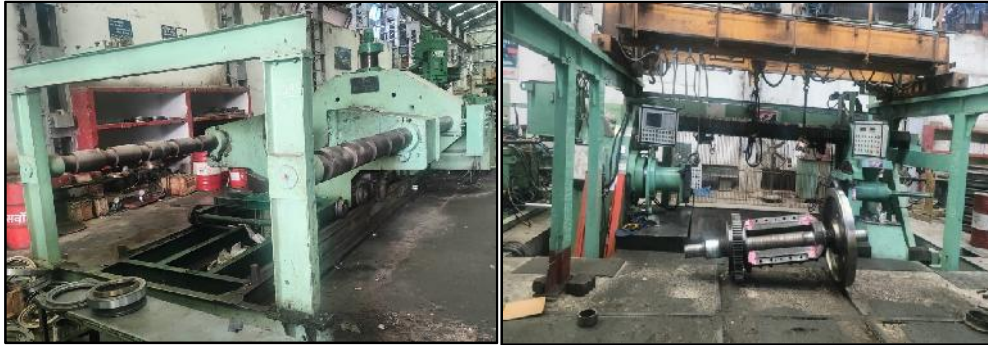
Wheel Press Machine (Manual)  
DoC: 1987  
Make: Indian Sugar General Engg.  
Corporation Ltd.  
Without graph plotting feature

CNC Wheel Press Machine  
DoC: 25.05.2013  
Make: M/s Electropneumatic &  
Hydraulics (India) Pvt. Ltd. Pune

2. Facility of recording of pressure graph is not available in manual machine, but this machine is being used for only press out of wheel.
3. CNC Machine is not under AMC since last 3-4 years, **So calibration of machine is also not done. Analog pressure gauge attached in machine is showing that calibration is due since 2018.**
4. Before assembly interference between wheel seat and wheel bore is being measured. On checking of record it is found that interference is being kept within limit.
5. **Surface roughness is not being measured** at the time of wheel pressing. One ready axle for wheel pressing checked visually found groove line. **On checking found surface roughness out of limit (Ra 5.47  $\mu\text{m}$  against limit of Ra 3.2  $\mu\text{m}$ ).**
6. **Presence of taper on wheel seat is being checked but very vaguely and also it is not being recorded anywhere.**

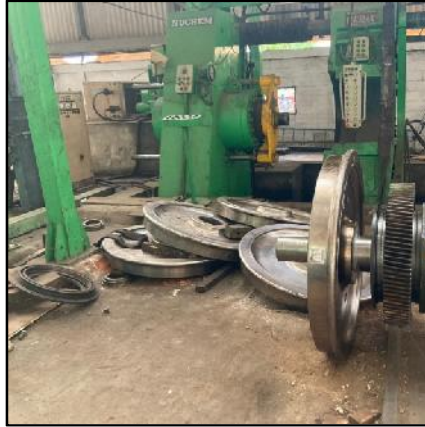
7. No calibration record found for inside and outside micrometer on shop floor. It is told that record being maintained by tool room. As per calibration certificate collected from tool room, calibration is due since Feb' 2023.
8. **UST of wheels is not being before wheel pressing.**
9. **Kluber make OKS 200 MoS2 Assembly paste is being used, which is not as specify the TC-132 or MP.IB.VL-01.02.09 (Rev 01).**
10. Some wheels were not properly stacked. On checking some new wheels dent mark were found on them.

**Improper Stacking of wheels**

3. Ensure proper handling of wheels to avoid any dent mark on wheels.
4. The axle shall be fully machined and finished as per the relevant drawing. If any taper exists (within limit), the small diameter must be at outside end (reversed taper not allowed).

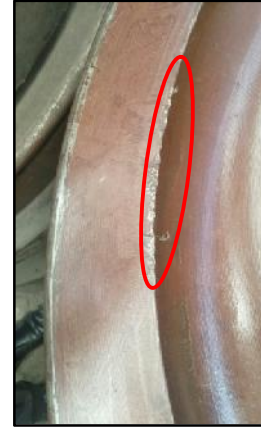
**Dent mark on wheels**

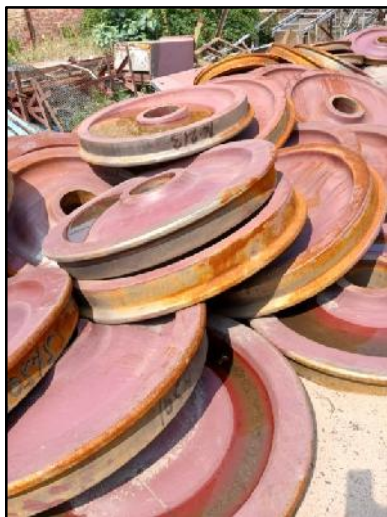
11. It was told that M/s DSP is sending wheels in loose in truck which may cause damage to wheels. Whereas imported wheels from M/s TZ Taizhong Hong Kong International Lmt.-Hong Kong are received properly stacked and tied in stand as shown below.

**Loose wheels received from M/S DSP**

10. At ELS/CNB it was found that new imported wheel from M/s M/s TZ Taizhong Hong Kong International Lmt.-Hong Kong were received in proper stacked and tied in stand to avoid damage. M/s DSP may be asked to send the wheels in same manner.

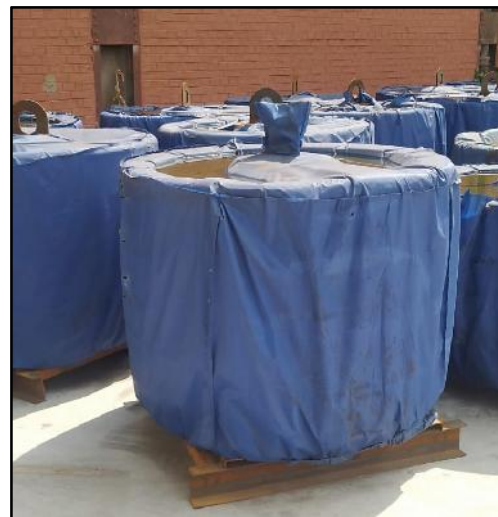
**Properly Stacked and tied in stand wheels**

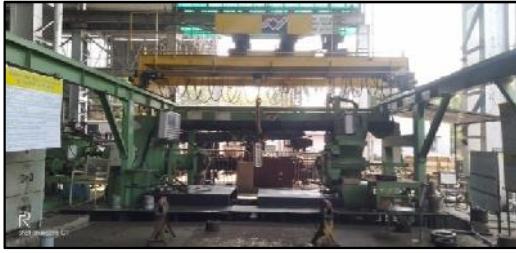
**New CNC Wheel Press Machine**  
DoC: 24.12.20  
Make: M/s Electropneumatic &  
Hydraulics (India) Pvt. Ltd. Pune

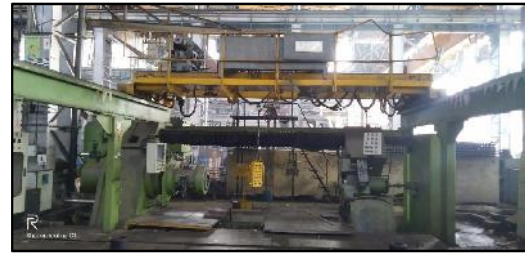
**Old CNC Wheel Press Machine**  
DoC: 27.04.2002  
Make: M/s Electropneumatic &  
Hydraulics (India) Pvt. Ltd. Pune

2. Old Machine is being used only for pressing out of wheel as pressure graph is not saved due to some fault in Machine. Workshop is in touch with manufacturer for maintenance of the above fault.
3. As per wheel set out-turn data collected from workshop around 158 wheel sets are assembled per month.
4. Handling and storage of wheel found satisfactory.

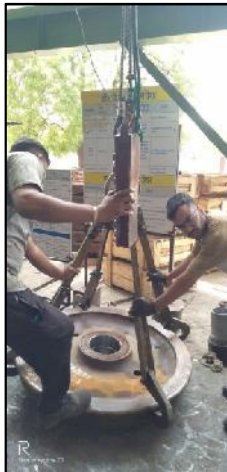
**Lifting of wheel**

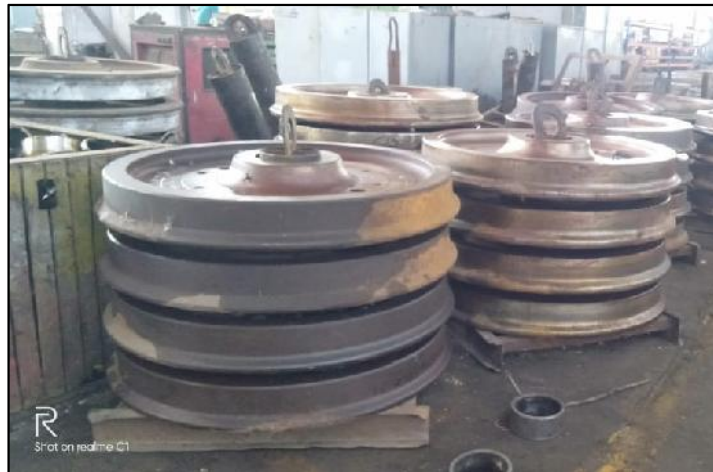
**Storage of wheel**

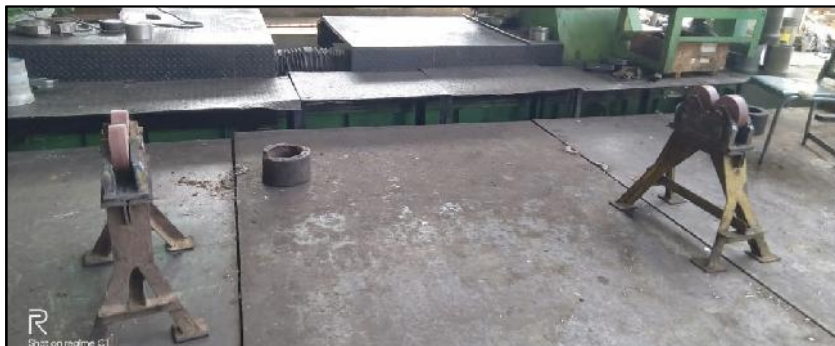
**Arrangement for holding of axle before assembly**

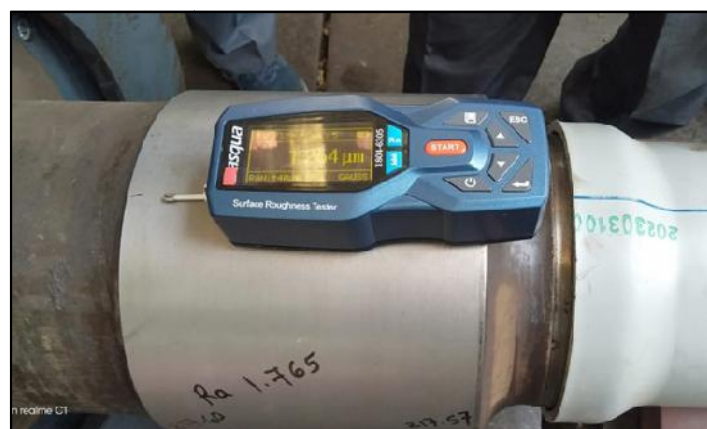
7. As per the new register measurement of surface roughness of wheel seat & taper and ovality of wheel seat and wheel bore is being done and being recorded since April'2023.

Surface roughness checking

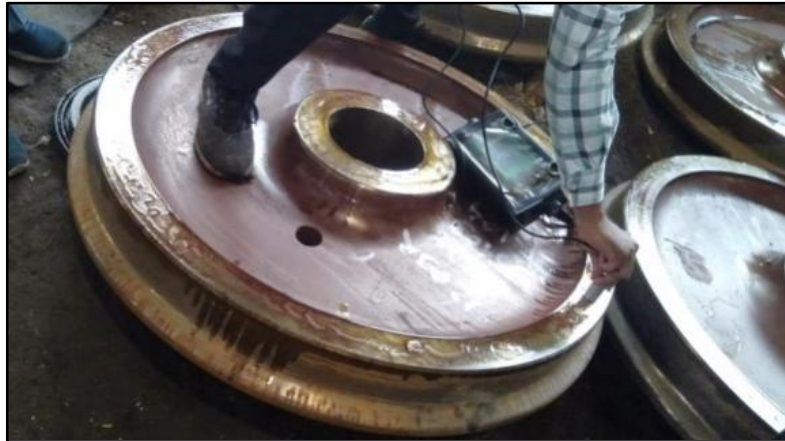
15. No of rejection of wheel pressing-in for 01.04.22 to 11.04.23 is 48 wheel set.
16. Before pressing in UST of wheel is being done.

**UST of Wheel rim and hub**

2. 100% Ultrasound testing must be carried out by a fully trained person on wheels and axles before wheel pressing. The results should be recorded and preserved for future reference.

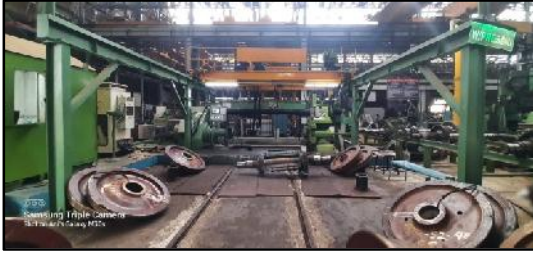
**New CNC Wheel Press Machine**  
DoC:24.08.20  
Make: M/s Electropneumatic &  
Hydraulics (India) Pvt. Ltd. Pune

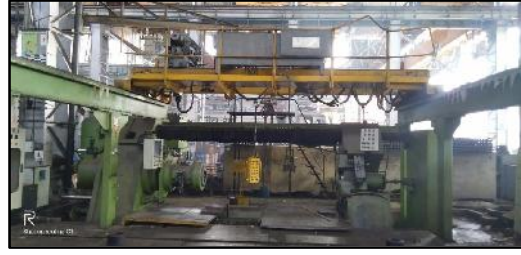
**Old CNC Wheel Press Machine**  
DoC: 14.09.2013  
Make: M/s Electropneumatic &  
Hydraulics (India) Pvt. Ltd. Pune

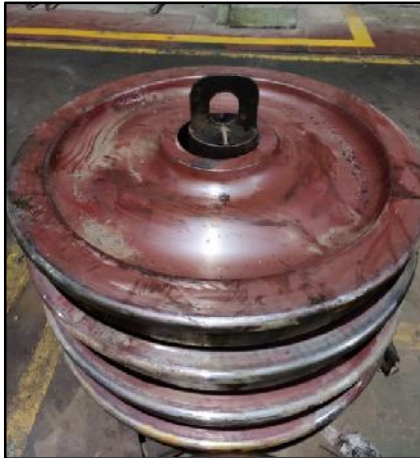
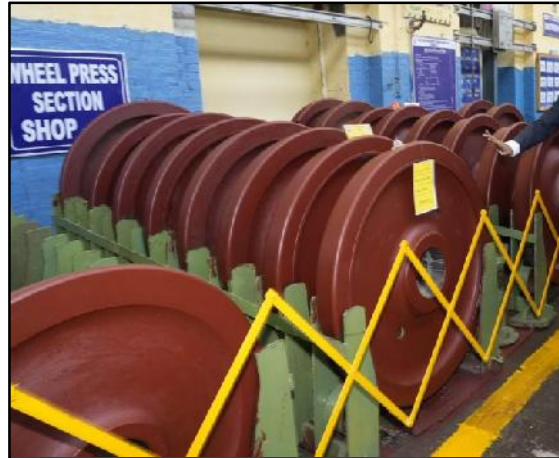
3. Handling and storage of wheel found satisfactory.

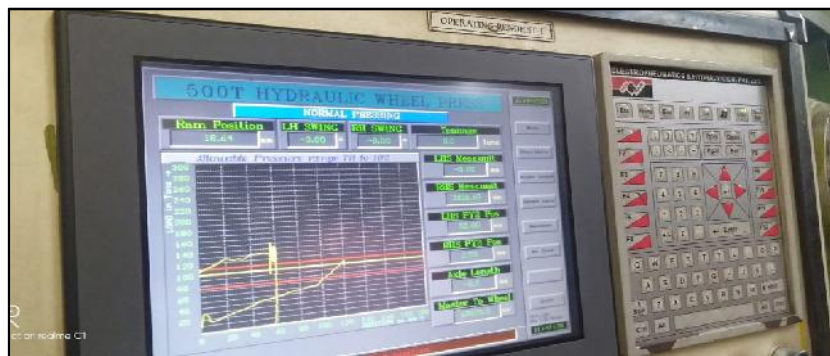
- 6. In old machine if pressing-in is stopped in between for any reason (such as for final adjustment of wheel gauge or for achieving gap between MSU tube and hub of wheel) and started again, a separate graph is being generated for second stroke rather than in continuation of earlier graph as shown. Workshop should approach OEM for rectification of the same.

6. The wheel must be pressed in single stroke.
7. The wheel pressing machine shall be equipped with a correctly calibrated pressure indicating gauge and automatic recorder producing a plot of pressing-in force as a function of wheel displacement relative to the axle wheel seat throughout the pressing operation. This plot shall be large enough to permit a precise determination of pressing-in force at any position on the curve.
