Technical Audit Report

Maintenance of Sandwich Mounting at ELS/MGS

Report No.: RDSO/2017/EL/TAR/0014 Rev. '0'

Technical Audit at ELS/MGS**Date: 03.07.2017****1. Availability of latest guidelines and procedures**

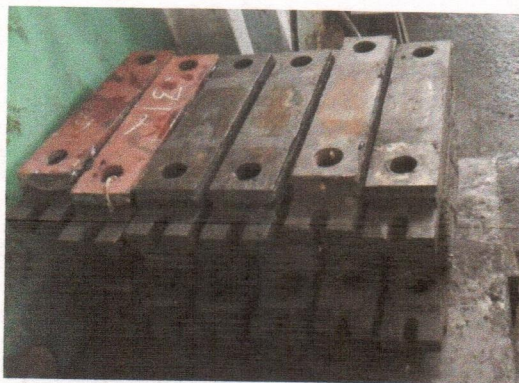
Fig.1: storage of sandwich mounting in ELS/MGS

- Sandwich mounting was being purchased as per old spec IRS: R49-75, instead of new spec no. RDSO/2014/EL/SPEC/0115 Rev. 0 dt. 22.08.14.
- 13 mm thick manganese steel liner was being used instead 6 mm as per SMI 186 amendment 1. Material was also not as per the SMI.
- Earlier annual average consumption of sandwich mounting unit at ELS/MGS was 150 nos. it has now been increased to 400 nos. and further being increased to 500 nos. to meet the requirement of replacement of sandwich mounting during TOH.
- Sandwich mounting unit was being stacked in the racks in non air conditioned atmosphere.

- 6 mm liner as per SMI 186 amendment 1 should be used.
- Sandwich mounting unit should be stored in air conditioned room as it is a rubber item. Also in the store depot system should be there to ensure first in first out to avoid storage for a long time.

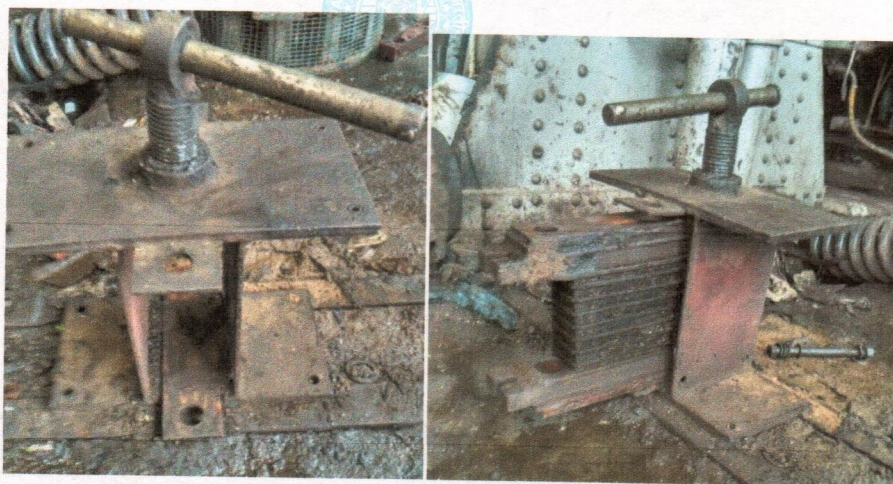
Fig.2: fixture for pressing SMU for fitment in locomotive

- ELS/MGS has developed a fixture as shown below to compress the sandwich mounting unit (SMU) unit for fitment in loco. With development of this fixture only one person can compress SMU easily.

- All electric loco sheds should develop similar type of fixture as in ELS/MGS for compression of SMU.
- If a serviceable SMU is being refitted, its dimension should be checked separately not with end blocks. It should not be at par of serviceable limit rather it should be at par of limits for new SMU.
- Proper record of SMU should be maintained. During overhauling TM wise complete record of removed SMU as well as new SMU being fitted in loco should be maintained.

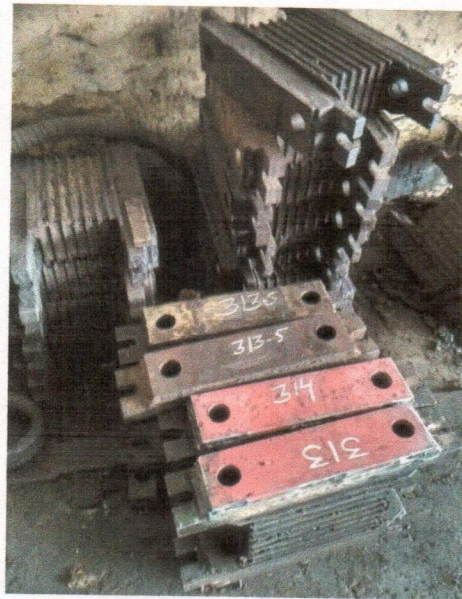
Fig.3: Old removed SMU

- During major overhaul removed SMU of 2013 batch was planned to use it again in loco as its dimensions were just with in service limit.

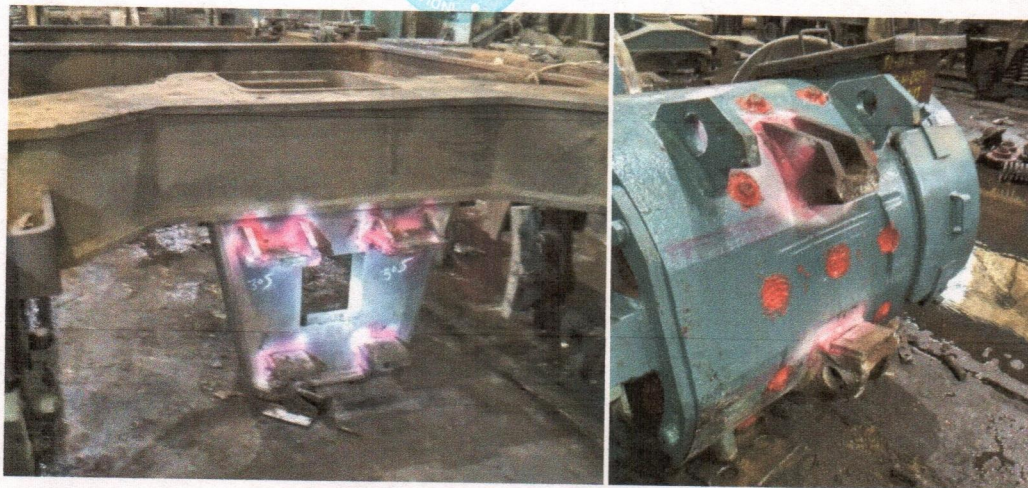
Fig.5: RDPT on TM nose stay and bogie lugs

- No record of SMU removed from loco is being maintained during major overhauling. Earlier it was being maintained since April' 2014.
- RDPT of TM and bogie lugs is being done during overhauling. Staff was aware of correct RDPT process that to clean the job and remove the paint before doing RDPT.

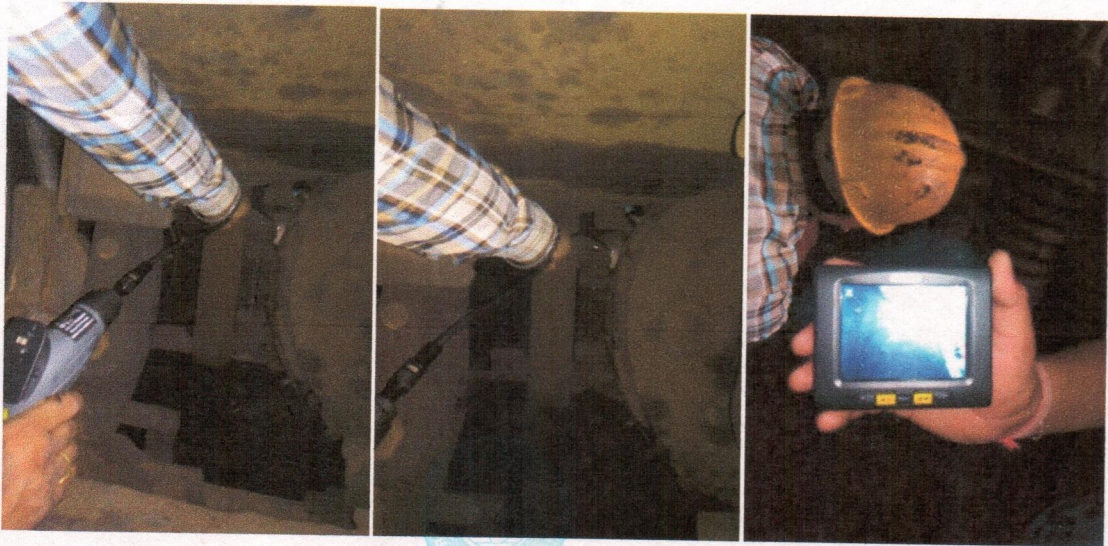
Fig. 6: Use of Boroscope for detection of crack

- Gap of TM lugs was being checked with go-no-go gauge. No such gauge was available for checking of gap of bogie lugs, it was being measured with vernier caliper.
- As per TC 126 during minor schedule gap between traction motor bottom nose and SMU is being checked and record is being maintained. Although the gap is not being measured in a proper way. It is being checked by finger tips and being recorded in ambiguous manner.
- ELS/MGS is checking cracks of TM nose/lugs by boroscope during minor inspection, which is a good practice.

- Go-no-go gauge can also be developed for bogie lugs. These should be calibrated from time to time.
- An 'L' type go-no-go gauge can be developed for checking of gap between traction motor bottom nose and SMU or filler gauge can also be used.
- Other sheds may also purchase boroscope and check for TM nose/bogie lugs crack.
