A. PROCEDURE FOR REPAIR OF CENTRE PIVOT BOTTOM CROSS PALTE AS PER ARRANGEMENT SHOWN IN CLW DRAWING NO. 03/1/31/2.

B. SYMPTOMS OF POOR WELDING OF VERTICAL PLATES (ITEM NO.6) IN WAP1/WAP4 LOCOMOTIVES :

C. PROCEDURE FOR CHECKING THE HEALTH OF BOX SECTION FORMED BETWEEN TOP CROSS PLATE (ITEM NO.31) TWO VERTICAL CROSS PLATES (ITEM NO.5) AND MIDDLE PLATE (ITEM NO. 14) AS PER ARRANGEMENT SHOWN ON CLW DRAWING NO.03/1/31/2

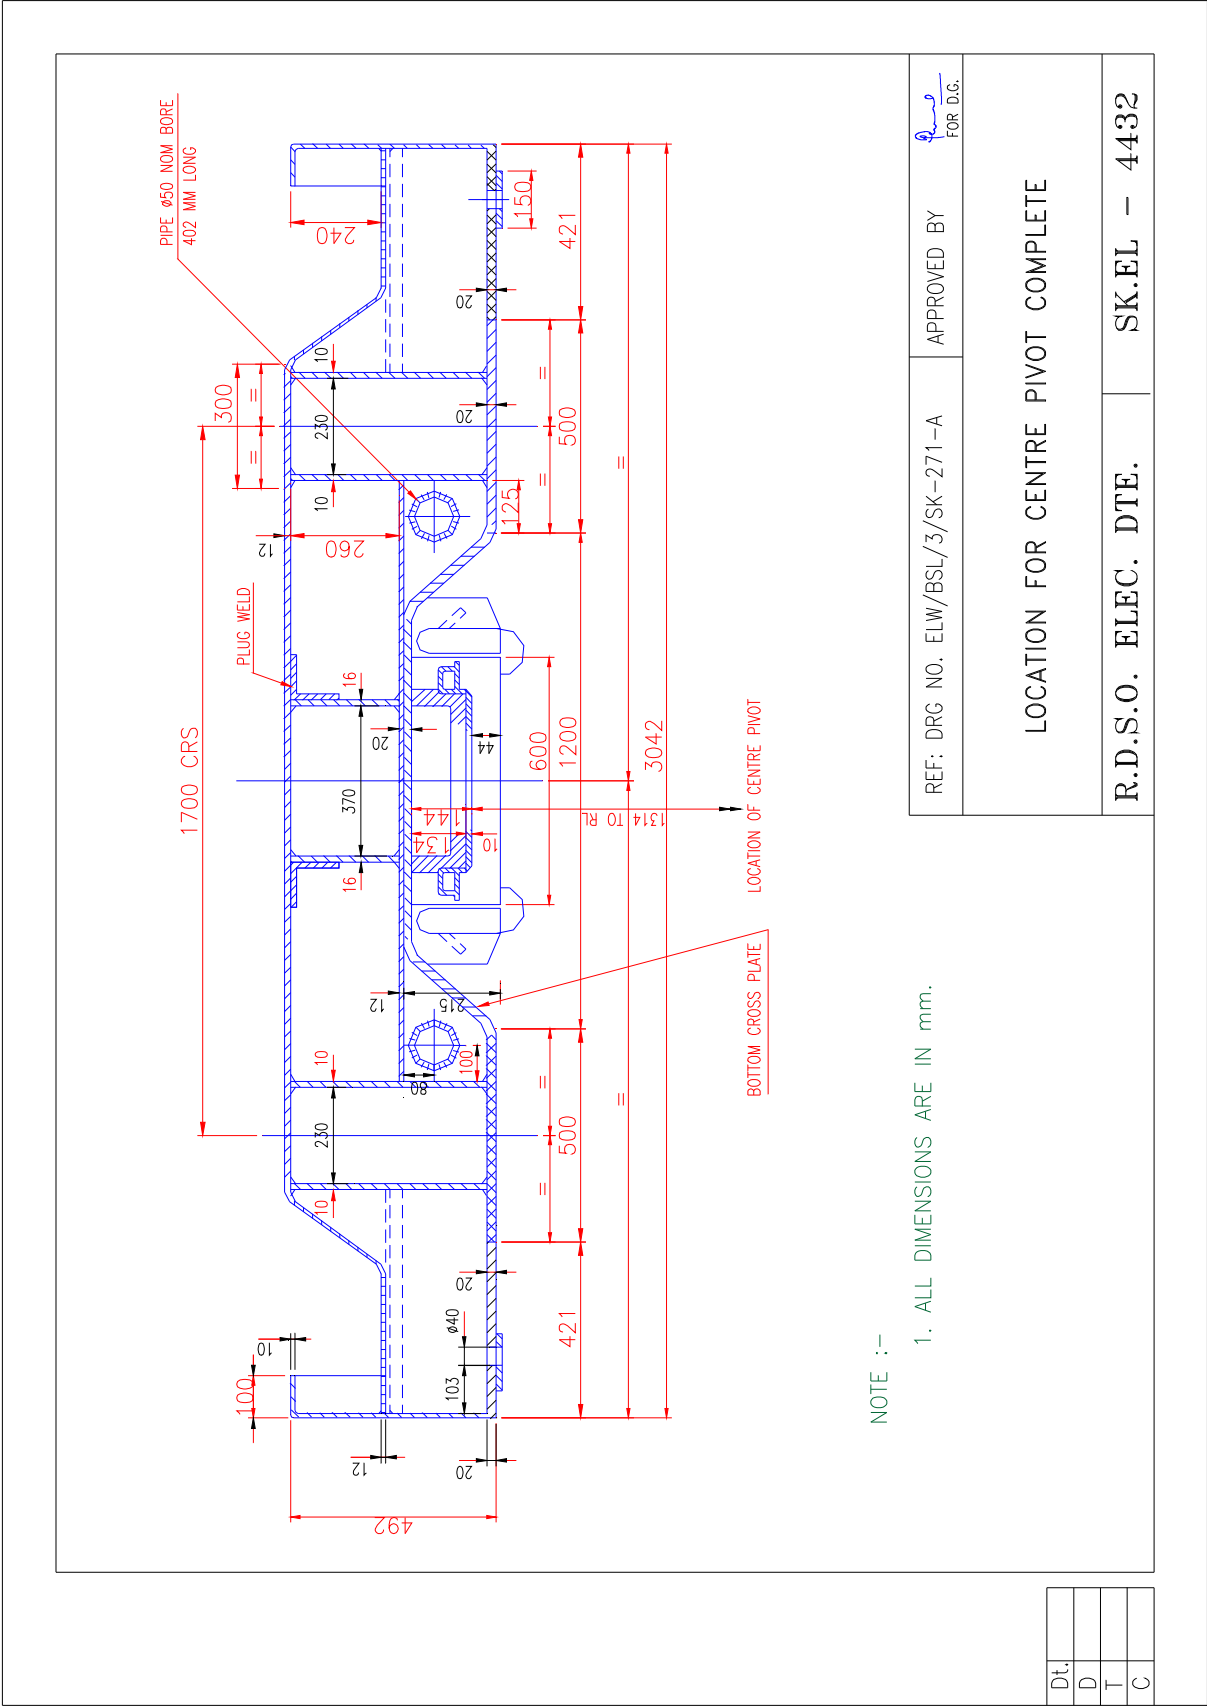
In almost all the cases above, vertical plates (Item No.6) were found very poorly welded with top cross plate (Item No.3) , two vertical cross plates (Item No.5) and middle plate (Item No.14). Since it is due to negligence during manufacturing at CLW, it may be existing in WAP1/WAP4 locomotives manufactured subsequent to 22007 (WAP1). It is therefore necessary that sheds keep a watch on symptoms as described above in B1 and should plate inspect centre pivot bottom cross carefully, during routine lifetimes of WAP1/4 locomotives.

- C4. Suitable peep holes should be cut in the top cross plate (item No.3 of Drg. No. 03/1/31/2) to check the welding condition of vertical plates (Item No.6 of Drg. No. 03/1/31/2) with two vertical cross plates (Item No.3) and middle plate (item No.14). The welding of vertical plates (Item No.6) with two verticals cross plates (Item No.5) and middle plate (Item No.14) should be continuous on all sides.

- C6. If the vertical plates (Item No. 6) are found only tack welded with two vertical cross plates (Item No.5) & middle plate (Item No.14) then top cross plate should be removed carefully by weld cutting and continuous welding of vertical plates (Item No.6) with two vertical cross plates and middle plate should be properly done on all sides. The condition of plug welds between middle plate (Item No.14) and bottom cross plate (Item No.4) should also be checked and redone if required.

- C.7 Suitable angles of 20 mm thickness may be welded with the two vertical plates as per enclosed drawing SKEL 4432 so as to provide accessibility for welding with top cross plate (Item No.3).
- C.8 Now new top cross plate (Item No.3) should be placed in original position and to be welded carefully with the longitudinal beams (Item No.2), Vertical cross plates (Item No.5) and plug welded with angles provided on vertical plates (Item No.6).
- C9. Now all the removed equipments should be fitted back in the reverse and locomotives may be released for normal service.
