Technical Investigation Report of Axle seizure due to Bearing failure of Traction Motor type 6FRA6068 fitted in Locomotive No. 30549/WAP-7/SRC on 24.04.2019 between Bhusawal –Badnera section on Bhusawal division.

No. RDSO/2019/EL/IR/0186 Rev. '0'

**ELECTRICAL DIRECTORATE
RESEARCH DESIGNS & STANDARDS ORGANIZATION
MANAK NAGAR, LUCKNOW-226011**

Investigation Report of Loco No. 30549 WAP-7, SRC failed due to wheel set-5 locked on 23/24.04.2019

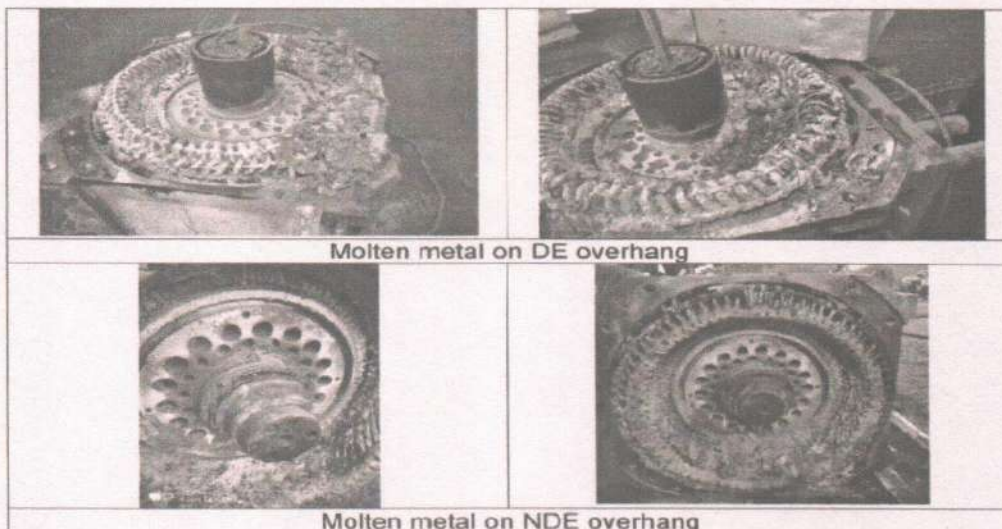
Common observations for DE and NDE side :-

- 1) Both DE and NDE bearings found seized.
- 2) No grease found inside DE as well as NDE bearing since burnt.
- 3) DE & NDE side winding badly melted at overhang portion and molten copper deposited on the bottom portion of overhang along with fire extinguisher powder and ash. Copper coils of winding were visible due to burning of insulation.
- 4) Molten metal found stick to copper coils on DE as well as NDE overhang.
- 5) Induction brazing material of rotor bars with end ring found melted on both ends.

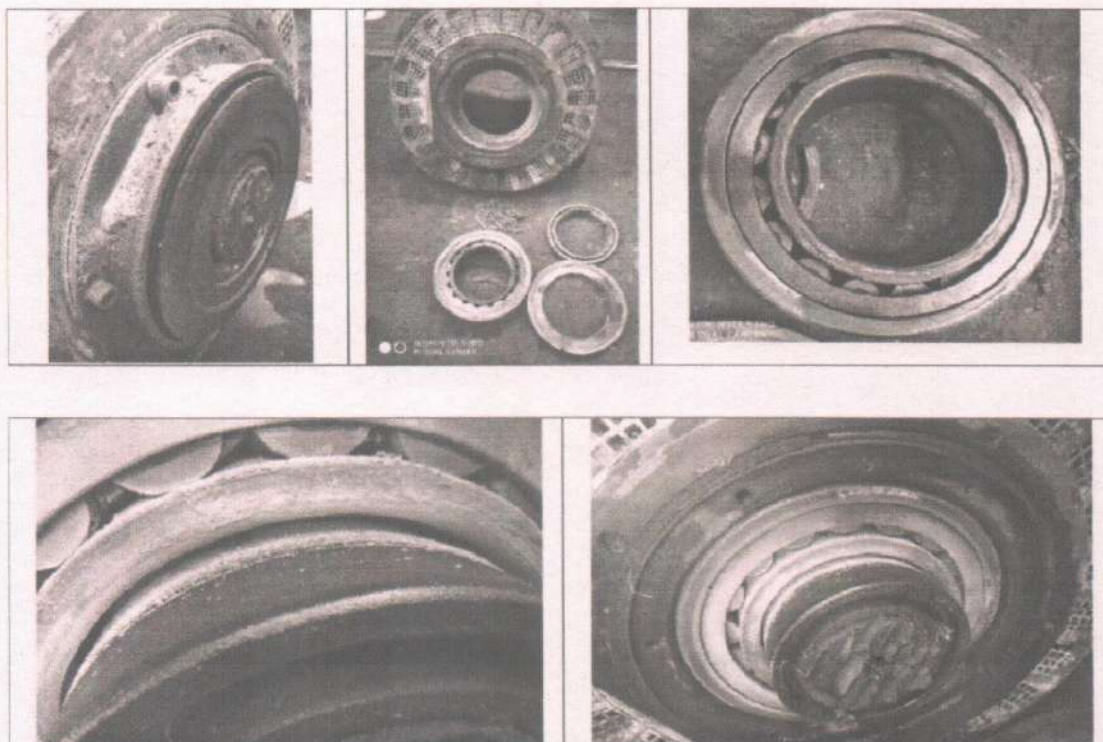
NDE side:

- 1) NDE end frame has overheating signs on its complete periphery.
- 2) NDE side 3 Nos. lock plate bolts found intact (size M16 X 45) with proper tightness . Same removed for dismantling the rotor. (One no. bolt broken during dismantling)
- 3) Tried to remove NDE end shield along with rotor from NDE side but could not be removed out since burnt material and molten metal trapped between stator and rotor and NDE side bearing stuck up with inner racer on shaft and labyrinth.
- 4) NDE grease cover removed out. Angle ring (Annular ring) found badly rubbed with rollers.
- 5) NDE Brass cage all rivets found broken & front ring came out, rollers de-shaped and accumulated at one place.

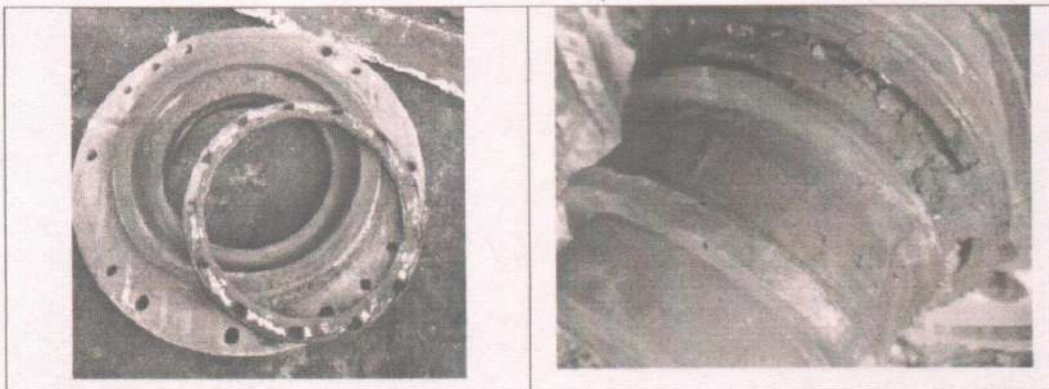
SN	Description	Standard dimension as per MS 0415 (in mm)	Measured dimension on 26.04.2019 (in mm)
1	NDE end shield ID at bearing seat	214.948 to 214.960	214.914 /214.920 / 214.951
2	NDE bearing outer racer OD	214.970 to 215.000	214.185 & 214.047
3	Shaft OD for NDE inner racer seat	100.023 to 100.045	99.920 /99.980

NDE end shield bore for outer racer seat found undersize despite rotation of outer racer. OD of outer racer drastically reduced due to wearing of ceramic coating due to its rotation. Considering the standard OD of NDE outer racer (214.990 mm), the interference seems to be in the order of 49 to 76 micron.

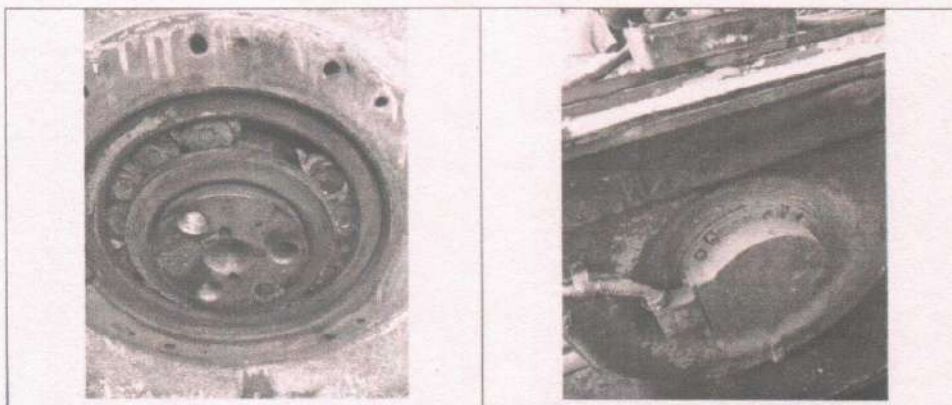
**Other observations :-**

- 1) Temperature sensor Florican make, values checked and found AB-109 Ω and CD-154.4 ohms. Lead insulation of both elements completely melted. Silicon rubber gasket burnt to ash. Element and fixing bolts badly overheated.
- 2) Speed sensor badly rubbed with PG ring & damaged. (Speed sensor make Medha)
- 3) Terminal box of traction motor found badly overheated & green coloured RTV found melted & spread inside the junction box.
- 4) Some portion of speed & temperature sensor cables, which were touching to stator body found burnt.
- 5) All the measurements of DE and NDE side will be jointly checked by CLW and KMRI, HWH representatives afterwards as desired by CEE/TM/CLW.

Conclusion : From the above observations it is suspected that the DE bearing seizure is the after effect of NDE bearing failure. Whereas the probable cause of failure is suspected as NDE side bearing seizure due to very high interference between NDE outer racer and end shield bore.
