भारत सरकार - रेल मंत्रालय
अनुसंधान अभिकल्प और मानक संगठन
लखनऊ - 226011
Government of India - Ministry of Railways
Research, Designs & Standards
Organization, LUCKNOW - 226011

No. EL/11.5.5/5

MODIFICATION SHEET NO. RDSO/2010/EL/MS/0393 (Rev.0), Dated 22.11.2010

Modification to address failures of Auxiliary converter cards.

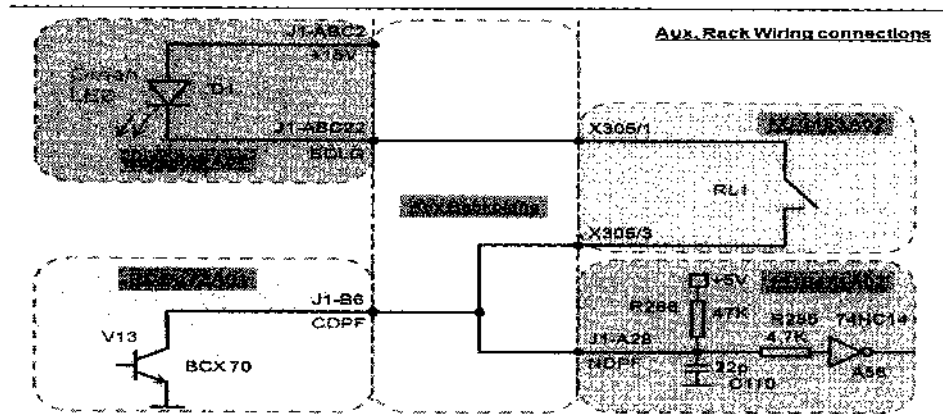
Figure-1

- 2.1 There have been many failure cases reported in auxiliary converter cards of controller board (PPB471A02), chopper/GG/WRE controller (RDB472A01) and KUC153A01. In most of the cases life sign missing cases from PPB471A02 and KUC153 A01 have been reported. In some cases failures of transistor BCX70 (position V13 on board) on RDB 472A01 has been reported.

- 2.2 It has been reported by TOT partners that some of the failures occurs during functional testing also without any apparent reason.
- 2.3 On analysis of these failures it has been noticed that reversal of connector X305 in the back plane of KUC153 A01 card is leading to the wrong connections and consequently failures are taking place. This connector is no mechanically coded and has only two wire connections. When connector X305 is wrongly connected (connected upside down), the circuit formed is shown in figure 1. In this case +15 Volt supply connects via green LED on KVB993 card to relay RL1 on KUC153 card. The other end of this connects to the collector of transistor V13 on RDB 472. Sometimes transistor V13 gets turned on before relay RL1 is completely opened therefore leading to a short circuit of +15 V supply to ground for a short duration. As a result of this the voltage output of KUC153 may fall and this could lead to an interruption of the life sign from auxiliary converter rack to the VCU. This may also interpreted as a problem of "life sign missing" with KUC 153 card or PPB471 card. In some cases transistor V13 on RDB 472 also fails. The flow of current is shown in figure-2.
